LYNDHURST GATEHOUSE

Tech Notes

NUMBER 3

Exterior Storm Windows: Casement Design Wooden Storm Sash

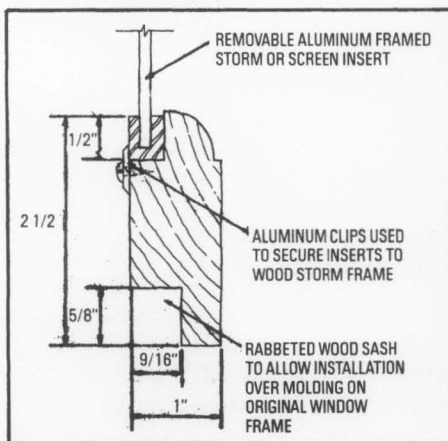
Figure 1. The single casement, wooden storm window had two removable panels for screen and glass inserts. This custom design fulfilled a variety of requirements established for the project with minimum physical damage and visual changes to the historic windows. Drawing: Martha L. Werenfels

dows and attached to the existing frame (see figure 1). The arched-headed wooden storm window with one-over-one glass panes matched the size of the original double-hung sash. Molding details similar to the original were incorporated in the new storm sash. Each of the two panes in the storm sash was set in thin aluminum frames and secured in the wood storm window with standard clips. This installation technique enables the storm panels to be easily removed by a person on the inside of the house and replaced during the summer with screens (see figure 2).

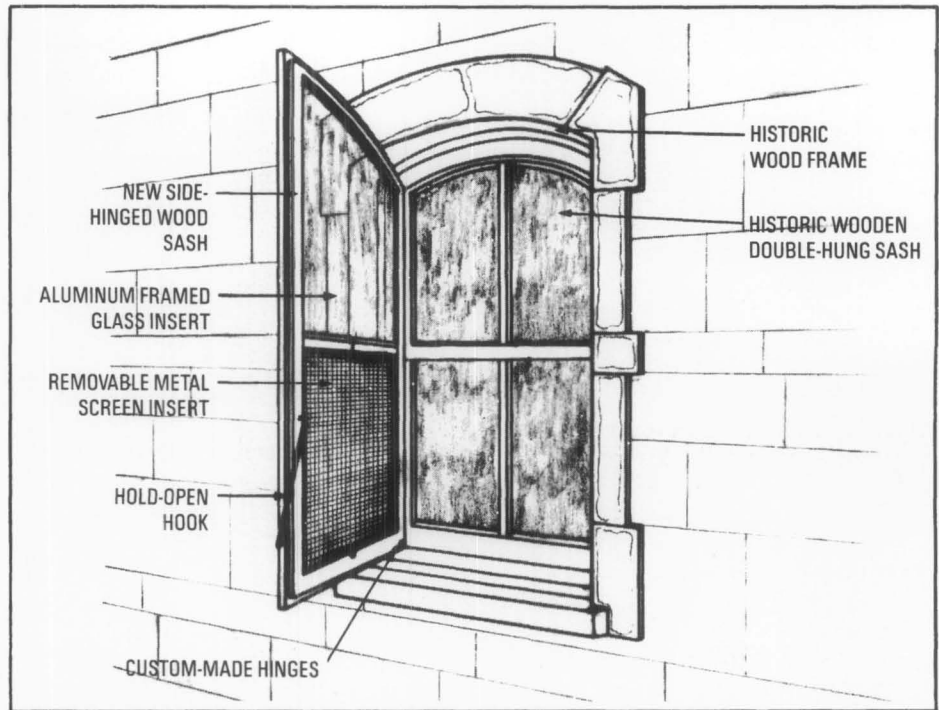
Figure 2. Section of the wood stile shows how the removable screen and storm panels are secured by use of aluminum clips. Also note that the storm sash was rabbeted along the inside edge to allow retention of original window molding. Drawing: Martha L. Werenfels

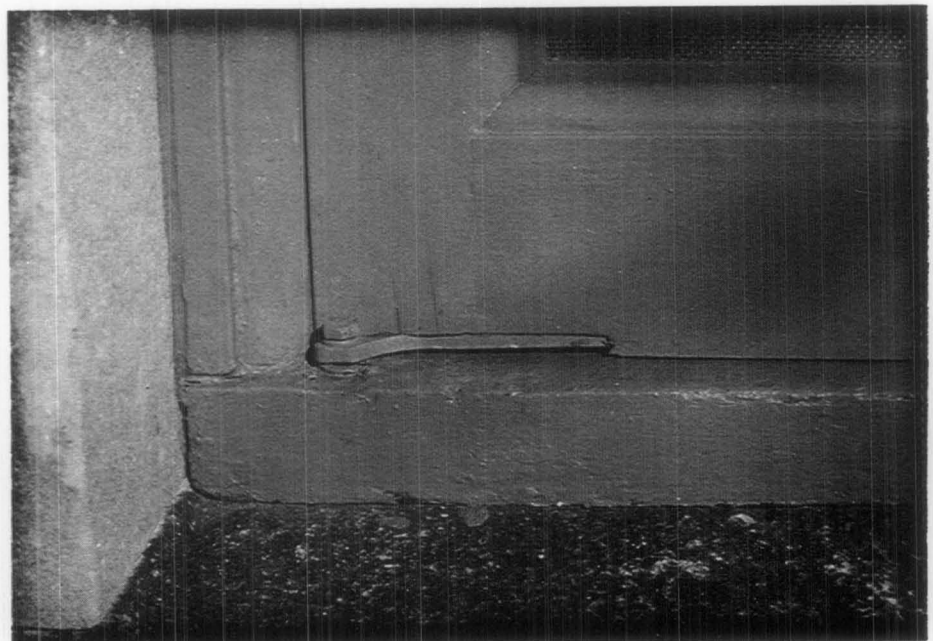
Figure 3. The only feature of the storm window that required expensive custom work was the pin-in-socket hinges (bottom one shown in photograph). Commercially available hardware could have been used; however this project sought to minimize physical damage to historic woodwork and thus tested a prototype design. Stainless steel was used for reduced maintenance costs. Photo: Richard Bierce, AIA

Mounting hardware consisted of pin-in-socket hinges which required the drilling of only two holes in the existing frame (see figure 3). The hinges allow the window to open casement-style for egress and ventilation purposes.

Custom-made stainless steel hinges of a pin-in-socket design were attached to the left side, top and bottom, of each window. The windows were then sanded, treated with a non-toxic preservative, and primed with an oil-alkyd paint.

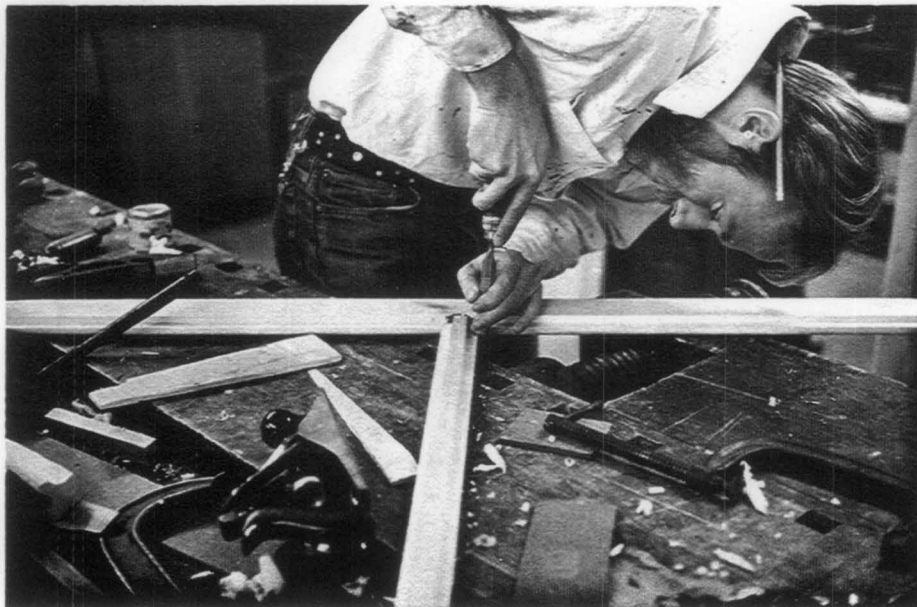
Figure 4. The center muntin in the storm window lines up with the meeting rail on the historic sash and is shown here being fitted to the wood stile. Photo: Courtesy, National Trust for Historic Preservation

In fitting the windows together, the parts were glued at the joints with resorcinol glue, dowels inserted, and the clamps attached while the glue hardened overnight (see figure 4). After the joinery was completed, the tops of the stiles were cut to fit the curvature of the arch. For the first floor windows, a 5/8" by 9/16"

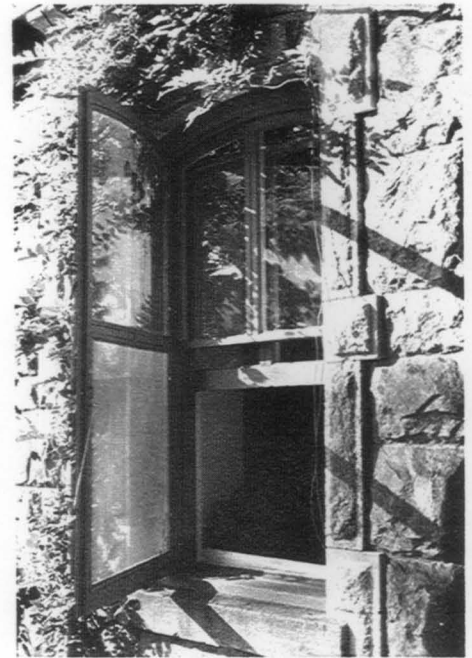
Figure 5. The new wooden storm sash was installed in the historic frame; the edge of the storm frame was rabbeted to accommodate the historic molding on the old wood frame. Photo: Richard Bierce, AIA

wood preservative used on the sash, then filled with a polysulfide caulk before the anchor was inserted. After the windows were installed, 1 inch hook-eyes were attached to secure the windows shut while a second hook-eye, 1 foot long, was installed on each window to hold it in a fixed position when opened (see figure 5).
