# Tech Notes

## OLD WATKINS NATIONAL BANK

## WINDOWS NUMBER 5

### Interior Metal Storm Windows

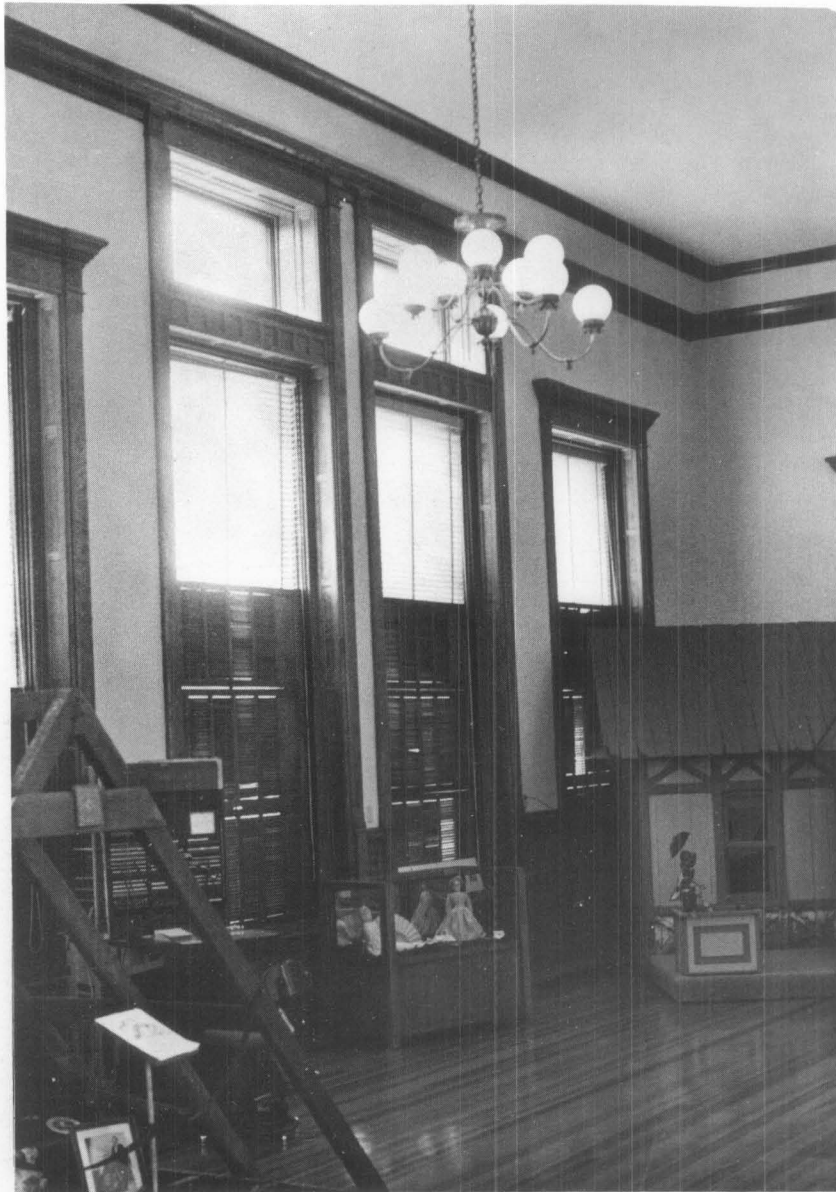
**Figure 1.** The monumental windows are elegantly detailed on the interior and contribute to the grandeur of the spacious banking rooms. The original interior shutters are still being used for comfort and light control. Photo: Charles E. Fisher

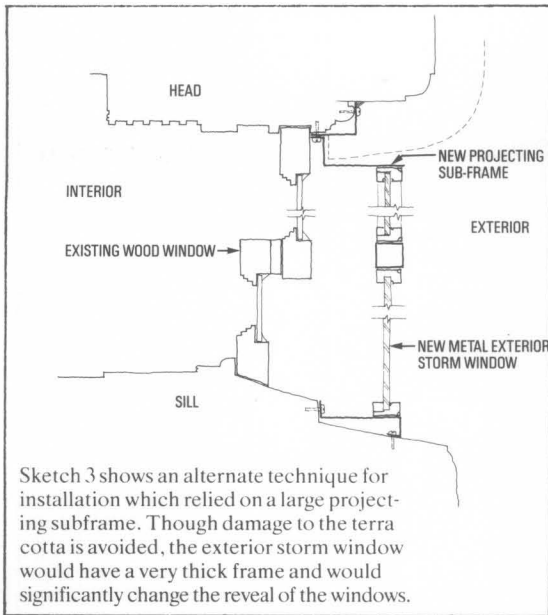
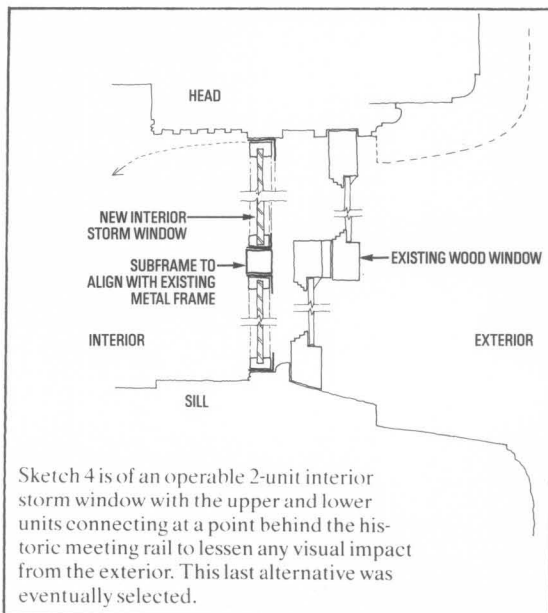
Use of exterior storm windows was initially explored both for energy conservation purposes and as a way to extend the useful life of the original windows (*see figure 2*). Unfortunately, the prices quoted for exterior storm windows by local contractors were around \$65,000, nearly double the budgeted amount. In addition to the high cost of exterior storm windows, one further problem with an exterior storm application arose when it was discovered that the decorative terra cotta capitals adjacent to the upper level window openings returned against the original frames. As a result, the proposed exterior storm windows could not be easily installed in these locations without cutting back or covering portions of the terra cotta (*see figure 3*).

Figure 3. Exterior storm windows were initially considered but presented several problems. The terra cotta capitals on the pilasters returned against the windows, making normal installation difficult without damaging the terra cotta. Many of the windows also had round heads which would require additional custom work—these same windows on the interior had square tops. Photo: Charles E. Fisher

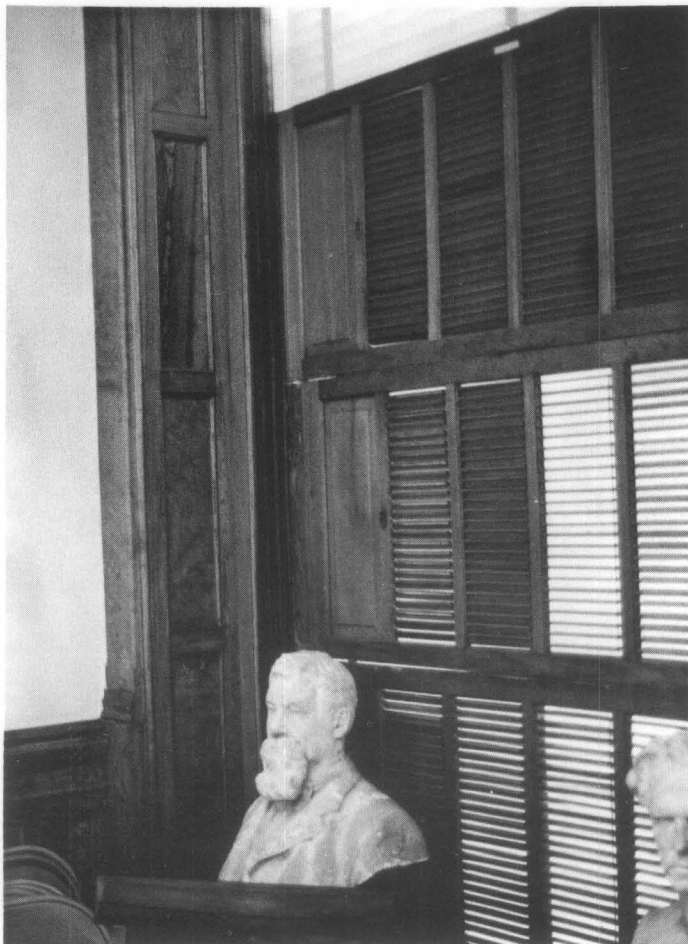
Figure 7. Continued use of the unique shutter system required that the frame of the interior storm window be narrow. The storm windows are set between the shutters and the historic sash. Photo: Charles E. Fisher

vided a sufficiently wide dead air space for energy conservation purposes, yet still allowed the interior shutters to remain operable (see figure 7).

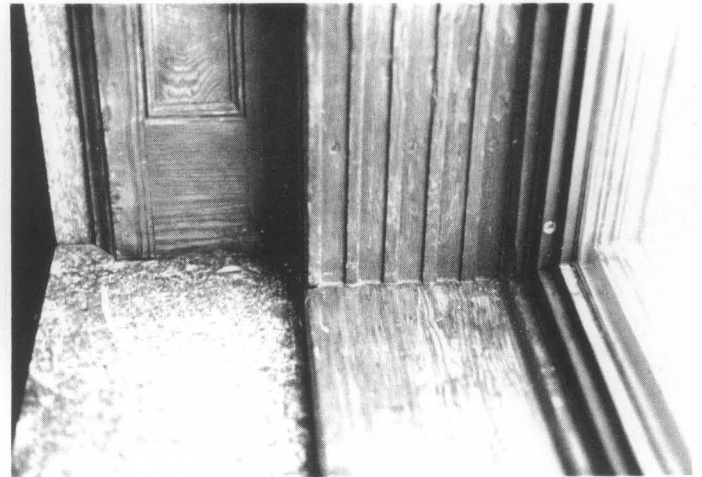
Figure 8. The decorative jamb panel on the left and the interior shutter tracks were unaffected by the installation of the interior storm window shown on the right. Photo: Charles E. Fisher
