COLONIAL WILLIAMSBURG

Tech Notes

NUMBER 9

Interior Storm Windows: Magnetic Seal

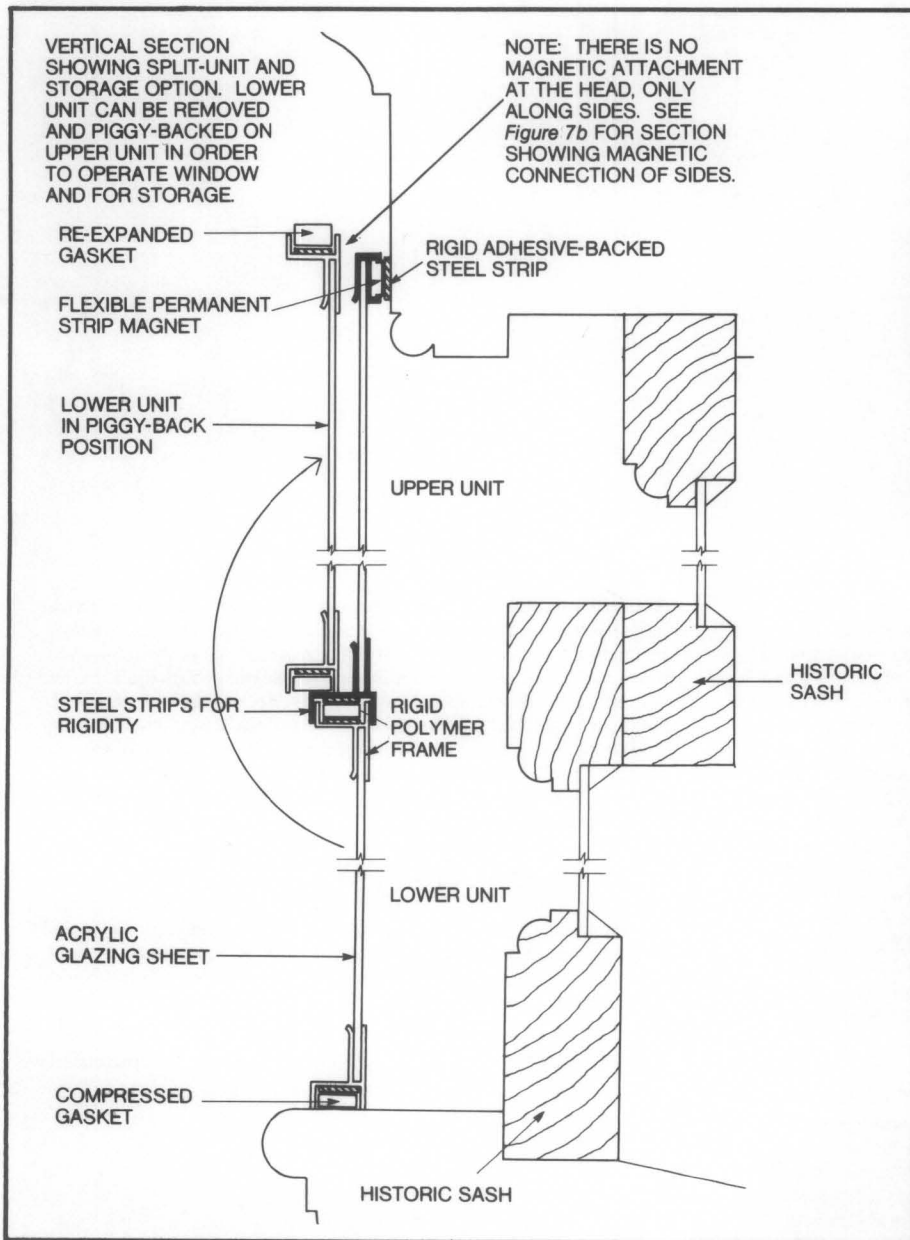
The storm window design most commonly used at Colonial Williamsburg consisted of a separate upper and lower part with an interconnecting meeting bar. This style was used in windows where the original double-hung sash needed to remain operable. A split-unit interior storm window has an advantage over a single unit in that it did not need to be removed and stored in the summer months. By attaching the lower unit to the upper unit via a magnetic seal, the storm window could be left in place, thereby avoiding problems of storage and reducing the chances of the acrylic sheets being scratched or warped (see figure 3).

Figure 3. Vertical section showing a split unit in place and the option of piggybacking the lower unit onto the upper for storage during the summer. See figure 6 for detail on the manner of attaching the piggybacked unit. Drawing: Christina Henry.

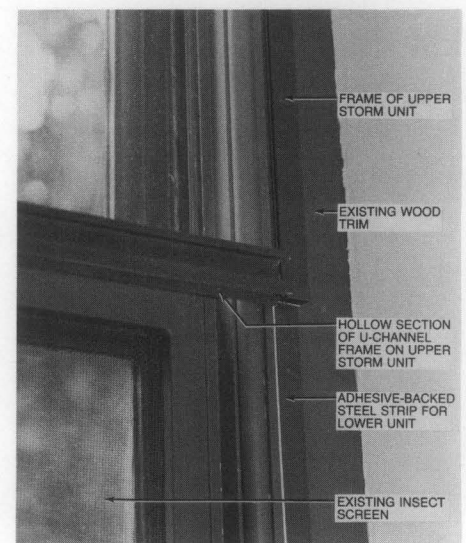
Figure 4. This view shows only the upper unit in place. The U-channel along the bottom of this unit was designed to fit over a similar U-channel at the top of the lower unit. With the lower unit removed in summer as shown, only the adhesive-backed steel strip is visible. Photo: Tom H. Taylor.

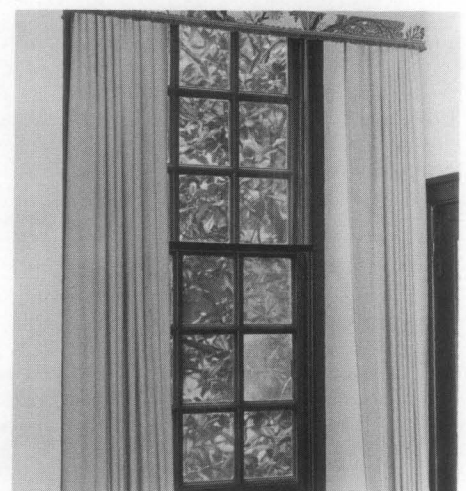
The placement of this meeting bar primarily depended on its visual impact on the outside. Where the historic upper and lower sash were the same size, the meeting bar of the interior storm was lined up as closely as possible behind the meeting rail of the historic sash (see figure 5). In a number of windows, however, the pane configuration made it harder to disguise the appearance of the interior storm meeting bar from the outside. These windows had 6 panes over 9, the bottom sash being considerably larger. In such cases, it was specified that the bottom of the top storm unit would stop at the first horizontal muntin below the meeting rail on the historic sash.

Figure 5. The meeting bar of the split storm unit shown in place was located adjacent to the historic meeting rail in windows where the upper and lower sash were the same size. Photo: Tom H. Taylor.

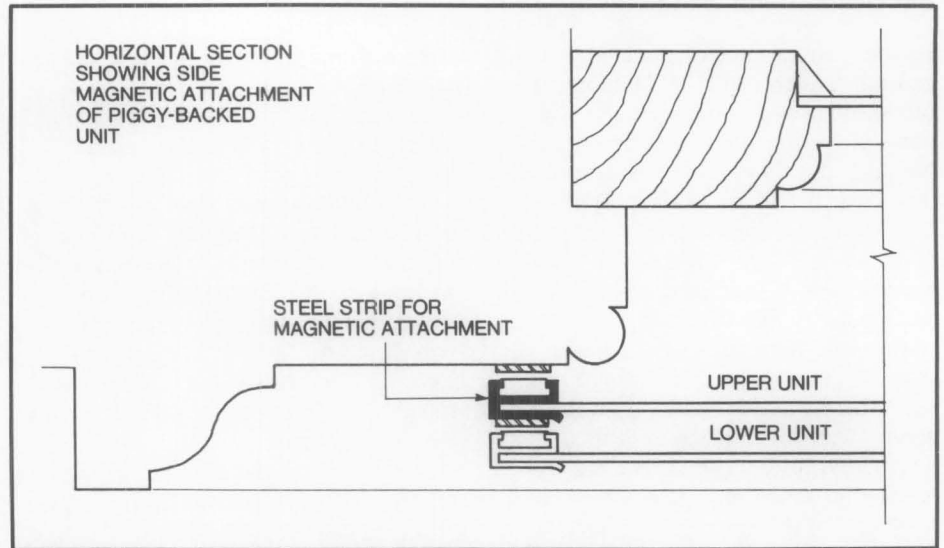
To allow for the storage of the lower unit, an adhesive-backed steel strip was attached to the face of the vertical polymer frame on the upper unit. Thus the two vertical framing members in the upper unit had a magnet on one side and a steel strip on the other. The addition of the metal strip allowed the lower unit to be magnetically attached to the steel on the upper unit when in a storage position (see figure 6).

Figure 6. Horizontal section of the upper storm unit shows how with an additional adhesive backed steel strip added to the sides of the upper storm frame it was possible to piggyback the lower storm unit for storage purposes during the summer. Drawing: Christina Henry.

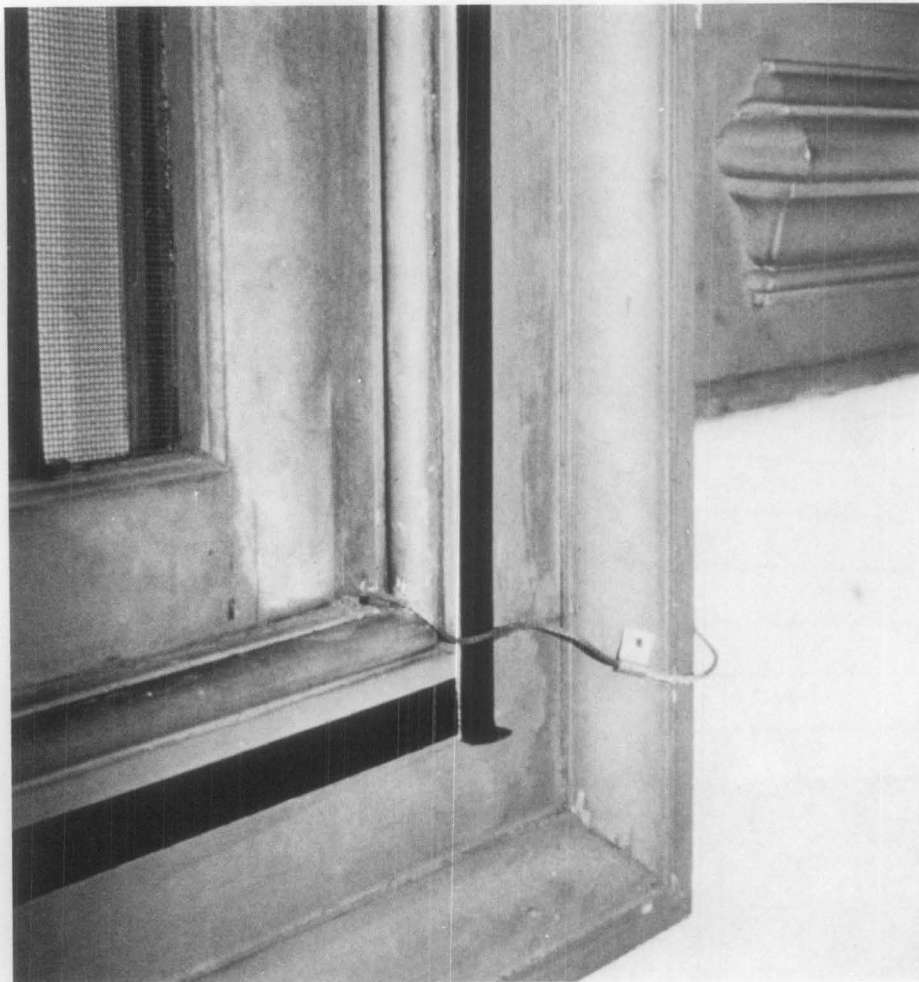
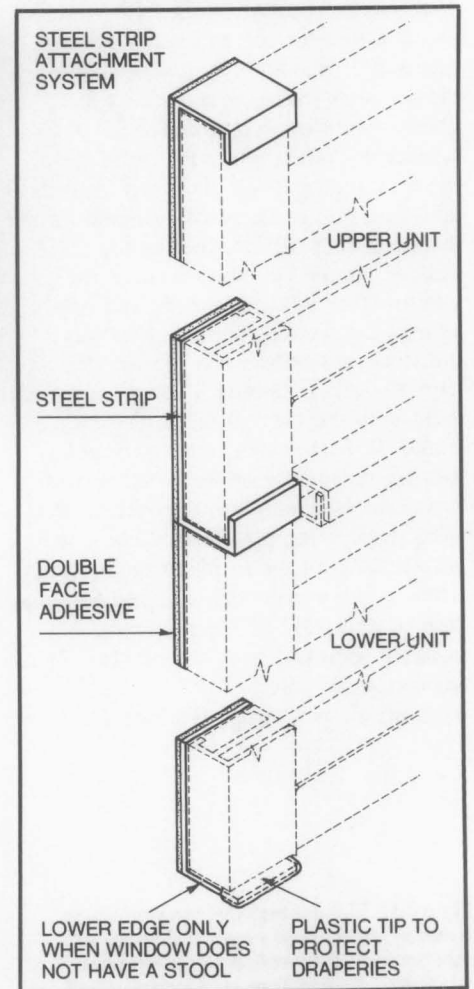
To keep the upper unit from creeping downward due to the additional weight of the piggybacked lower storm, a $\frac{3}{8}$ " shelf with a $\frac{3}{16}$ " upward turn was formed in the two wood-adhering vertical steel strips at a point aligning with the bottom of the upper unit (see figure 7).

A similar feature was added at the bottom of both single and split units when no stool existed in the historic window. To deter possible creeping and, as a safety measure, the bottom of the vertical steel strip was turned 90 degrees outward to act as a small shelf for the storm window. A small plastic tip was attached to the sharp edge of this shelf to protect draperies.

Figure 7. (a) In cases where there were no stools and also where a split unit was used to facilitate self-storage, small "shelves" were made in the vertical steel strips to deter creeping. Photograph shows a 90 degree angle at the bottom of the vertical steel strip in a situation where there was no stool. Photo: Tom H. Taylor. (b) The adjacent drawing shows the two "shelves" used with split units as well as a top safety catch formed at the end of the steel strip. Drawing: Christina Henry.

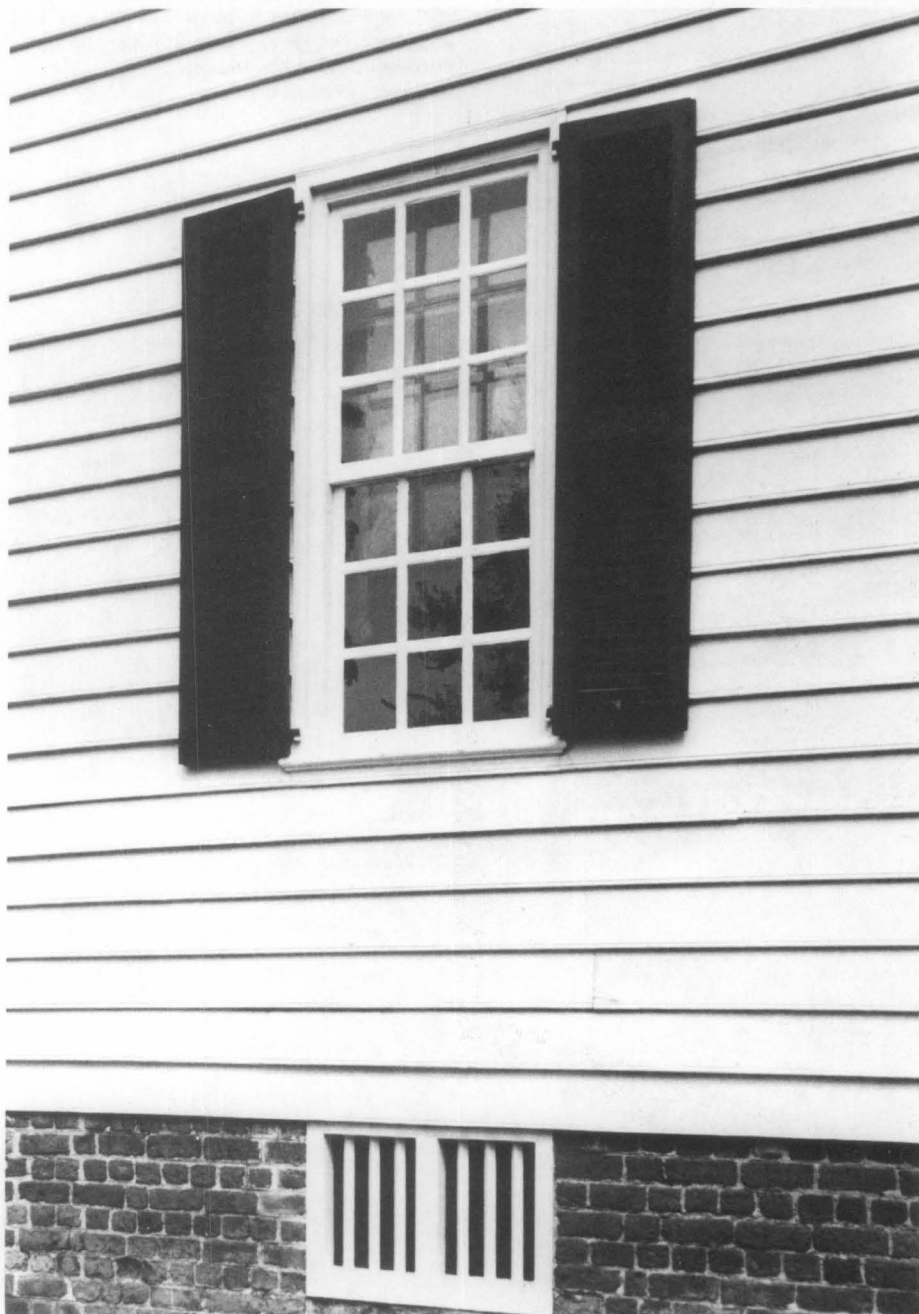
The unobtrusive nature of these storm windows is an advantageous feature, along with the fact that no physical damage or alteration to the original window is required (see figure 8).

Figure 8. The unobtrusive interior storm window required no physical damage or exterior visual alteration to the original window. Photo: Tom H. Taylor.
