COLCORD BUILDING Oklahoma City, Oklahoma

Tech Notes

NUMBER 8

Thermal Retrofit of Historic Wooden Sash Using Interior Piggyback Storm Panels

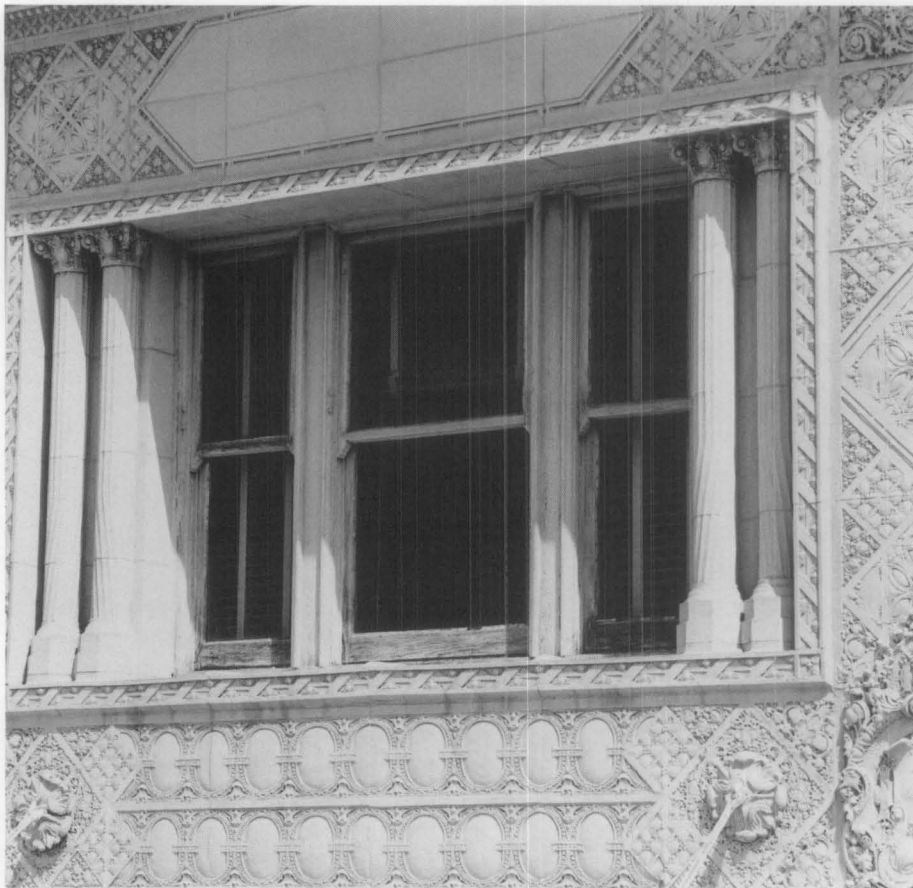
Figure 1. Deeply recessed windows with ornamental terra-cotta surrounds were character-defining features of the building which the owner wanted to retain. Photo: Jack Graves, AIA

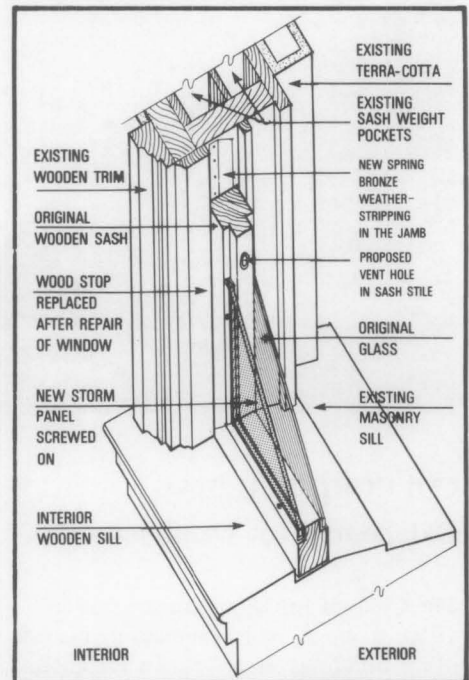
This approach would necessitate routing or cutting out a portion of the historic wooden sash and would add to the weight of the sash due to the attached storm panel. The sash rails and stiles measured 1-7/8" deep by 2" wide and were in sound condition. They were therefore capable of tolerating the required cut—3/8" deep by 1/2" wide. The issue of the additional weight of the storm panels was directly related to the choice of materials selected for the piggyback units. Since acrylics are purported to be 40% lighter than glass and 15% more thermally efficient for the same thickness, the architect investigated their use. Because of expense and the tendency of acrylic to bow or discolor due to sun

Figure 2. Cutaway view of the proposed retrofit solution showing how the historic sash would receive a recessed storm panel through routing or cutting an inside rabbet. Drawing: Sharon C. Park, AIA

While researching new window units, the architect found a commercially available wooden replacement window that incorporated a removable storm panel piggybacked onto the single glazed sash. This second layer of glazing was recessed on the inside of the primary wooden sash, allowing the double-hung window to operate without interference from the applied panel. The architect applied this concept to the Colcord Building's windows and proposed to retrofit a recessed storm panel to each existing sash, provided it would not structurally weaken the sash in the process (see figure 2).

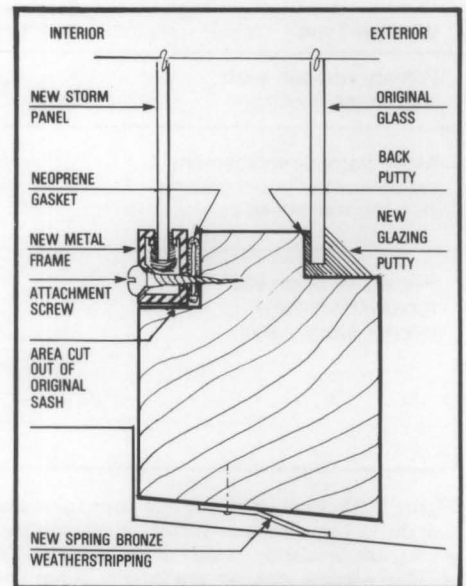
Figure 3. The completed retrofit shows the storm panel screwed onto the historic window. Photo: Tamara Coombs

As the panels would only be removed for maintenance purposes, the architect determined that the panels simply could be screwed in place, using a neoprene gasket set on the back side of the panel as a seal (see figure 3). Should the panels ever need to be removed, an electric screw gun would do the job quickly (see figure 4).

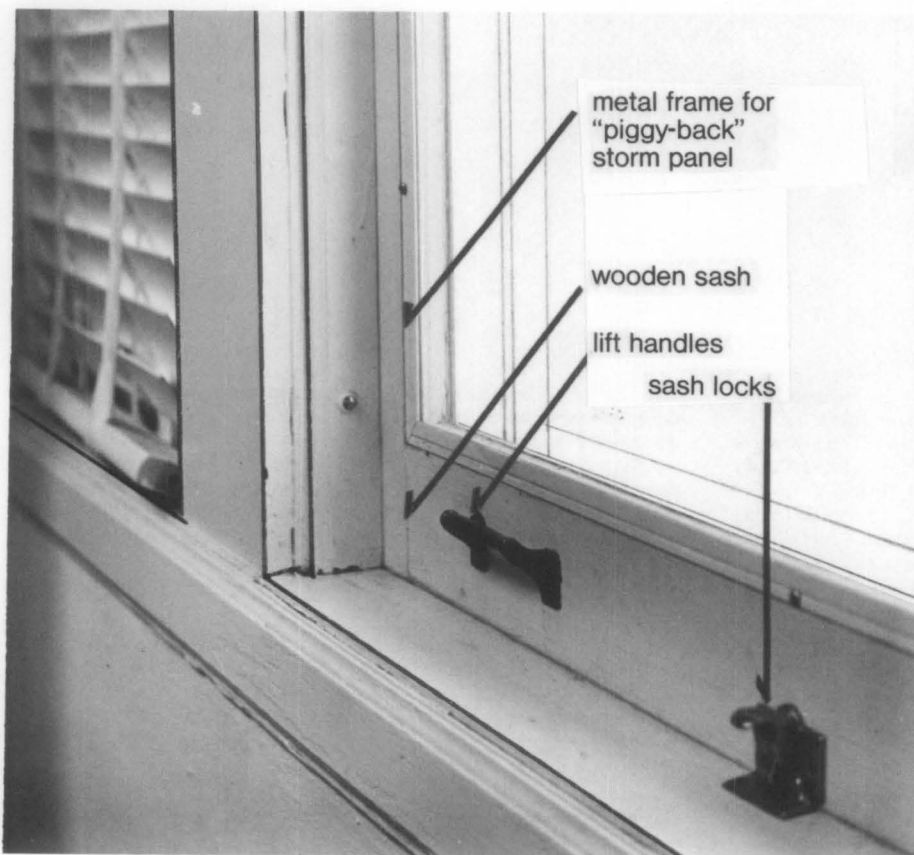
Figure 4. The applied interior storm panel was screwed in place. Note the use of the neoprene gasket, which provides an air seal between the storm panel and the historic wooden window. Drawing: Sharon C. Park, AIA
