# **HE Machining Complex & Support Buildings Deactivation and Decommissioning Project at the Pantex Plant**

This paper describes the issues related to the deactivation and decommissioning of a very unique building at the Department of Energy's Pantex Plant located in Amarillo, TX. Building 12-24 was unique in the fact that it had a number of obstacles that have not been previously addressed in the deactivation and decommissioning (D&D) of a single structure such as asbestos, beryllium, possible radionuclide contamination, lead paint, heavily reinforced concrete walls, and high explosive (HE) contamination inside and out. To date, the building has been razed and the majority of all equipment has been disposed of. Remaining work includes concrete and soil debris removal, earthen barricade removal, and site leveling.

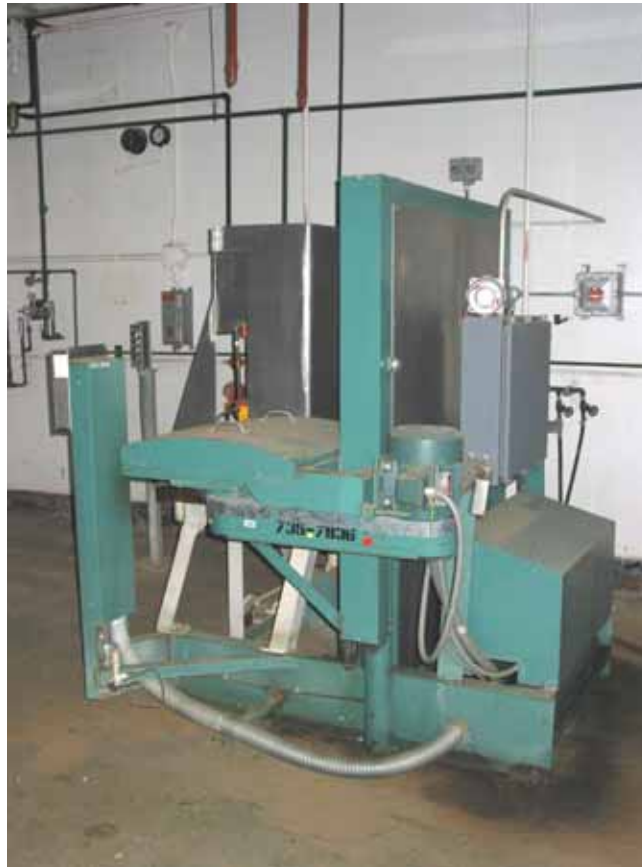
**Figure 1: Bay 1 Saw**

<b>Location.</b>	<b>Machine</b>
Bay 1	Band Saw/Well Saw (Figure 1)
Bay 3	Olofasson Lathe
Bay 7	High Performance Mill (Figure 2)
Bay 9	High Performance Mill
Bay10	Moore Mill
Bay 11	Bourn & Koch Vertical Turret Lathe
Bay 13	High Performance Vertical Lathe (Figure 3)
Bay 15	Mill and Lathe (Figure 4)

Equipment that was contaminated with HE was subjected to a process known as flashing. Each piece is loaded into a flashing chamber, which is located on the Pantex site. The flashing chamber is a thermal device used to remove HE contamination by subjecting the items to intense heat and flame for a set period of time. Thermocouples are installed inside the chamber to ensure that the equipment and environment reach a high enough temperature to completely burn any HE or HE residue that may be present. After being flashed, the equipment can then be disposed of in a more traditional manner such as being recycled as scrap metal.
