Post Storm Event - Considerations For Repairing Damaged Concrete and Clay Roofing Tiles

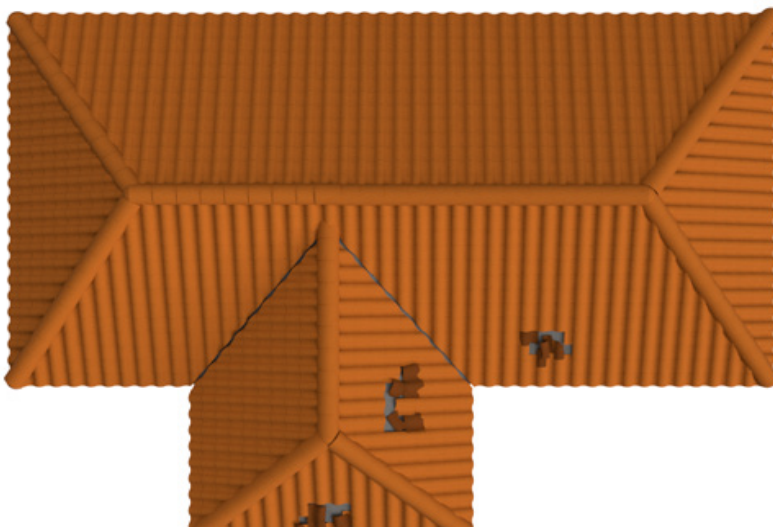
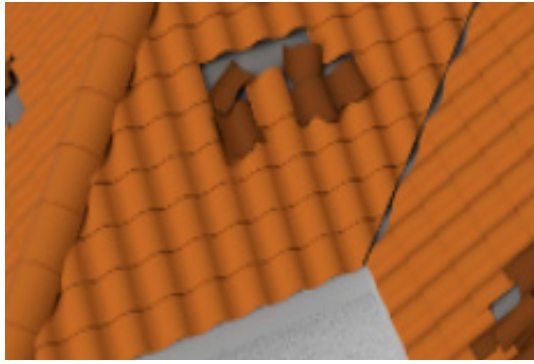
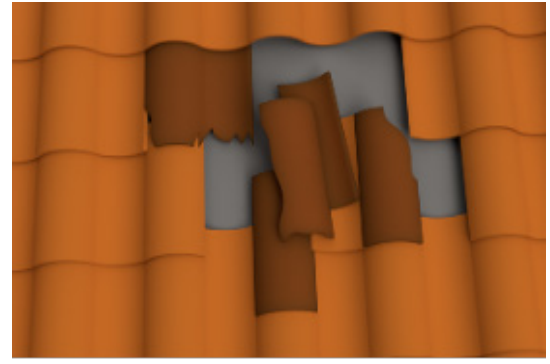
Example of tile roof damage created by wind-borne debris:

A roof as illustrated below that experiences minimal damage may be repaired or the Harvest and Repair method may be used in accordance with the Florida building code, which states, “not more than 25 percent of the total roof area or roof section of any existing building or structure shall be repaired, replaced or recovered in any 12-month period unless the entire roofing system or roof section conforms to requirements of this code. Total roof area may be determined via field measurement, or via commonly available aerial measurement programs. *(see footnote 1)*

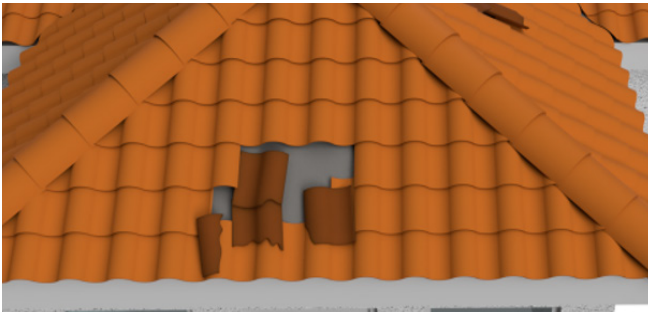
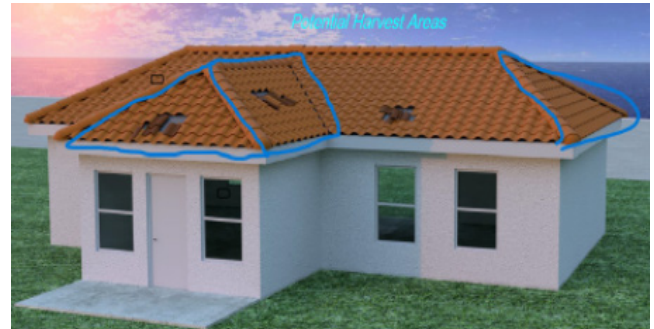
Example of a “Harvest Area”:

When tiles of exact fit and finish are not available for necessary repairs, however tiles of similar shape and finish are available **AND** the roof design possesses an area where hip and ridge tiles provide a natural break between roof planes, the roof tiles may be harvested from “hip to hip” or “gable to gable” and used to facilitate street visible repairs. Hip & ridge tiles cover the cut edges of field tiles, so they don’t require interlocking with original tiles and can be used with similar, but different field tiles. Spare tiles may be stored by owner for future repairs.

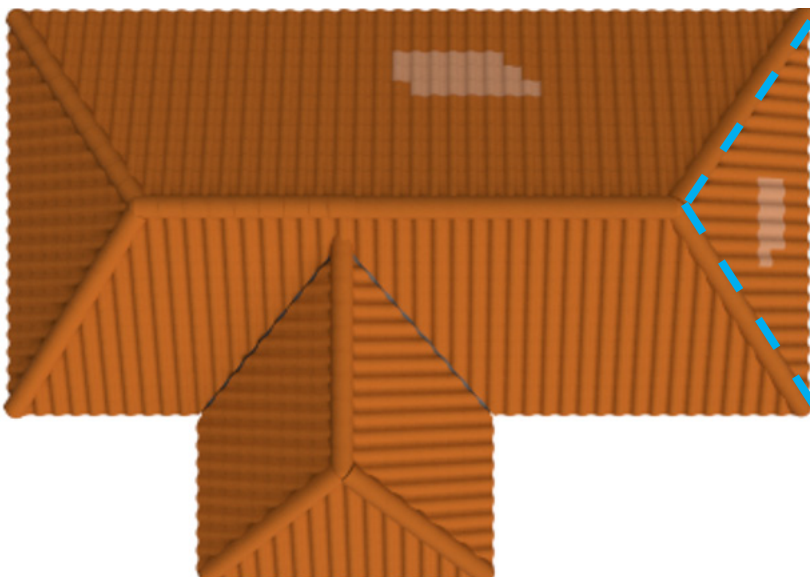
Example of completed repair:

Plane or roof area that was removed and installed with new tiles. (when similar tiles)

If new tile design, then remove entire roof plane (hip to hip)

New tile may appear different in color when viewed up close, but will blend into the roof when viewed from a distance.

In most instances the repaired tiles will not match the existing tiles due to naturally occurring aging. Your roofing contractor may recommend color coating the repair roof tiles to assimilate with the majority roof tiles to the best of his/her ability. Color coating repaired roof tiles does not affect the integrity of the tile roof.
