# A Rotting Timber Frame

Foam sheathing, too much moisture, and a broken vapor barrier almost spelled disaster for a four-year-old timber-frame house in southern Vermont.

## by Steven Bliss

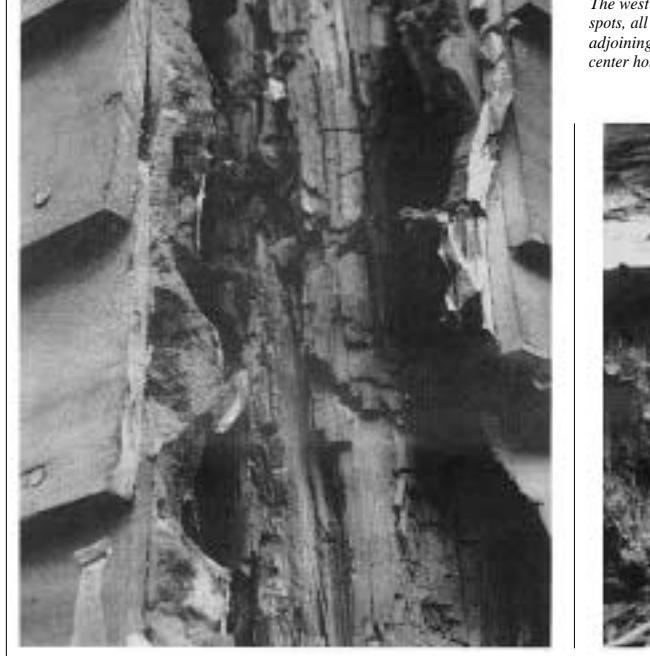
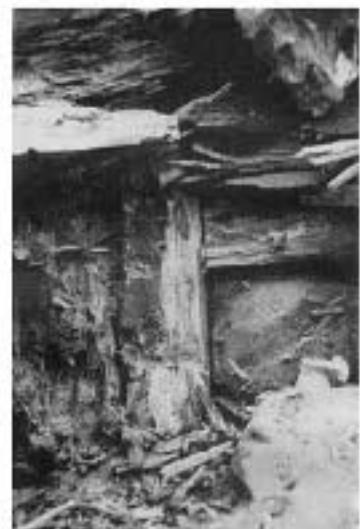
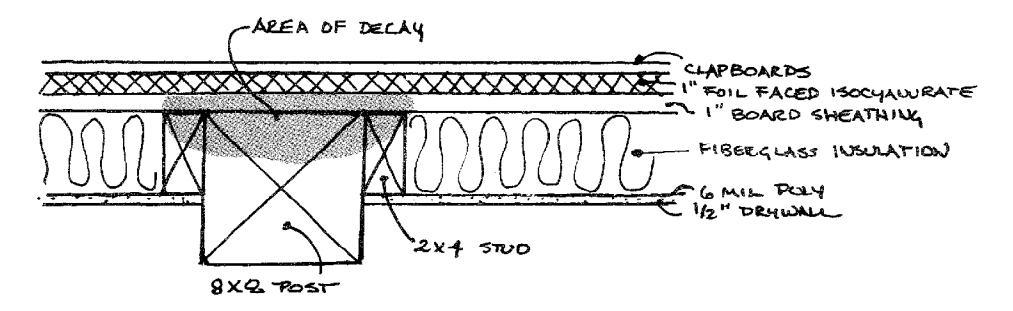
The owner discovered the problem when a renovation contractor opened up the south side of the house in order to add a sunspace. He found extensive decay in and around the timbers. The rot occurred on the outer face of the timbers-up to two inches deep in some sections—and in the sheathing and 2x4s wherever they touched the timbers.

To learn more, the owner cut out sections of siding and sheathing on all sides of the house and found decayed wood on the north, south, and west. Only one hole was cut on the east side, and showed only minor damage.

There was decay on nearly all the beams looked at—high and low, on vertical posts, and on horizontal beams. Rot also occurred in the 2x4s that were directly nailed to the beams, and in the 1x pine sheathing where it touched the beams. No decay was found in the wall sections between the beams, or elsewhere—although a thorough search was not made of all areas.

The west face of the house (above) was cut open in four spots, all revealing severe decay of the timber frame and adjoining wood. The southwest comer (below left) and center holes (below right) are shown close up.

To prevent further deterioration, the wood must be kept dry. A building consultant, Bill Lotz, recommended a three-pronged approach:

1. Keep household moisture levels down by adding fans and venting the dryer outdoors.

2. Seal the checking in the beams and the gaps around the beams with caulking. Then seal the beams with a clear finish.

3. Replace the foil-faced sheathing at the beams with beadboard to allow some drying at these points.

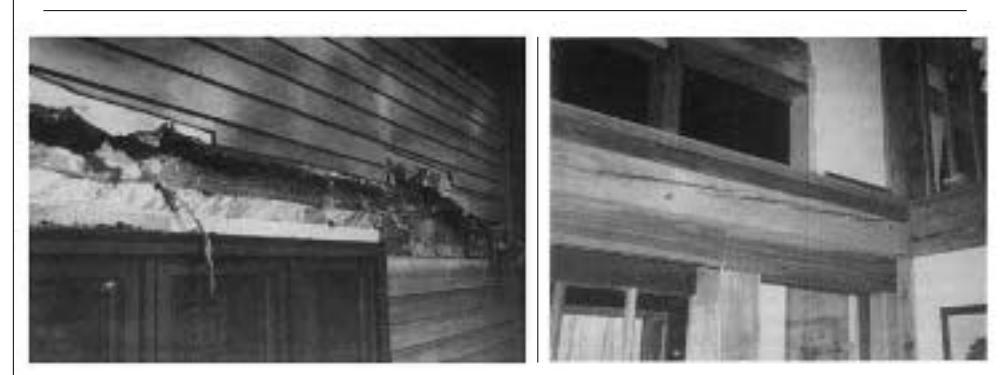
The beams were heavily checked on the inside (right) and rotting on the outside (left).

Why didn't the beams dry toward the inside of the house over the summer? They did—at least near the inside faces, which became severely checked. But when winter came, the high moisture levels in the house drove the moisture back into the beams toward the sheathing, where it condensed.

The large gaps in the 8x8s provided an easy path for moisture into the wood, which is quite permeable anyway. Moisture could also penetrate the wall along the sides of the beams. Other interruptions in the vapor barrier—at floors, ceilings, and electrical outlets let more moisture into the wall cavities. The inside face of the foam was below the dew point of the moist interior air throughout much of the winter (see sidebar). The exposed inside sections of the beams dried, but the wet outer sections festered. Enough water got into the wood each winter so that warm spring temperatures caused decay before the wood could dry out. The foam kept the wood from drying outward, and kept the sun from drying the wood inward. By midsummer, perhaps, the wood fell below saturation levels, stifling decay growth. But the next winter the cycle would repeat.

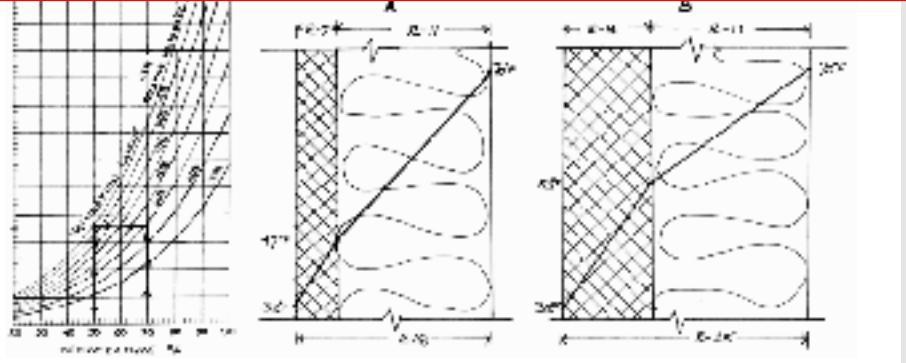
How can you gauge this for yourself? First, you need to calculate the dew point of the interior air during the winter. To be conservative, assume an indoor relative humidity of 50 percent at 70°F. That gives you a dew point of about 50°F, according to the chart. Next, calculate how cold it must

To find the dew point for any temperature and relative humidity: Start with the temperature, move up to the current relative-humidity line. Move left to the saturation curve and down to find the dew point, as shown.

R-values are in direct proportion. For example, in Wall A, when it's  $32^{\circ}F$  outside, the temperature at the sheathing surface is 7/18 of the way from 32 to 70, or 47°F, which is *below* the dew point of the interior air. In Wall B, with two inches of foam, the temperature at the sheathing surface is  $53^{\circ}F$  safely *above* the dew point. Since the average winter temperature in most of central and northern New England is at or below 32°F, Wall A appears risky unless you use one of the more permeable rigid insulations (headboard or rigid fiberglass), or have a perfect air/vapor barrier. That's not a bet I'd like to make.
