GYPSUM ASSOCIATION

REPAIRING SCREW OR NAIL POPS (GA-222-08)

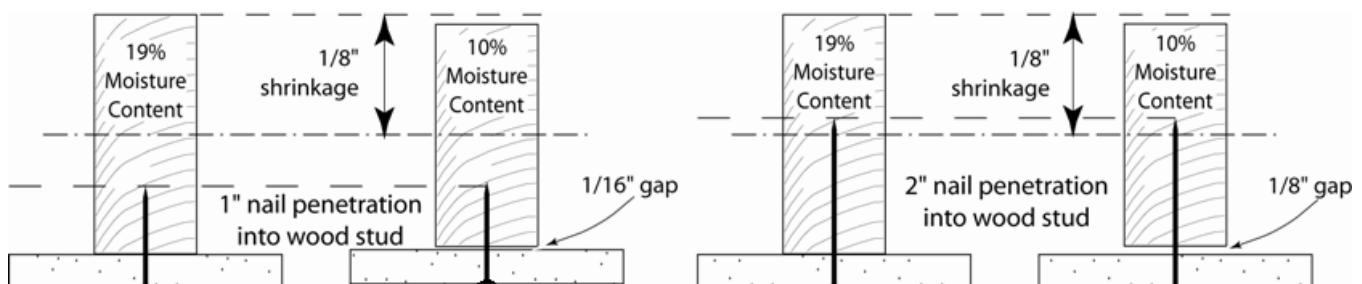
The protrusion of screw or nail heads above the gypsum panel surface is caused by one or more of the following:

- Lumber shrinkage occurring after gypsum panel product application,
- Loose attachment of the gypsum panel product to the framing,
- Improperly aligned, twisted, bent, warped, or bowed framing,
- Incorrect fastener length, or
- Improper fastening

Fastener pops are largely caused by lumber shrinkage due to initially high moisture content lumber. Overly long fastener length contributes to the problem and fastener penetration into wood framing should not exceed 7/8 in. (22 mm) for nails, 5/8 in. (16 mm) for screws. For fire-resistance rated systems use fastener lengths specified in the listing.

Fastener pops are repaired by reattaching the gypsum panel product to the framing by driving a new screw or nail of the proper length into the same framing member about 1-1/2 in. (40 mm) from the popped fastener. Apply sufficient pressure to the gypsum panel to bring the back surface into firm contact with the framing member to which it is being reattached. Remove the fastener or reset the popped fastener so that it is just below the face of the gypsum panel. Remove any loose material before treating with joint compound and redecorating.
