# Third Party Analysis of Manufactured Home Retrofit Tie Downs

Assessment & Analysis - State of Florida Residential Construction Mitigation Retrofit Program

Developed by FEMA, Mitigation Section, Technical Services Branch DR-1539 / 1545 / 1551 / 1565 - Orlando - LTRO

June 2005

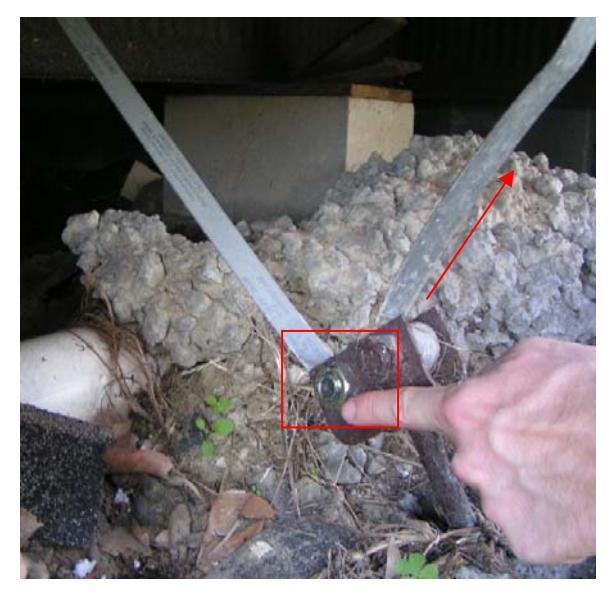
**Figure 1.** Lot # 155 Emerald Lake Punta Gorda 33950 Original auger and vertical strap with replaced **retrofit horizontal strap**. Vertical slightly loose. Overall good condition. Contrast with Photo 2, below.

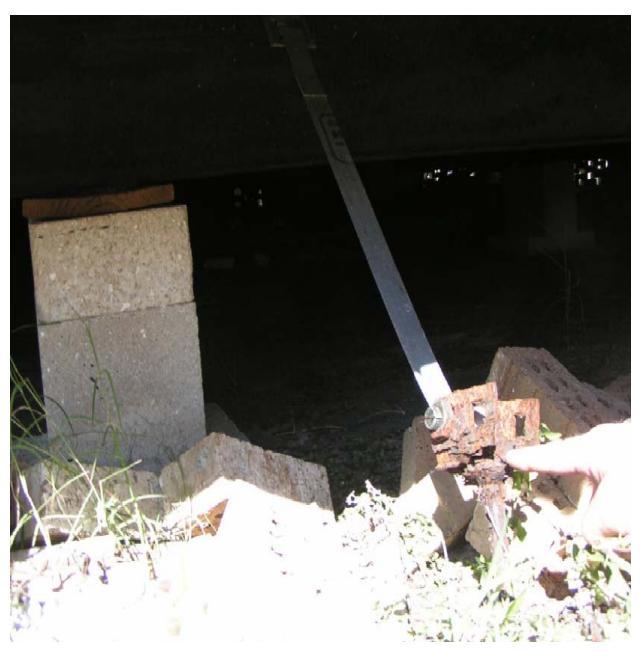
Figure 2. Lot # 120 Emerald Lake Punta Gorda 33950

- c. Some installation anomalies were noted in Punta Gorda (pictures 2 & 3).
- \*<u>Few longitudinal Tie</u> <u>Downs</u> observed except in Colonial Pines, Navarre Beach – use of longitudinal bracing substituted in most cases.
- e. A significant amount of damage was caused by roof failure associated with the destruction of additions (carports, sunrooms, etc.), debris.
- f. Discussions with numerous homeowners indicated overwhelming approval of program and apparent increased overall structural stability after retrofit.

Retrofit galvanized strap replaced on original anchor auger (rusted and broken from ground)

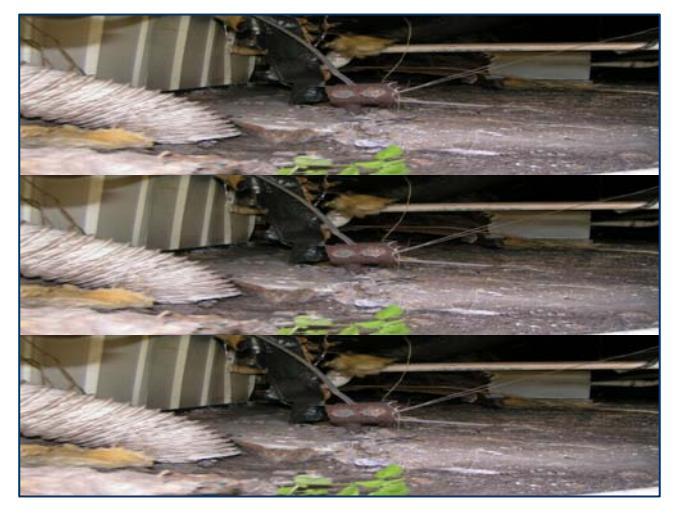
- Observation and photos indicate that corrosion is not an issue for the entire anchor
    - mechanism. The corrosion observed appears to be strongly influenced by location along the anchor system, with the interface area between strap and anchor swivel suffering substantially, often 95% or more corrosive impacts compared to strapping two inches above broken areas and anchor below the swivel/attachment plate. It would appear that we are observing galvanic corrosion caused by a metal anchor being placed in an electrolyte (soil in this case) and dissimilar metals being joined at

Figure 3. Corrosion at Anchor Plate – Casa Loma

a stress point. The stress point occurring where the strap is rolled around the tensioning bolt on the anchor plate. Manufacturers of galvanized steel products warn about excessive bending of the steel and about bending the steel too quickly. Both of the above practices can lead to cracking of the zinc coating since the coating is less malleable then the steel substrate. Small cracks in the zinc coating are of less impact with a thicker coating, due to the fact that the zinc will mobilize to local areas to form a protective layer on the steel. Wide cracks, however might still suffer from corrosion.

Unless significantly more sophisticated measurements are taken, it is only possible to speculate on the different causational modes for the corrosion observed in the field. In some cases, the soil may contain a higher admixture of saline components. Proximity to the ocean can significantly increase the salinity of rain falling on a location. This might result in a more saline soil with greater potential as an electrolyte. A second factor in corrosion of tie down straps is often related to the prior use of the site. A large number of manufactured housing parks occupy areas formerly devoted to agriculture, often citrus orchards. These old orchards were treated with fertilizers that increase the conductivity of the soil. This would increase the potential for corrosive activity at the joint between the strap and the anchor. It is important to

address the issue of corrosion due to the reduction in strength experienced by the strap, the tightening bolt and the anchor swivel plate. All of these experience reductions in strength, leading to potential breakage of strap, bolt or anchor. Straps are commonly the first item to break due to the difference in mass compared to the other components.

- Potential actions to prevent corrosion might be to place a non-conductive material in the connection. Use of ABS, nylon, ceramic or other non-conductive material between the strap and the anchor would break the connection. It might be prudent to seal the connection with a non-hardening sealer to prevent contamination bridging the gap between the strap and the anchor.

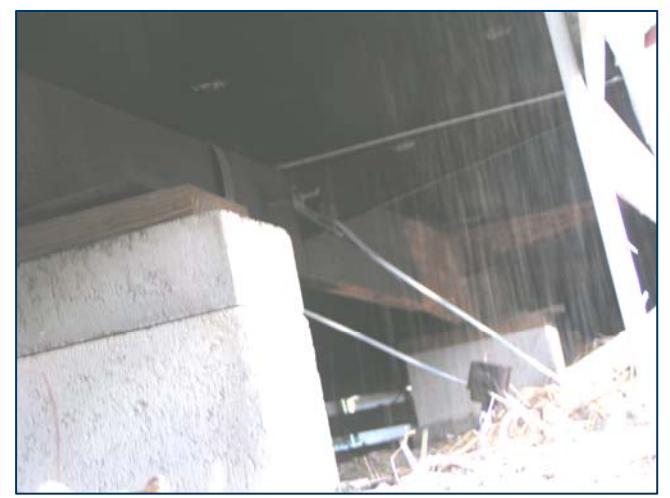
**Figure 5.** Note one tie hanger attached to a bolt, one tie is wrapped around chassis.

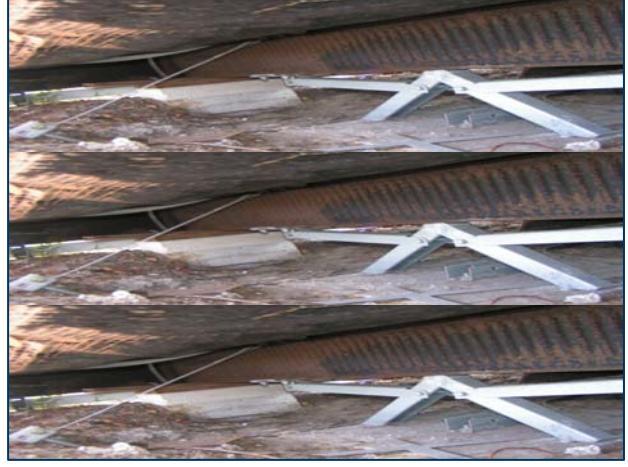
**Figure 6.** Piers are near minimum height, but dug into ground so that top had to be removed from longitudinal brace.
