FLORIDA STATE CAPITOL

Tech Notes

NUMBER 7

Window Awnings

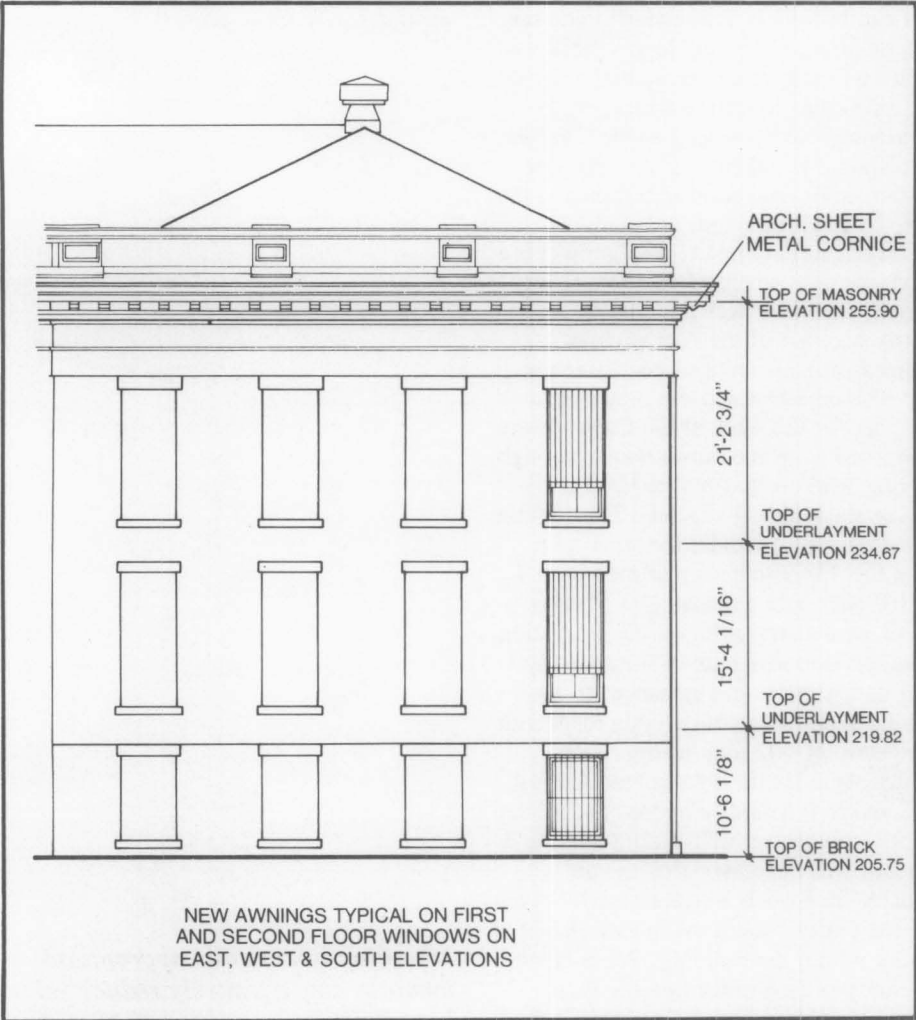
Figure 1. Large awnings were specified for all but the north elevation in order to reduce solar gain. Drawing: Courtesy, Shepard Associates, Architects and Planners, Inc.

Since the primary facades of the Capitol faced east and west, awnings were needed on the two main floors on all but the north side (see figure 1). Solar heat gain, which originally would have consumed 54% of the required cooling load, was now estimated to be 31.5% of the equipment load, and allowed a downsizing of the HVAC system by 25 tons. In typical first floor offices, the exposed glass surface would now only account for 46% of the required cooling load down from 72%. On the second floor, there was a similar change from 56% down to 30%.

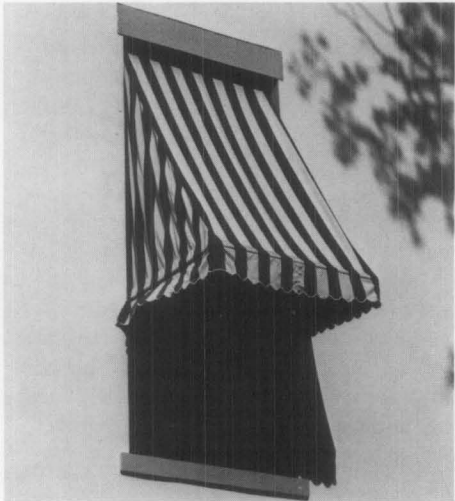
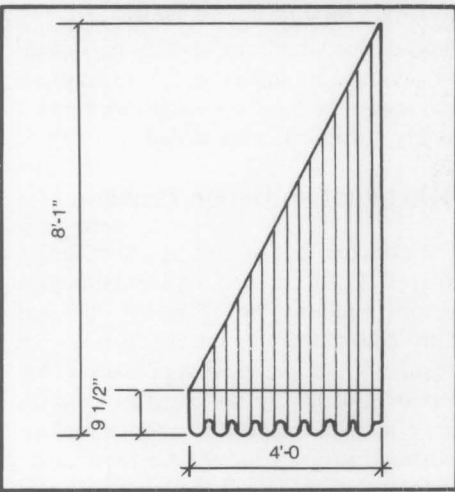
The awnings were fabricated to the architect's design of 4' wide by 4' deep with a height of 8'-1" and a 9 1/2" scalloped valance (see figure 2). The 100% acrylic fabric has vertical stripes four inches apart. Regrettably the production of the acrylic weave did not allow for pure color separation, and as a result the striping is in reality red and a very light pink; still the impression of red and white is maintained.

Figure 2. Early photographs were used in determining the appropriate design and size of the new awnings shown in the photograph. Drawing: Courtesy, Shepard Associates, Architects and Planners, Inc.; Photo: Courtesy, Florida Bureau of Historic Preservation.
