RESEARCH PAPER RP1046

TEST OF FLOOR COVERINGS FOR POST-OFFICE WORKROOMS

By Warren E. Emley and Carl E. Hofer

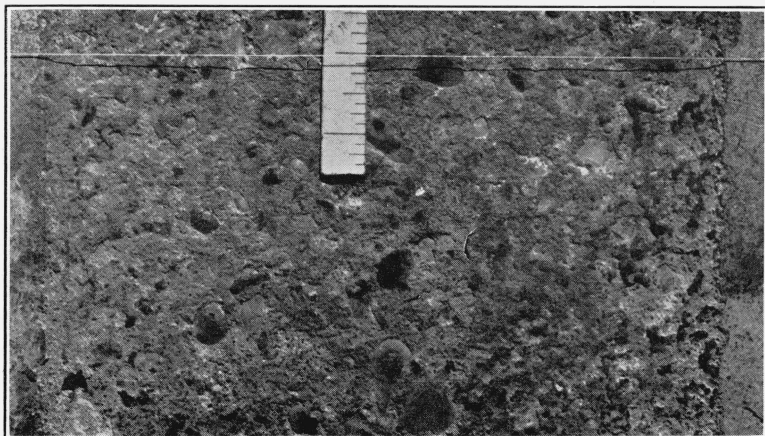
FIGURE 2.—*Plain concrete—no surface treatment.*

Concrete specimens 2, 3, 5, and 6 were made of 1:1:1½ concrete 1½ inches thick. Number 2 was given no surface treatment; number 3 had an abrasive aggregate in the wearing surface; number 5 was treated with three coats of liquid hardener after the concrete had set; and number 6 had a fine metallic aggregate or hardener in the wearing surface. Number 4 was made of 1:3 cement mortar, ¾ inch thick. The photographs show that the cement-mortar finish (no. 4) did not stand up well under this test. The plain concrete (no. 2) was not particularly durable, nor was it much improved by any of the three treatments tried.

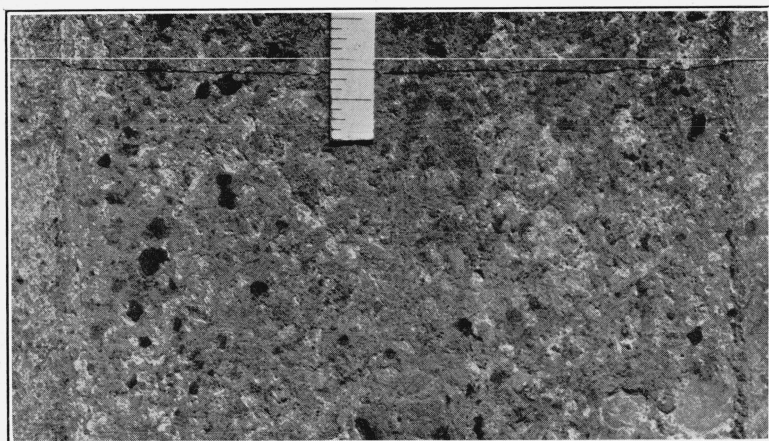
FIGURE 3.—*Concrete with abrasive aggregate in wearing surface.*

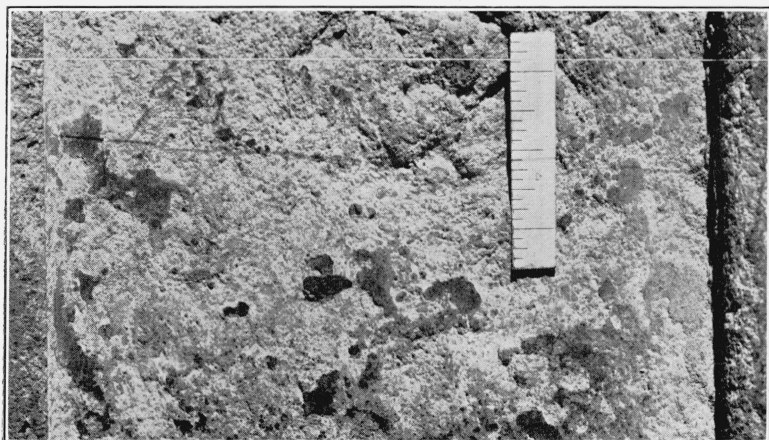
FIGURE 4.—Concrete surfaced with 1:3 cement mortar.

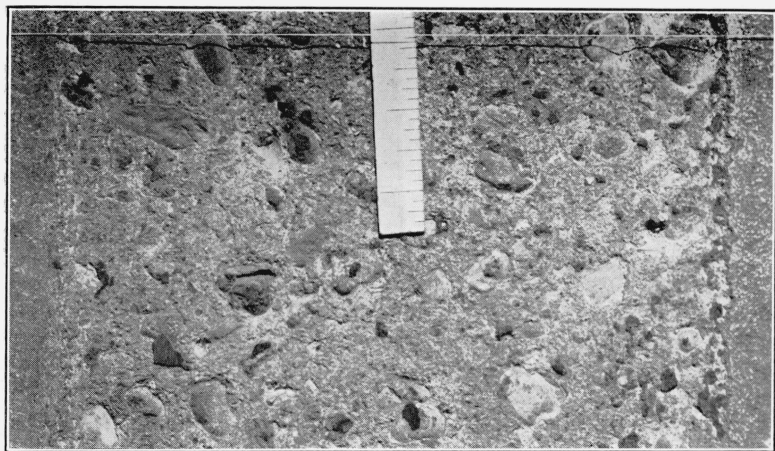
FIGURE 5.—Concrete treated with three coats of liquid hardener after the concrete had set.

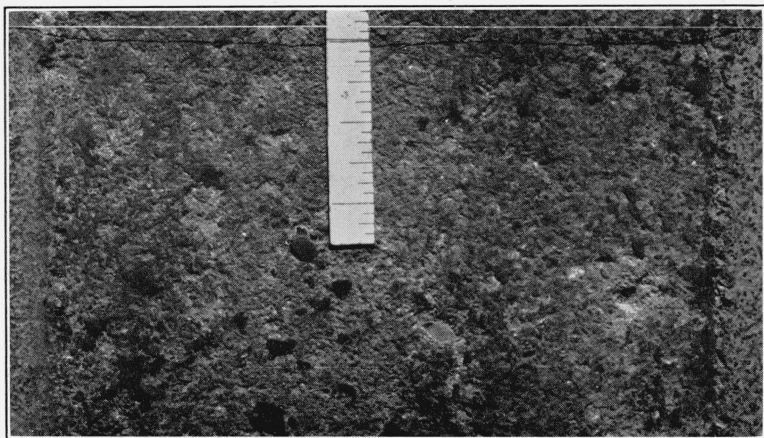
FIGURE 6.—Concrete with fine metallic hardener in wearing surface.

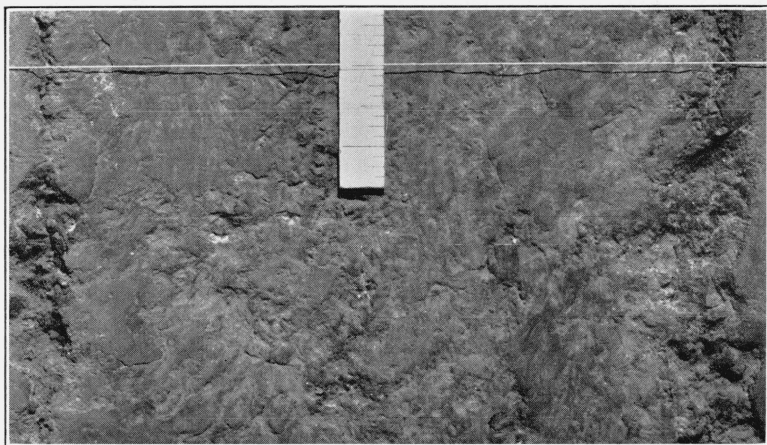
FIGURE 7.—Asphalt blocks 5 by 12 by 2 inches.

Asphalt specimen 7 was made of blocks 5 by 12 by 2 inches set in ½ inch of mortar. Specimen 8 was asphalt plank, ½ inch thick. The surfaces of both block and plank roughened quite readily under this treatment, and for this reason they could not be kept clean by sweeping. The plank showed considerably more wear than the block.

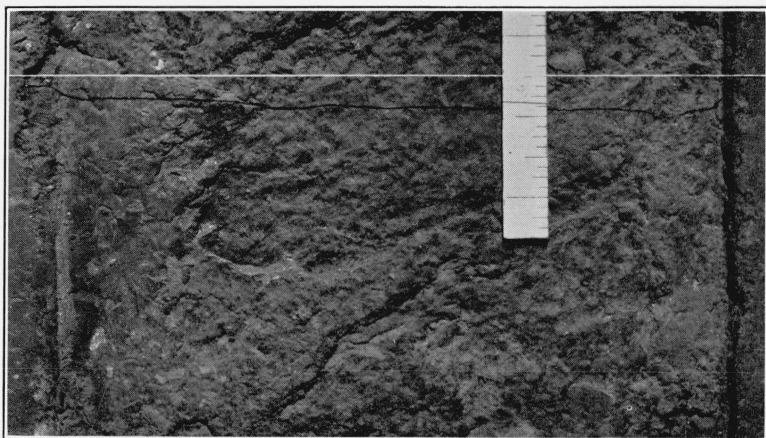
FIGURE 8.—Asphalt plank $\frac{1}{2}$ inch thick.

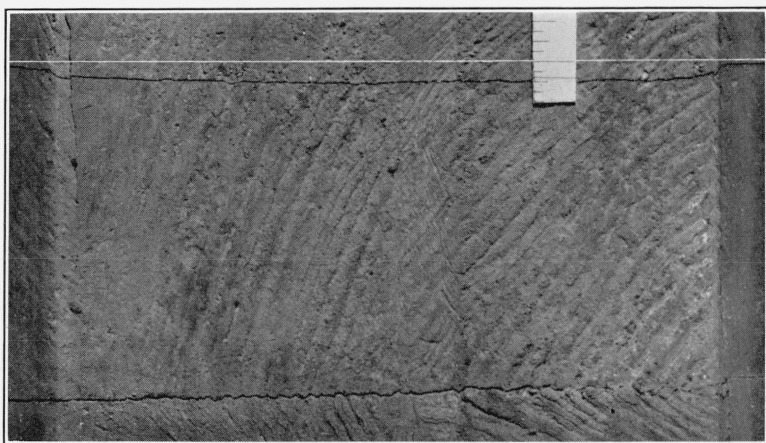
FIGURE 9.—Southern yellow pine end-grain blocks $2\frac{1}{2}$ inches thick, set in mastic.

The photographs show that the end grain (nos. 9 and 10) and the quartersawed grain (no. 11) wore appreciably under this test. Of the maple floors, there is little choice between the edge grain (no. 12) and the flat grain (no. 13); both stood up very well. Of the three methods of finishing examined, the four-coat job (no. 14) is better than the two-coat job (no. 15), and both are better than the linseed-oil finish. The differences, however, are in the appearance and the ability to keep the floor clean; there is not much difference in the wear.

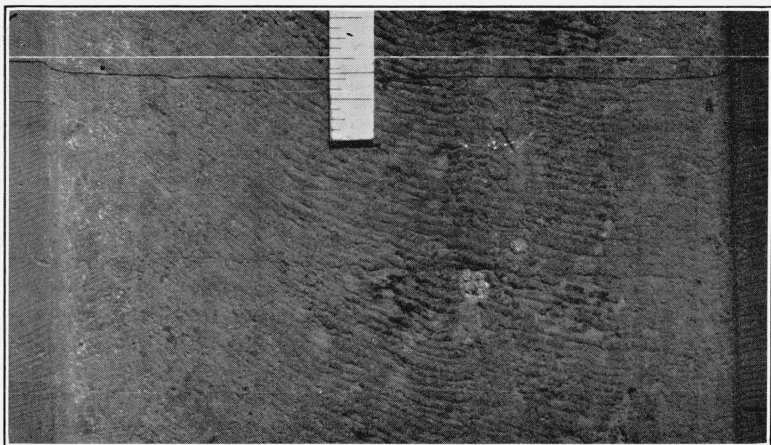
FIGURE 10.—*Douglas fir end-grain blocks $2\frac{1}{2}$ inches thick, set in mastic.*

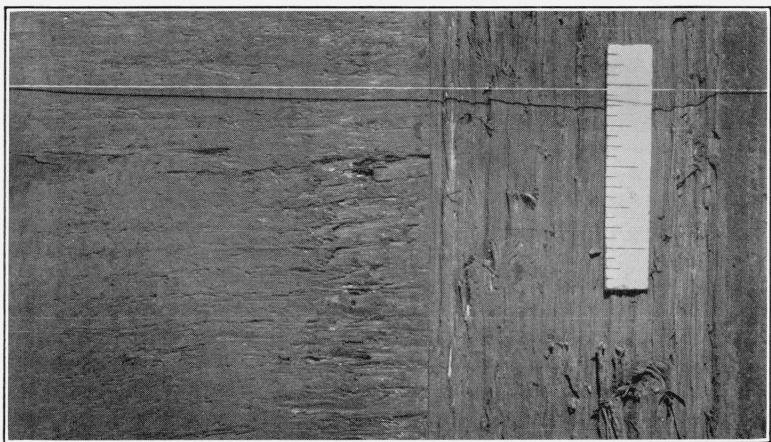
FIGURE 11.—*Quarter-sawn red oak $2\frac{5}{32}$ inch thick, set in mastic.*

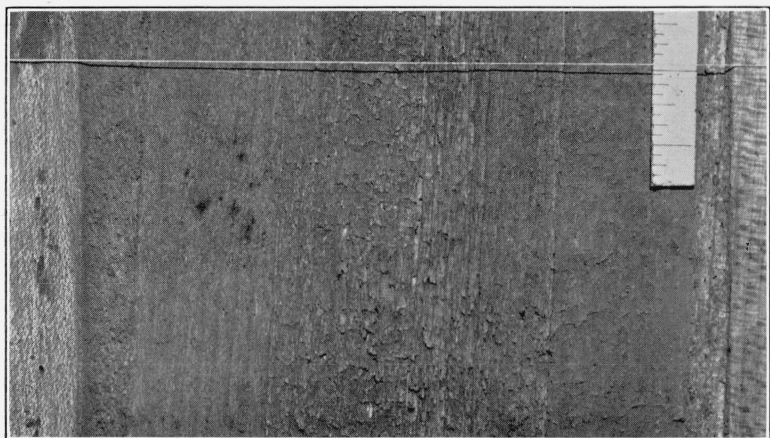
FIGURE 12.—Maple, edge grain $2\frac{1}{8}$ inches thick set in mastic.

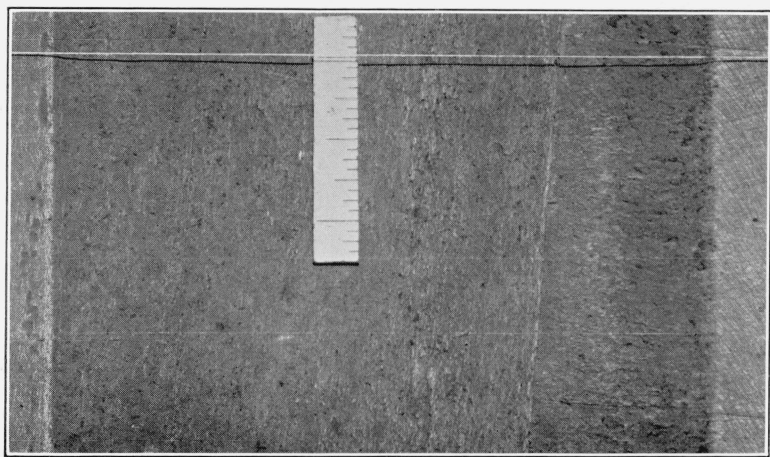
FIGURE 13.—Maple unit blocks $3\frac{1}{32}$ inch thick, set in mastic.

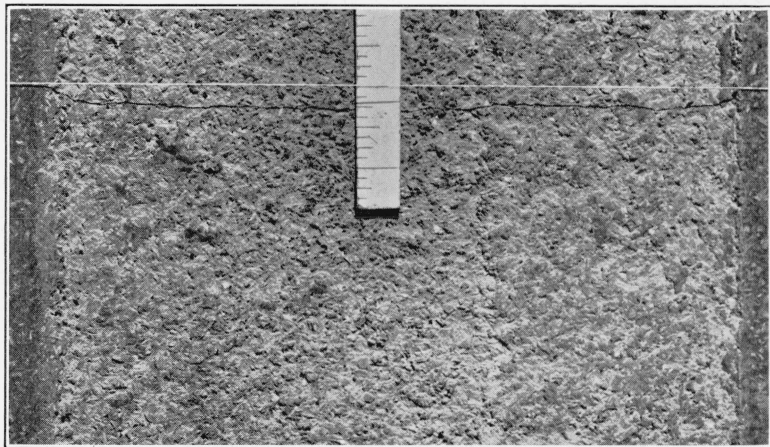
FIGURE 17.—*Magnesite with hardwood fiber aggregate 1 inch thick.*

Magnesite specimen 17 contained an aggregate of hardwood fiber and was 1 inch thick; no. 18 was ½-inch plain magnesite. Both of these specimens showed wear to such an extent as to indicate their unsuitability for this kind of service.

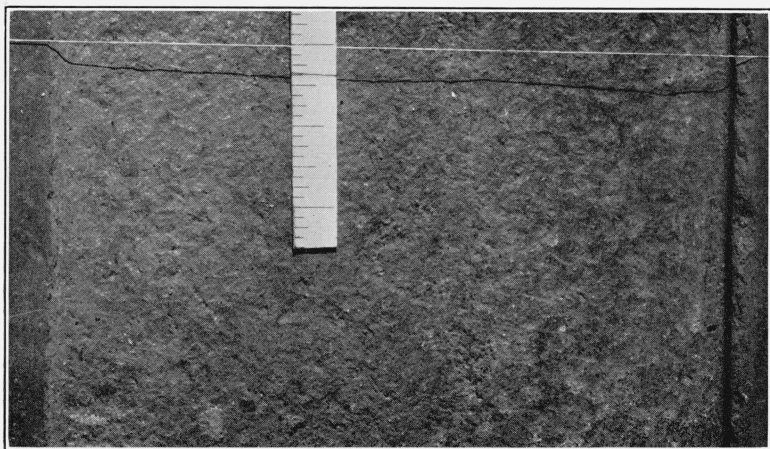
FIGURE 18.—*Plain magnesite* $\frac{1}{2}$ inch thick.

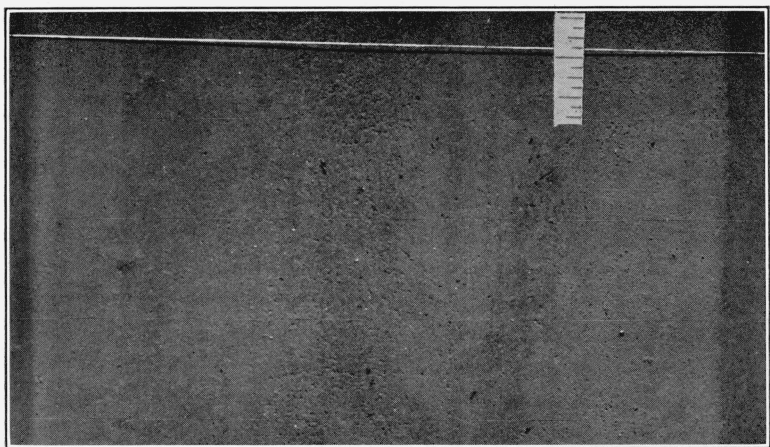
FIGURE 19.—*Battleship linoleum* $\frac{1}{4}$ inch thick.

Specimen 19 was ¼-inch battleship linoleum. This showed very little wear. There was a tendency to creep in the direction of the traffic, but the movement was not sufficient to break the bond between the linoleum and the concrete subfloor.

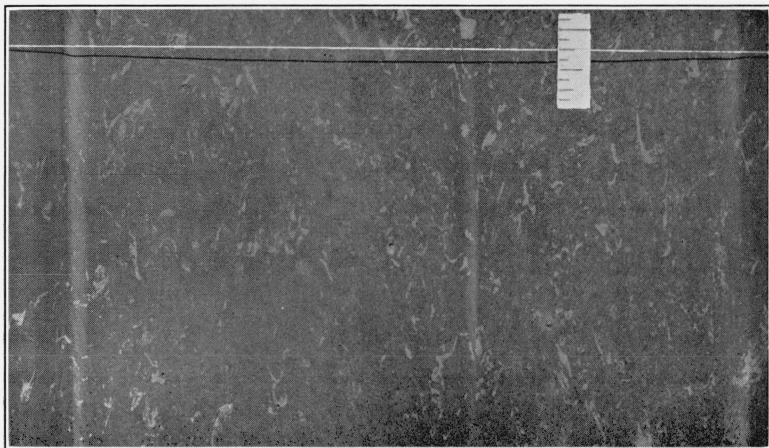
FIGURE 20.—*Rubber sheet $\frac{1}{4}$ inch thick.*

The first sample of rubber tile (no. 20) could not be made to stick to the concrete. It was finally taken up on November 14 and replaced by sheet-rubber flooring ¼ inch thick. The second sample of rubber tile (no. 21) adhered somewhat better, but it caused a great deal of trouble, tiles having to be replaced every few days. The results indicate that rubber will withstand the service fairly well, if some adhesive can be found to hold it to the concrete.

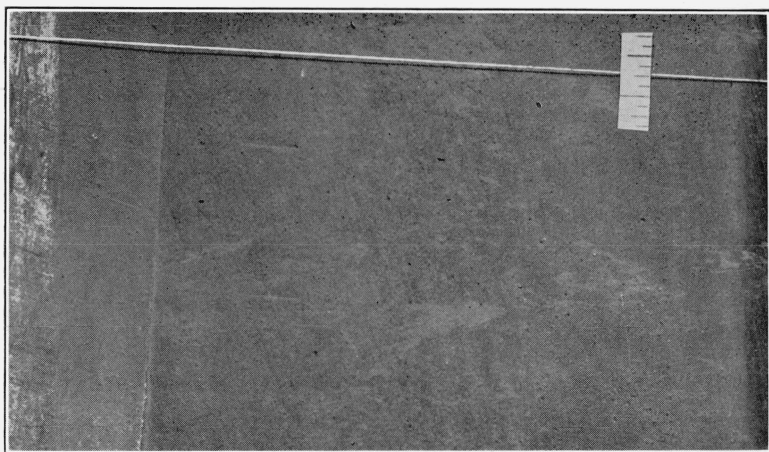
FIGURE 21.—*Rubber tile $\frac{1}{4}$ inch thick.*
