Tech Notes

NUMBER 1

Process-Printing Decals as a Substitute for Hand-Stencilled Ceiling Medallions

NATIONAL ARCHIVES Washington, DC.

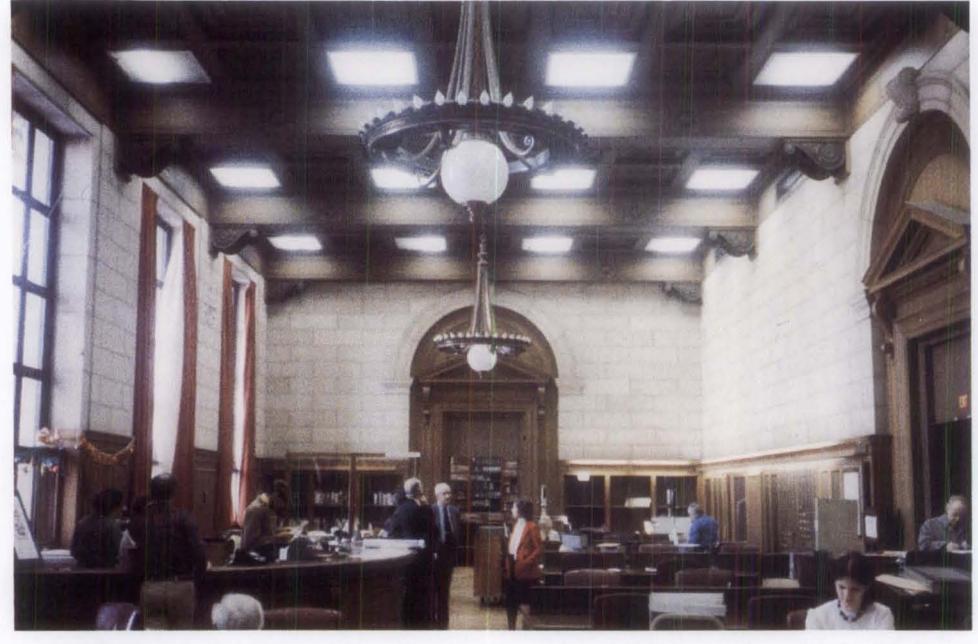
The coffered ceiling had been badly damaged in 1962 with the installation

of fluorescent light fixtures (see figure 2). Forty of the coffers had been drilled with large holes to attach the light fixtures and the central medallions had been removed (see figure 3). In 1988, the General Services Administration (GSA) authorized a new sprinkler system in the Central Search Room. As part of the sprinkler project, the 1962 instrusive fluorescent lights were proposed for removal, with attendant enhancement of the desk level lighting. The two historic chandeliers were to be retained.

2. The 40 large visually obstrusive fluorescent lights, installed in 1962, damaged the coffered ceiling in the Central Search Room. Photo: Dell Corporation.

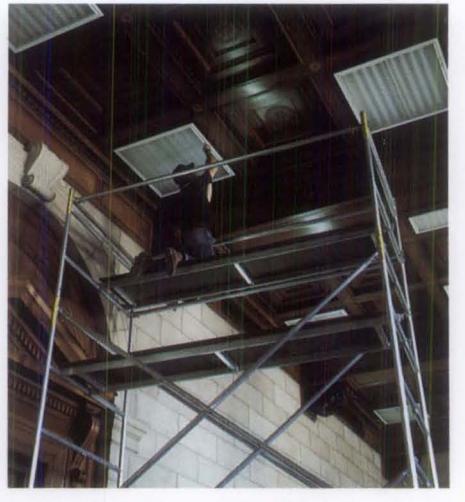
3. The light fixtures were carefully removed to permit installation of a sprinkler system behind the coffered ceiling and to restore the ceiling to its original appearance. It was necessary to reproduce 40 new panels for installation in the coffered ceiling, due to the damage resulting from the 1962 lighting work. Photo: Dell Corporation

Using the ceiling openings created by removal of the modern light fixtures, 2" diameter pipes were installed for the new sprinkler system. Because the intact historic panels were so tightly glued in place, it was difficult to remove them without damage. Therefore, the new sprinkler heads were located at the centers of the 40 replacement panels, which were evenly spaced across the ceiling. One historic panel was removed to serve as a model for the replacement panels.

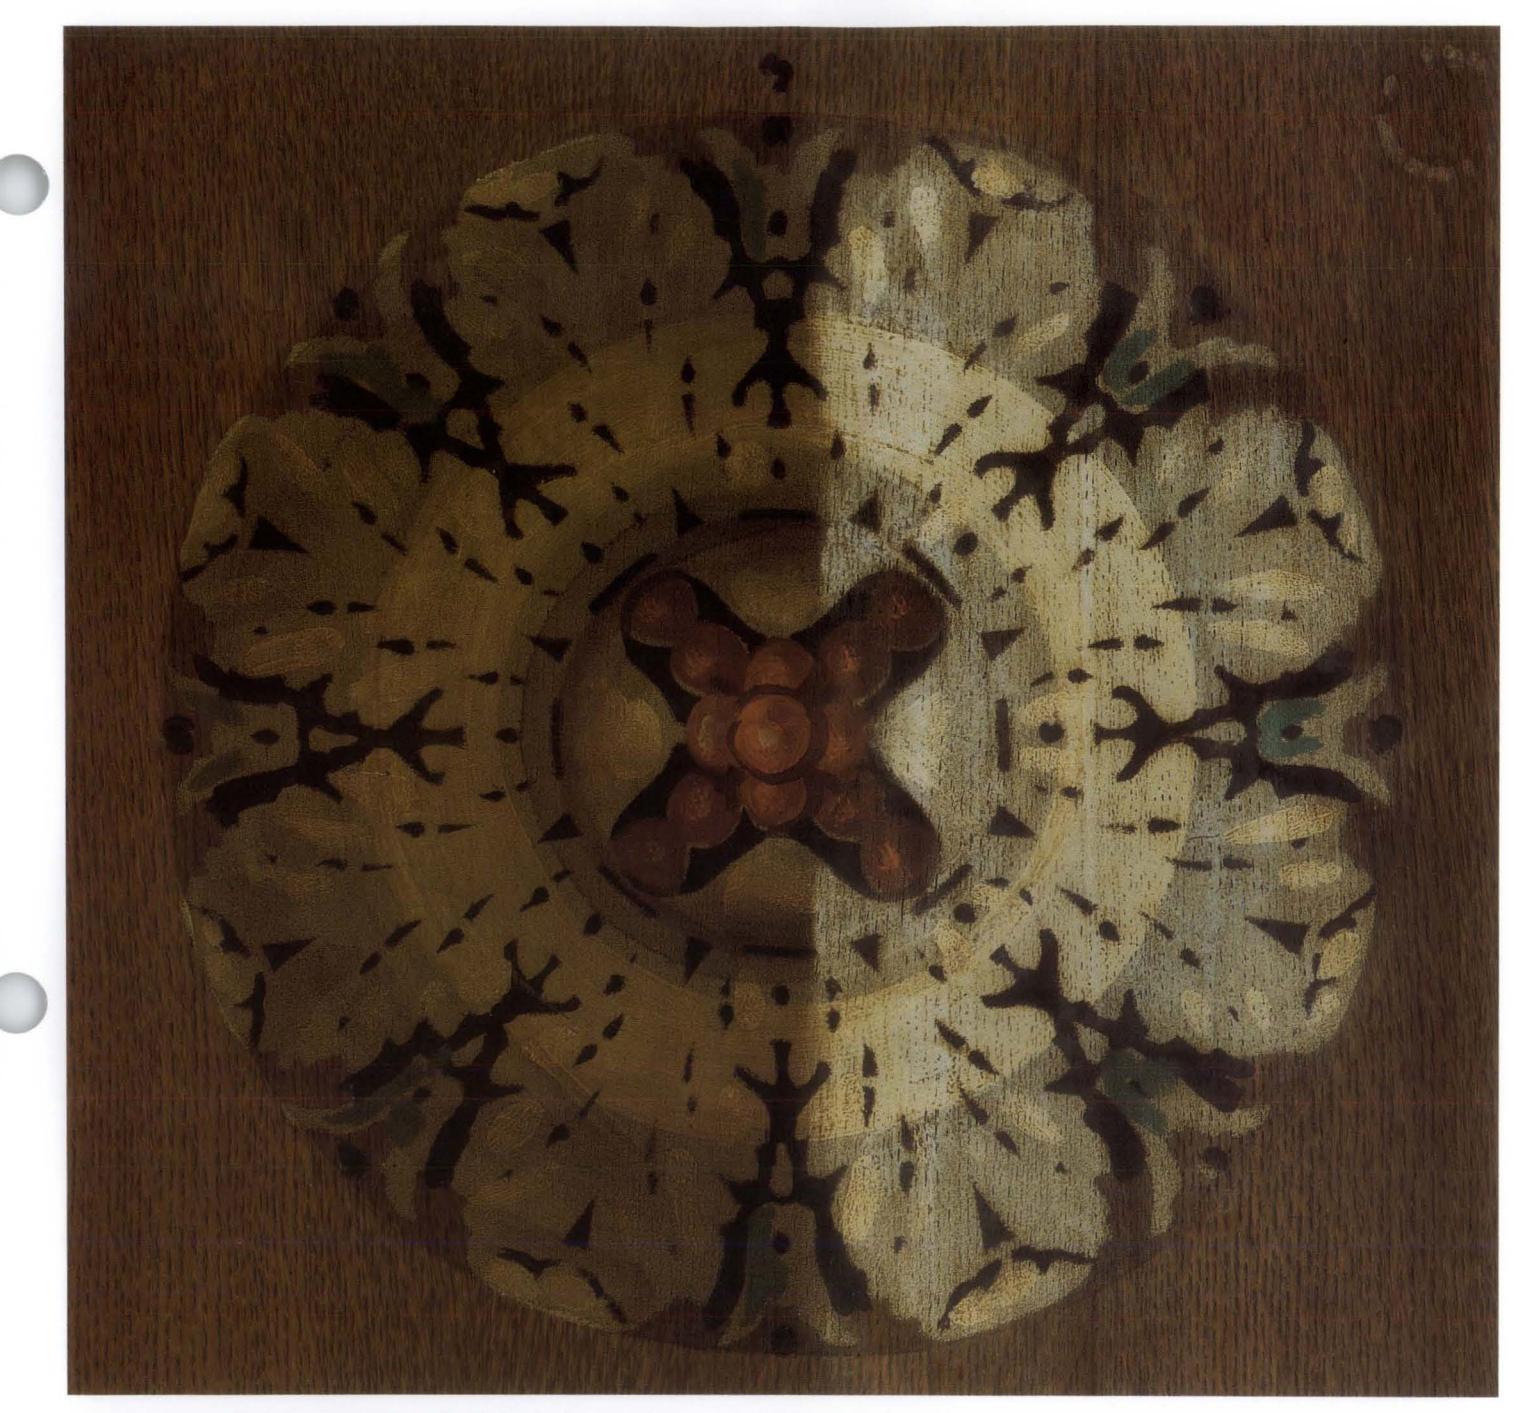
commercial stripper of toluene, acetone, and butyl-acetate. The result was that the original lighter tones of the white oak background were also revealed along with the bright colors of the original painted medallions (*see figure 4*).

4. A historic stencilled panel was removed and cleaned in order to have a model for the replacement panels. In this view, only half of the panel has been cleaned, revealing the difference between the aged and original appearance of the ceiling. Since the ceiling was not scheduled to be cleaned, a decision was made to reproduce the original panel appearance and then artificially age the replacement panels to blend in with the existing ceiling. Photo: Dell Corporation.
