# SP-291—10

## WHEN BAD THINGS HAPPEN TO GOOD [BUILDINGS]

### Dylan Freytag, Keith Kesner, Randall W. Poston, and Kenneth Bondy

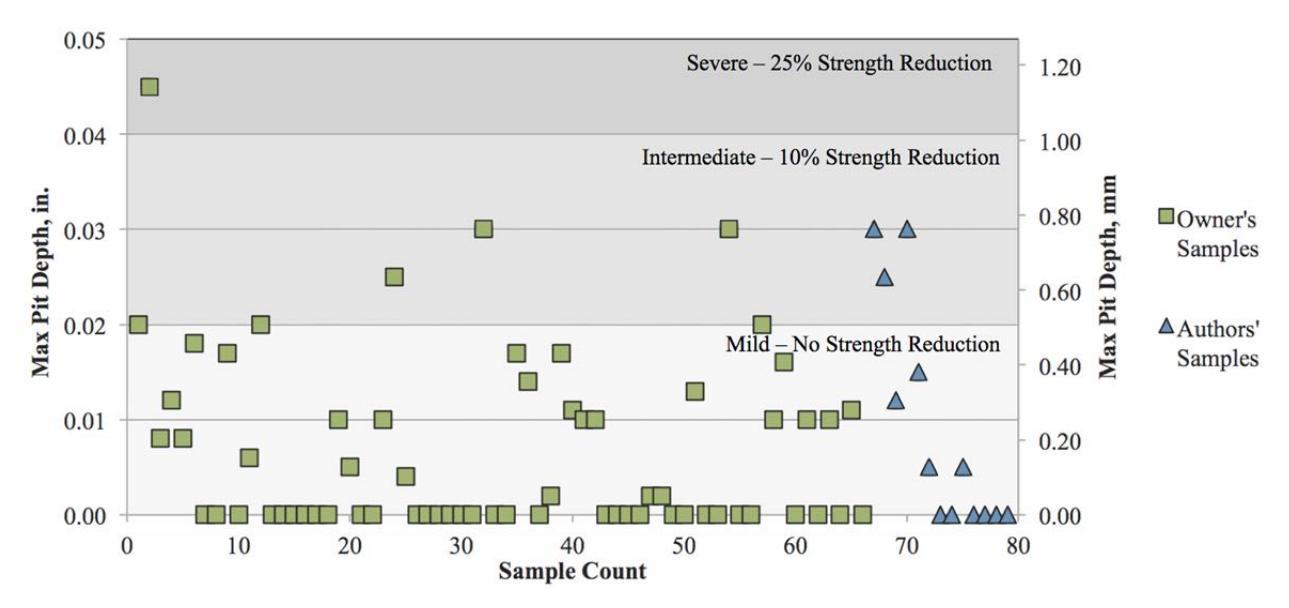
Figure 3—Measured pit depths for tendon samples removed from subject building; all measurements performed by the authors.

Both the building owner's consultant team and the authors' team removed post-tensioning tendons from the subject building for inspection and evaluation pursuant to an agreed investigation protocol. The other team removed portions of about 80 tendons ("live end" anchorages and several feet of strand) and the authors removed fifteen. Figure 3 below summarizes the extent of pitting corrosion that the authors measured on the tendons removed by both parties. The authors measured pits on tendons removed by both parties using ASTM G 46 – Standard Guide for Examination and Evaluation of Pitting Corrosion<sup>4</sup>. The International Concrete Repair Institute (ICRI) classifies the severity of pits for in-service post-tensioning tendons (ICRI 03736<sup>5</sup>), such as those at the subject building. The various levels of pitting have been overlaid in shades below. Note that only one tendon fell within the "severe" (darkest shade) category and was subject to the greatest strength reduction of approximately 25 percent.

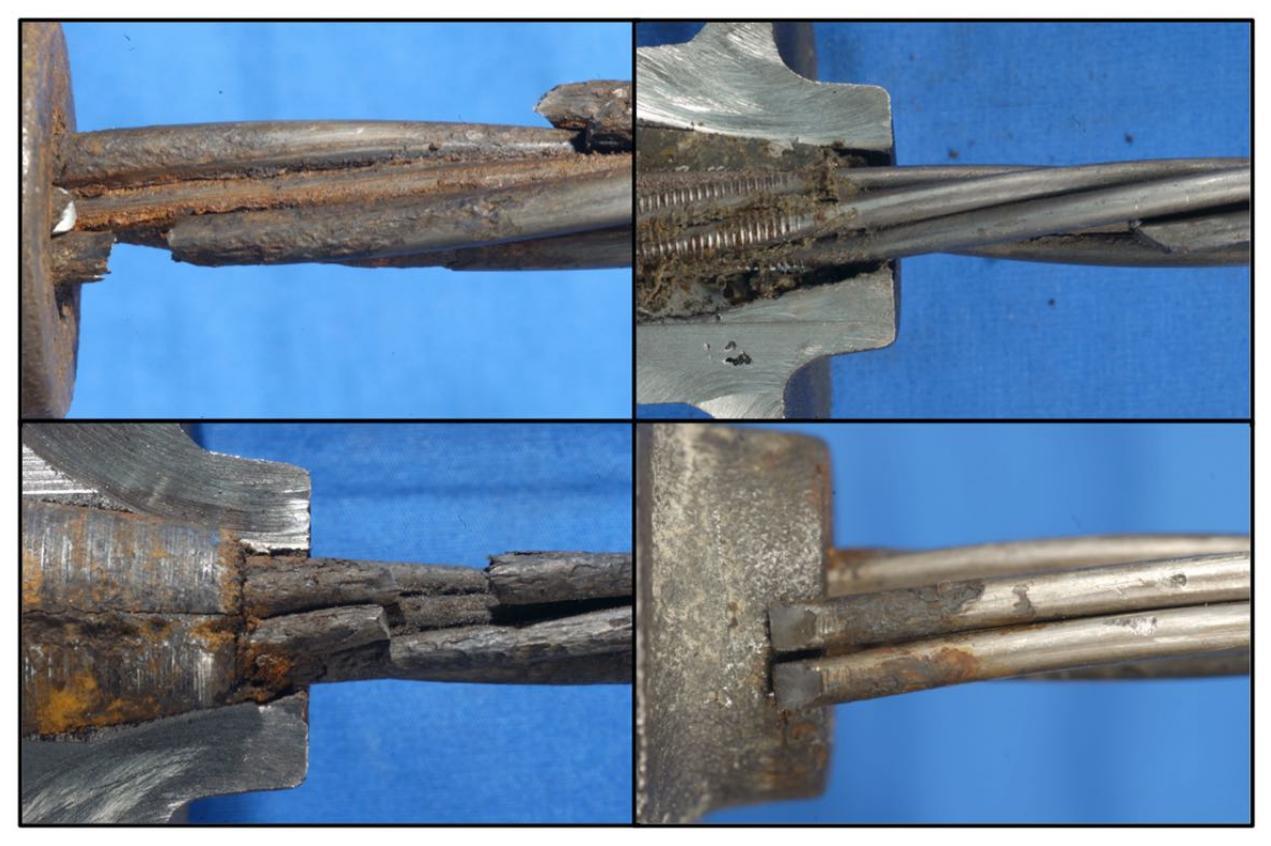
Figure 4—Selected photographs of fractures.

Selected photographs of specimens after testing are shown in Figure 4. In each of these photographs, wire fractures adjacent to the anchors and wedges can be seen.

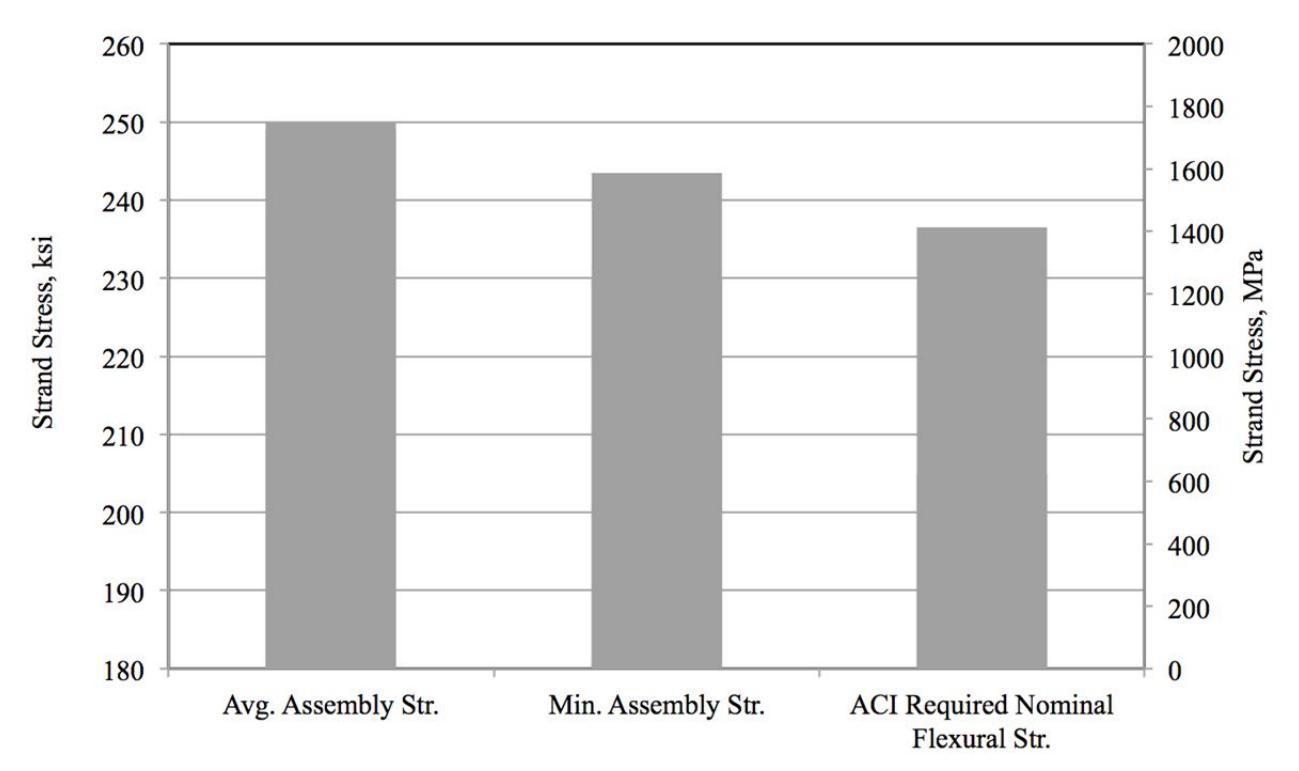
Figure 5—Required and measured tendon assembly strengths.

This reserve capacity is evident in Figure 5. The plot depicts the average and minimum assembly strengths as tested by the authors and contrasts them to the code-level required strength. Note that the required nominal strength of the tendon assembly (205 ksi/1415 MPa) is significantly less than the average measured strength (250 ksi/1725 MPa) and the minimum measured strength (230 ksi/1585 MPa). Based on these values, a substantial amount of reserve capacity remained, and the safety of the structure had clearly not been compromised to date.

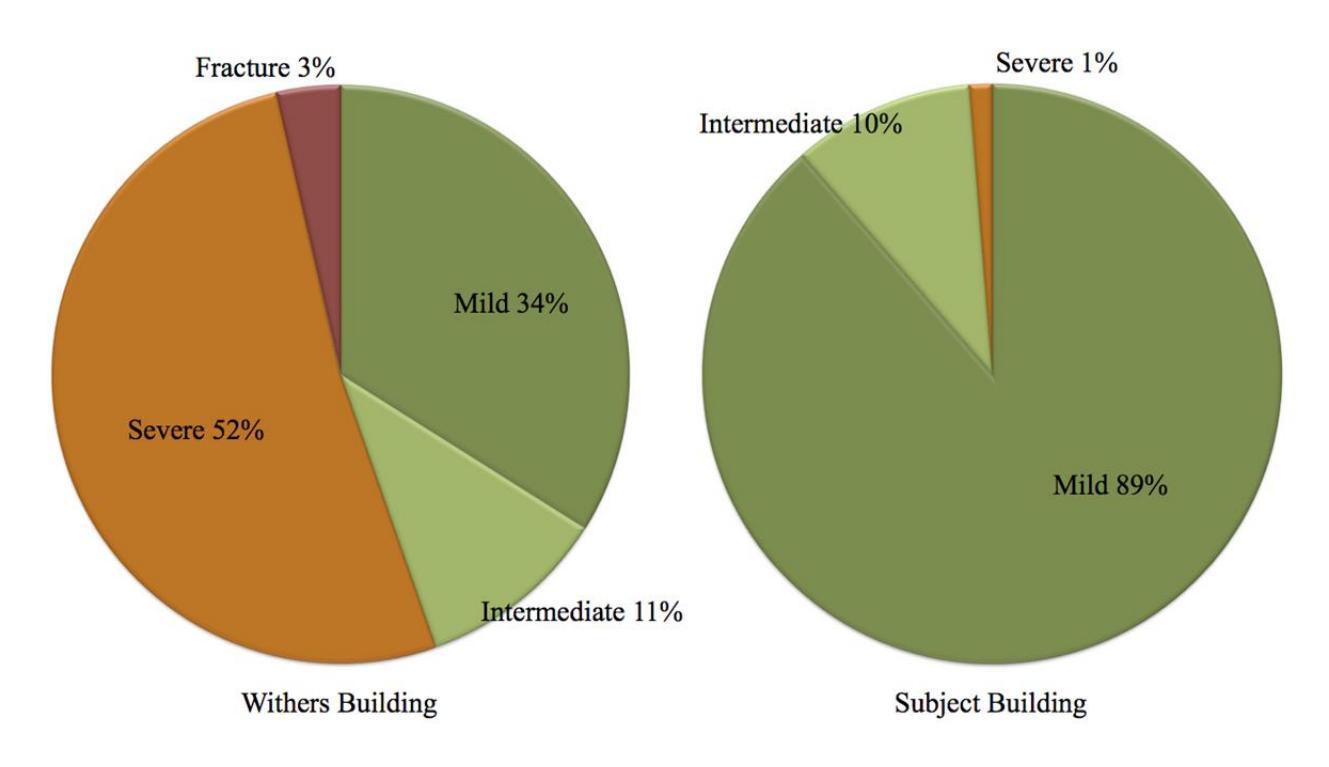
Figure 6—Comparison of corrosion in Withers Building and Subject Building.

To further illustrate the magnitude of the alleged deficiencies in the subject building, it is possible to draw comparisons with past projects. A dramatic comparison can be made between this structure and the Withers Building that was investigated and successfully repaired by the authors. The Withers Building had severe corrosion present at the time repairs were implemented. Since the completion of repairs the structure remains in-service. The building has been continually monitored since it was repaired more than 13 years ago. Recall that there have been 13 individual wire failures to date, (there are seven wires to a strand) but thus far the University of Virginia has elected not even to replace the tendons associated with those wire breaks. The repair and monitoring program has been so successful that the owner plans to abandon the monitoring system in the near future. Figure 6 compares the observed tendon corrosion on these two structures. Tendon corrosion categorizations for these charts are the same as those used in Figure 2 and Figure 3. Clearly, the Withers Building had a far more advanced state of tendon/anchorage corrosion than was present in subject building. Despite the advanced state of corrosion, the Withers Building was successfully repaired and remains in service; therefore no reason exists to believe that the subject building could not have been easily repaired.

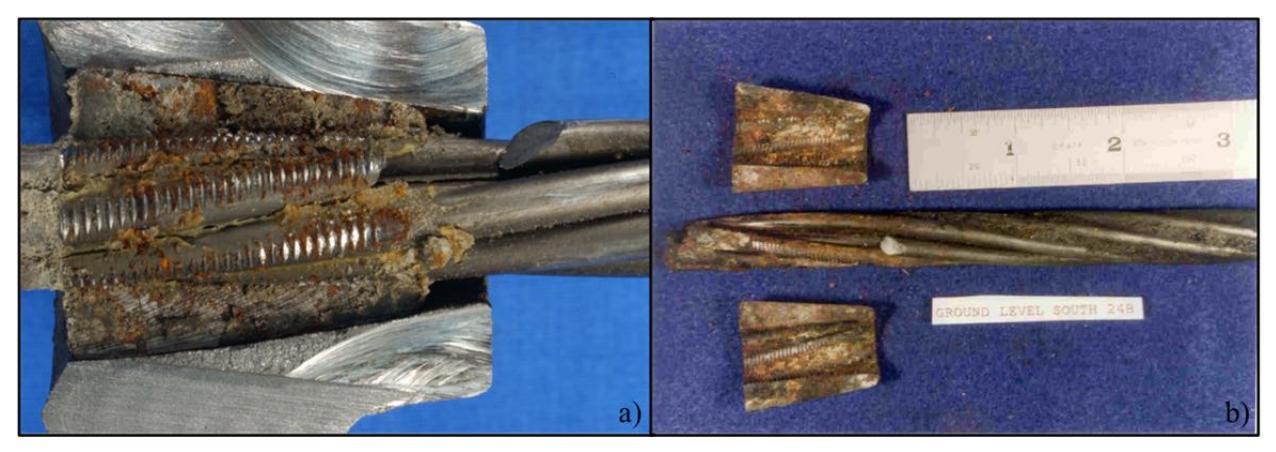
Figure 7—Wedge assemblies from a) Subject Building sample and b) Second Florida Building sample.

In Figure 7, two photographs of tendons and wedges are shown. On the left is a sample removed from the "subject" building and on the right is a sample removed from the second Florida Condominium building. These two photographs were taken after the specimens were tested to failure. Both exhibited the same type of failure: shear fracture of a single wire. However, the sample from the subject building is less corroded and had a greater tensile strength (258 ksi/1780 MPa) than the Second Florida Condominium Building sample (238 ksi/1640MPa). This building was successfully repaired more than 16 years ago and remains in service.
