Unpredictable Nature and Cause of Cracks at Gypsum Panel Ceiling Joints Perpendicular to Framing

By Frank Woeste and Joe Loferski

This is a revised version of an article first published in the May 2012 issue of *The Construction Specifier, www.constructionspecifier.com*.

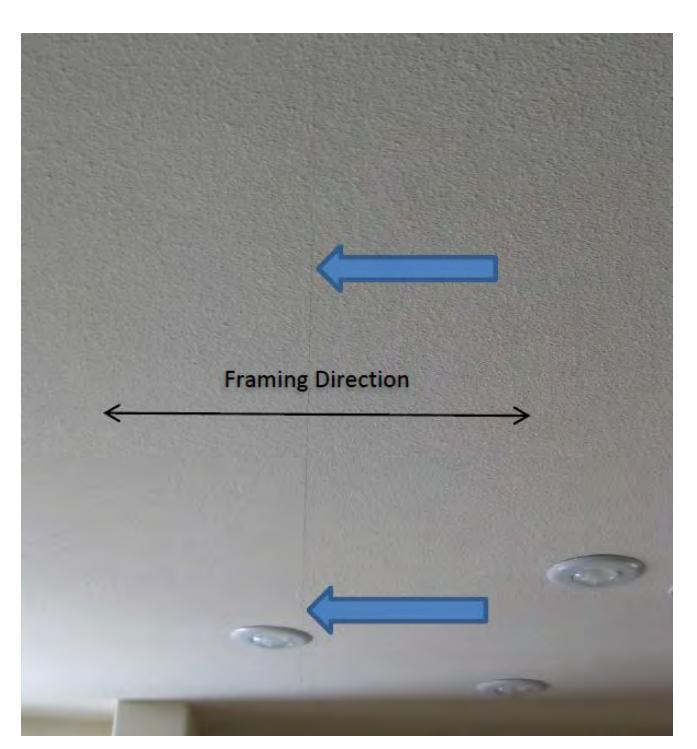
Of course, homeowners are displeased when they see long and straight joint cracks forming in the center of their living room ceiling or other areas. Furthermore, even after they are repaired, many joint cracks recur on a seasonal basis. As will be discussed in depth, the factors that interact to produce joint cracks are the hygroscopic behavior of framing lumber and drywall that is driven by climate and occupants. The purpose of this article is to explain the unpredictable nature and cause of ceiling joint cracks (for example, see Figure 1) and the factors that interact to produce joint cracks in some homes while not in others.

Figure 1. The trademark of the ceiling joint cracking problem is a straight line crack perpendicular to the framing direction.

While new and related information is being developed for preventing ceiling drywall cracks, Homebuilders and their Architects should explore drywall installation details that may accommodate the differential hygroscopic movement between ceiling drywall and truss bottom chords (or ceiling joists). One possibility is to specify framing directions that minimize the maximum lengths of uninterrupted drywall parallel to the truss spans. Ceiling drywall finished joints (without control joints) should be inherently more vulnerable to greater differential hygroscopic movement between the lumber and drywall assembly when the drywall is directly attached and the framing span between the walls is greater.

Another option to consider for current construction is the specification of resilient channel (RC). Based on a study conducted in the late 1990s and summarized in Walls & Ceilings⁹, Campbell states:

"However, the most effective way to prevent the seasonal cracking is to use resilient channel to buffer drywall panels from truss movement. Jundt reported that installing resilient channel provided the only effective means of remedying problems in troubled homes, and that—as a preventative measure—it's a relatively cheap and practical way of keeping problems at bay."

Lastly, the potential benefits of following the recommendations in Section 4.7.3 of GA-216-2010¹⁰ for control joints can't be overstated. It should be noted that GA-216 has been a "Referenced Standard" in the International Building Code® since 2000.
