Measured Crawlspace Conditions Under Manufactured Homes

ABSTRACT

The Florida Solar Energy Center conducted research utilizing two unconditioned, old, singlewide side-by-side manufactured homes, one with a ground cover and one with exposed dirt under it. Three different skirting options were tested, open or no skirting, perforated skirting, and solid skirting.

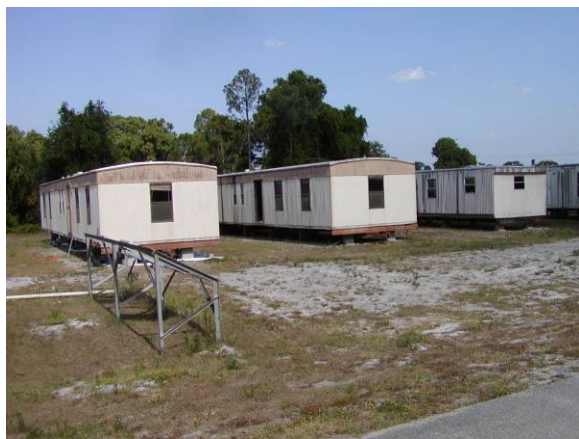
Figure 1 The Three experimental houses

The three singlewide homes are sited side-by-side at the site (Figure 1). Two of the homes are virtually identical 14' by 60' units, and the third is a 12' by 60' unit. One of the homes had to be moved into place for the three homes to be side-by-side, so when this was done a ground cover of 6-mil polyethylene was installed under the house (Figure 2). All houses were in poor condition, with badly breached rodent barrier (an air barrier installed under the home's floor insulation, isolating the home from the crawl space) and rotten spots in all three floors. For the sake of uniformity between the houses, it was decided to remove the floor's rodent barrier and insulation from all homes and remove all interior walls from the homes. When this was done the bad spots in the floor were repaired, and new vinyl flooring was installed on all three homes, creating a

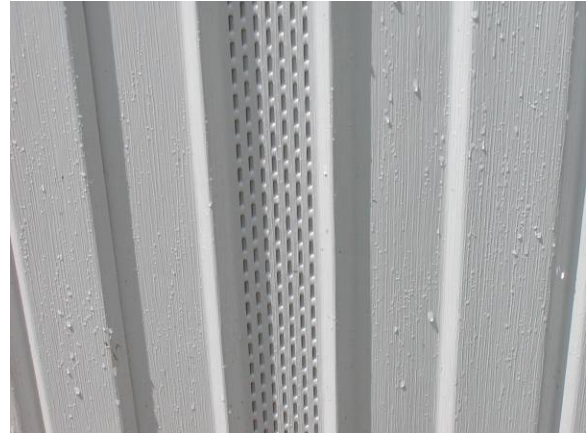
Figure 4 Perforated skirting

The results of these tests are presented below (Figures 6-8); three different crawlspace configurations chosen as representative of what is found in the field. The first test conducted was of open crawlspaces (Figure 2 and 6) with no skirting. As many local codes and park regulations prohibit un-skirted homes, the other tests used skirting. First tested was "standard" perforated skirting (Figure 4 and 7). Trends observed in the field are revealing more and more homes with the siding run all the way down to the grade level, or a solid faux rock skirting used. The result of these practices is a poorly vented crawlspace, simulated for these tests with solid skirting (Figure 5 and 8).

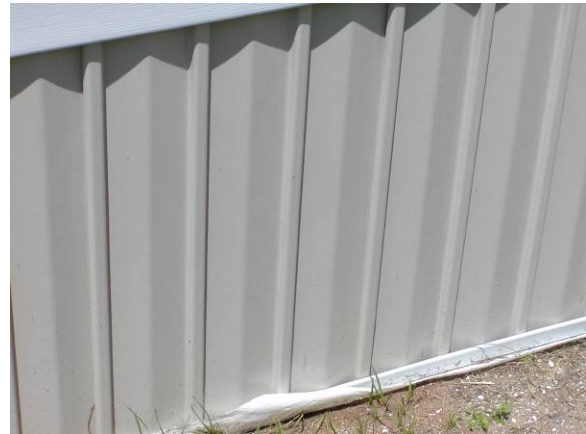
Figure 5 Solid skirting

Test three (Figure 5 and 8) employed solid, un-perforated skirting. We were unable to measure how airtight the crawl space was or whether the ground cover completely covered the ground. Hurricane Jeanne destroyed the test configuration before air tightness measurements could be taken.

However, we believe these crawlspaces were typical of poorly vented crawls one might find under a manufactured home.

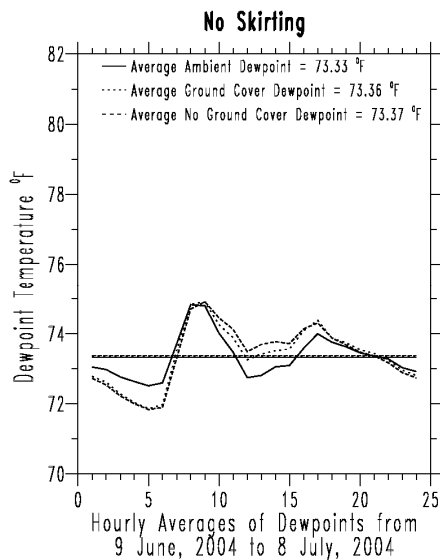
Figure 6 Dewpoints without skirting

All data is an hourly average of data collected at 15-minute increments. Crawlspace data is the average of the two measurements made at each end of the crawlspaces. The plots represent all available data during the period indicated by the dates at the bottom of the plot. The titles of the plots tell what skirting configuration is described, and the legends show which crawlspace is shown by the data. The data is presented as an "average" day; all the readings from 8 AM for the test period are averaged, all the 9 AM, etc.

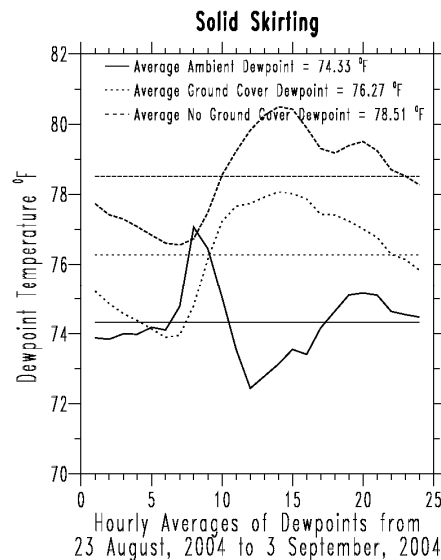
Figure 8 Dewpoints with solid skirting

As can be seen from the graphs, skirting installations increase the dewpoint under manufactured homes. Solid skirting (Figure 8) installed on a home without a ground cover increases the dewpoint under homes above the ambient dewpoint on average 7°F or more from 12 noon until 15:00. Installation of a ground cover mitigates this dewpoint increase, but crawlspace dewpoints are still increased over 5 °F during the same time period.
