## HISTORIC INTERIOR SPACES

### NUMBER 3

### Preserving Historic Corridor Doors and Glazing in High-Rise Buildings

**Chad Randl**  
Technical Preservation Services  
National Park Service

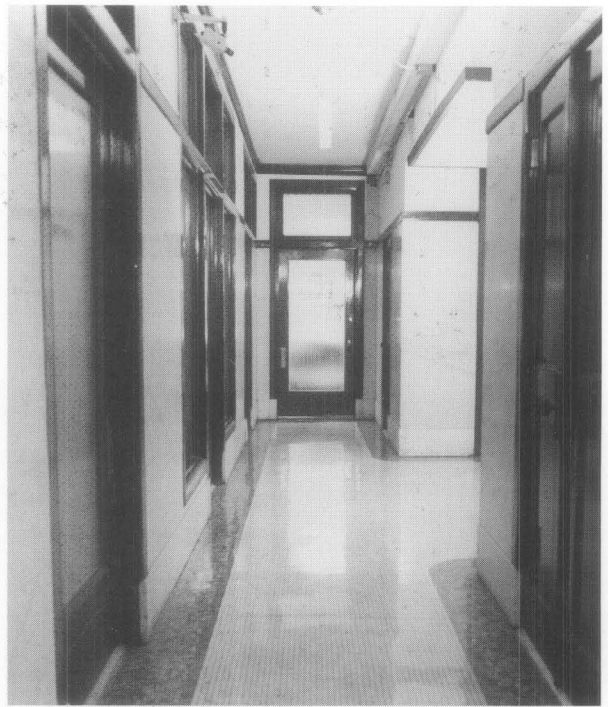
Figure 1. Historic corridor features such as doors, transoms and sidelights often do not meet current fire resistance regulations. Photo: Fisher Building, Frank Merrill Photography.

building undergoes a major rehabilitation or change in occupancy classification, the owner is usually required to bring the structure into compliance with modern codes written primarily for new construction. Among other provisions, current building codes often require that assemblies and materials provide a specified level of fire resistance. Historic doors, transoms and sidelights are common corridor features that are unlikely to meet such resistance ratings (*see figure 1*).

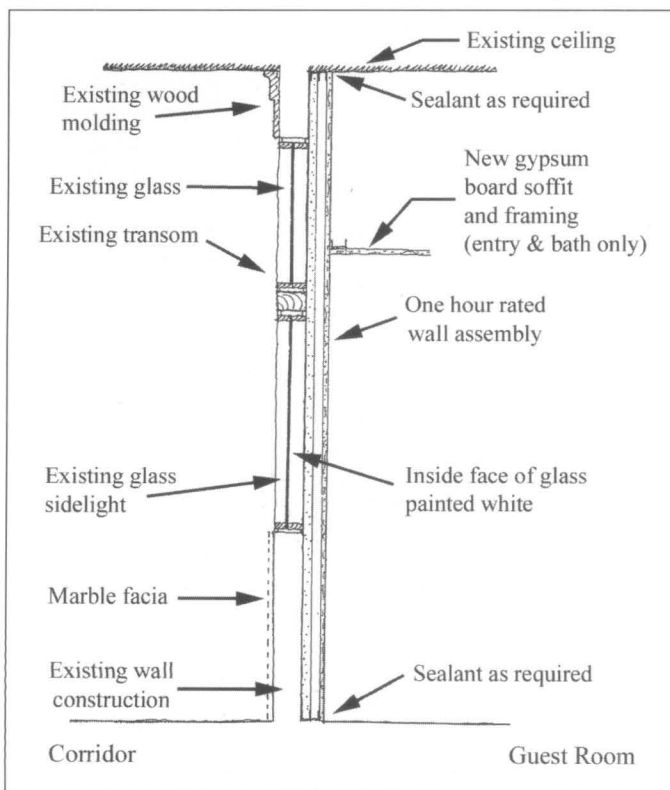
Figure 2. Typical Reliance Building corridor section showing additional wall assembly built behind historic glass sidelight and transom. Drawing: Antunovich Associates.

To retain the transoms and sidelights while complying with code requirements, the architects designed a non-combustible assembly that was integrated into the existing wall on the hotel room side (see figure 2). The 3-1/8" thick wall consisted of two gypsum boards separated by steel studs and sealed to the existing ceiling and doorframe. Back painting the glass white obscured the new wall assembly from the corridor.

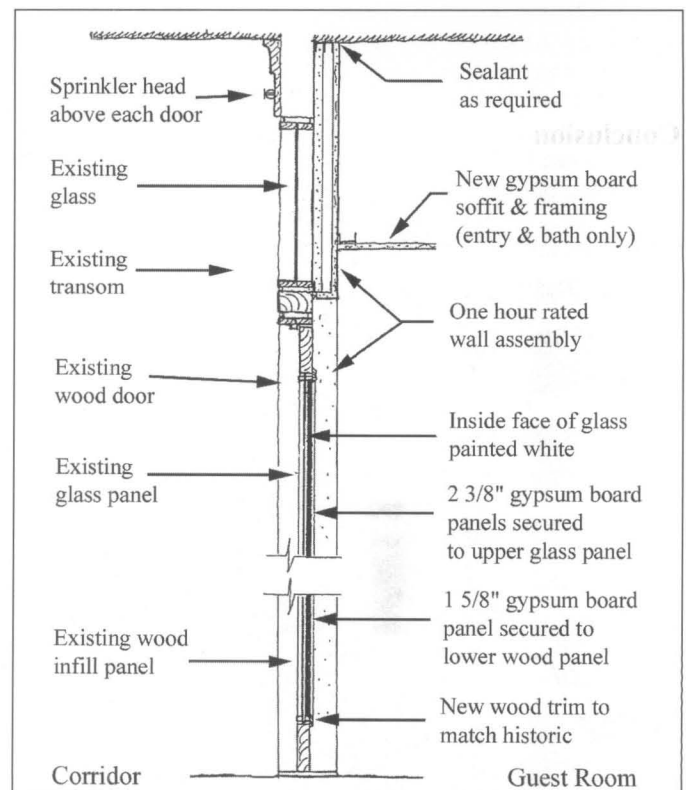
Figure 3. Typical Reliance Building door/transom section showing additional wall assembly and door panels. Drawing: Antunovich Associates.

The mahogany office doors were 2-1/2" thick with upper 1/8" thick glass and lower 1/4" thick wood infill panels. Both glass and wood panels were code deficient. To increase their fire resistance, two 3/8" gypsum boards were secured flush to the inside face of the glass and a single 5/8" sheet was used on the lower wood panel (see figure 3). New wood molding stained to match the original was placed around the border to secure and mask the edge of the added material. Mirrors were installed on upper panels facing the hotel rooms while lower panels were painted brown

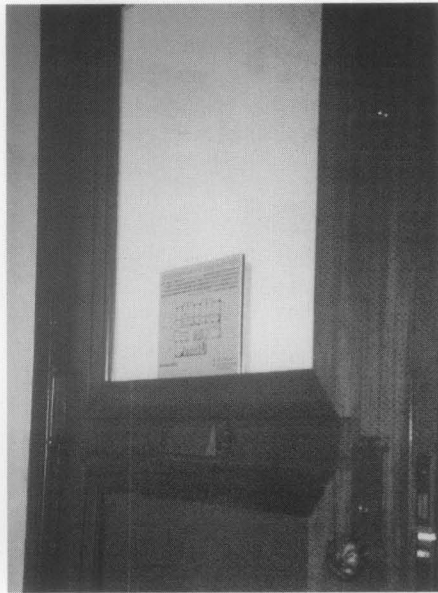
Figure 4. View of a Reliance Building office door from inside guest room. Upper and lower door panels have gypsum board secured to back with new molding. A mirror was affixed to the upper panel while the lower panel was painted to match original material. Photo: Chad Randl.

(see figure 4). Like the sidelights and transoms, the original glass was back painted with a white latex paint to conceal the infill panels from the corridor. Intumescent paint was applied between the door and frame to provide an effective smoke barrier and compensate for small irregularities in the fit of the historic doors. The mail slots were sealed and filled with a fire-rated putty. Further fire protection was provided by the installation of a sprinkler head on the corridor-side wall above each door. These heads were in addition to those specified by the building code.

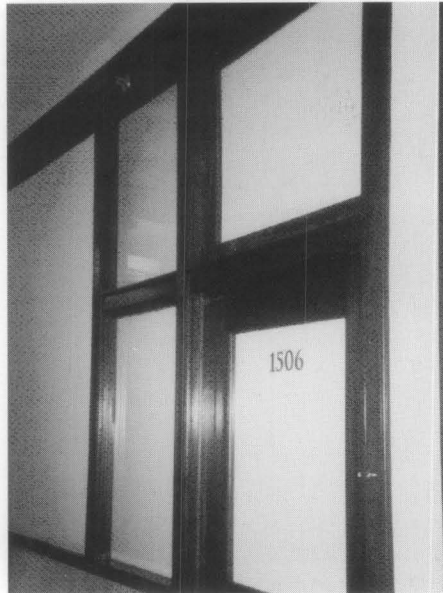
Figure 5. Completed Reliance Building corridor showing historic door panel, sidelight and transom. Photo: Chad Randl.

All surviving glass (plain, fluted and florentine) was retained in the door pan-

els, sidelights and transoms (see figure 5). New plain glass was used in locations where the original was cracked or otherwise required replacement. Room numbers were lettered on the glass with gold leaf. Finally, the direction of the door swing was reversed so that they opened inward and automatic closers were added in keeping with standard exiting code requirements.

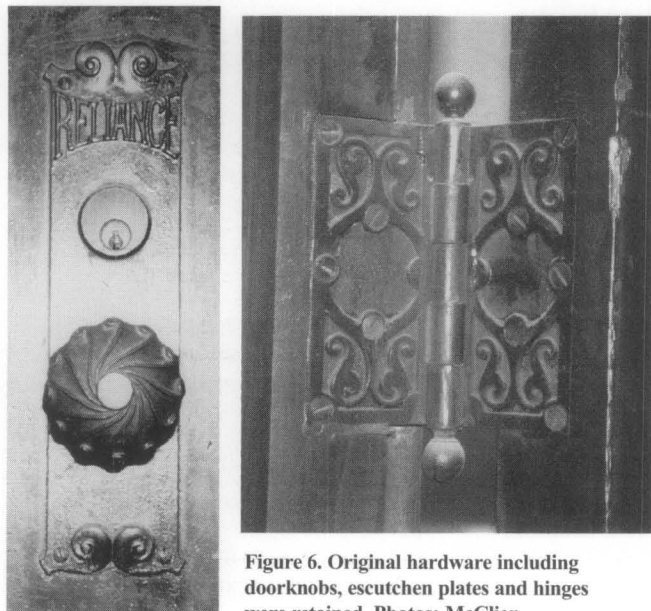
Figure 6. Original hardware including doorknobs, escutcheon plates and hinges were retained. Photos: McClier.

Retaining the doors and corridor glazing led to the preservation of a host of other features, including the mahogany trim found throughout the corridors and unique door hardware (see figure 6). Historic magnetite hinges, mail slots, doorknobs and escutcheon plates (inscribed "Reliance") were also retained.

have required replacing the historic escutcheon plates and knobs or significantly altering the door stile. Instead, a new mortise lock set appropriate to the door rating was installed with the original knob and escutcheon plate fitted over top.

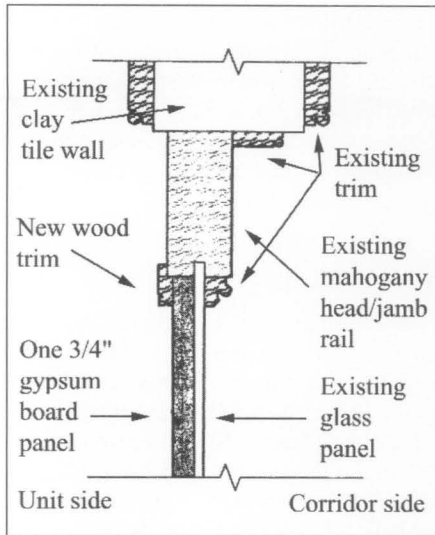
Figure 7. Section of Fisher Building door modified to improve glass panel fire rating. Drawing: Garet Stefanowski, Pappageorge/Haymes.

Door modifications paralleled those made in the Reliance Building. The interior stops were removed from the glazed areas of the doors, the original glass was cleaned and back painted, and a  $3/4$ " sheet of gypsum board was secured against the glass (see figure 7). A  $5/8$ " sheet of gypsum board was used

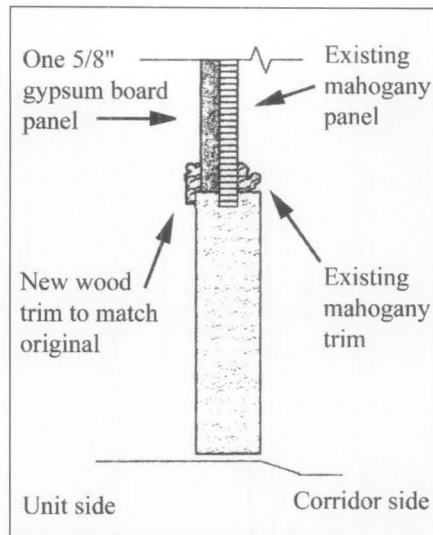
Figure 8. Section of lower wood panel with gypsum board reinforcement. Drawing: Garet Stefanowski, Pappageorge/Haymes.

behind the lower wood panel (see figure 8). Molding with profiles that were similar to those on the original door was attached at the joint between the gypsum and the original doorframe. Intumescent material was also applied to the edges of the door and doorframe (see figure 9).

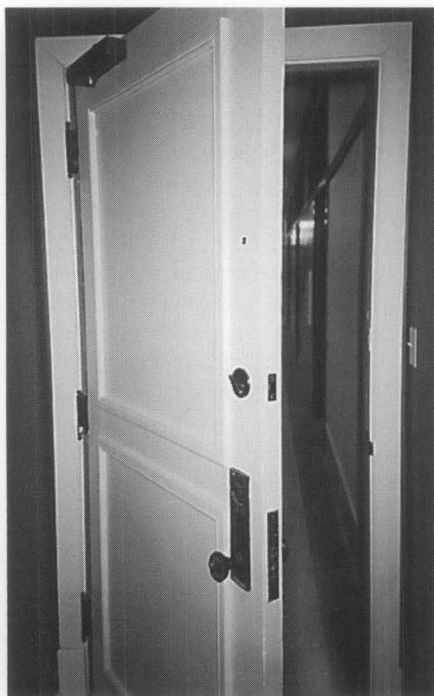
Figure 9. Fisher Building door viewed from apartment showing gypsum board infill panels, new trim and retained hardware. Photo: National Park Service File.

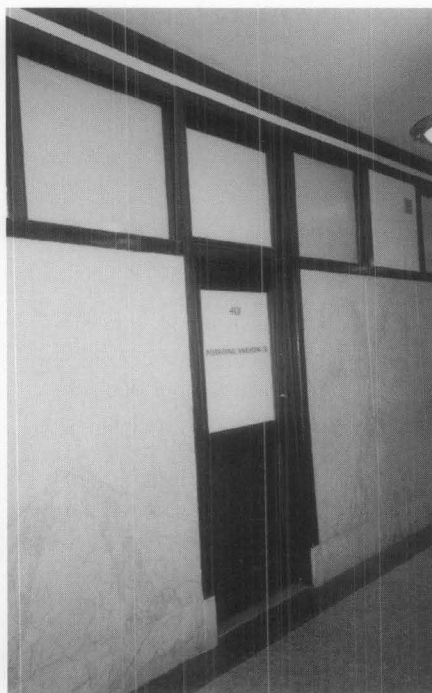
Figure 10. Completed Fisher building corridor with back painted door and tripartite transom. Photo: National Park Service File.

Following the Reliance Building model, all door hardware, including hinges, knobs, escutcheons and mail slots (where present) were preserved and incorporated into the rehabilitated doors (see figure 10). New deadbolt locks and peepholes were added to the door stiles above the original knobs. Automatic closers were added to all doors.

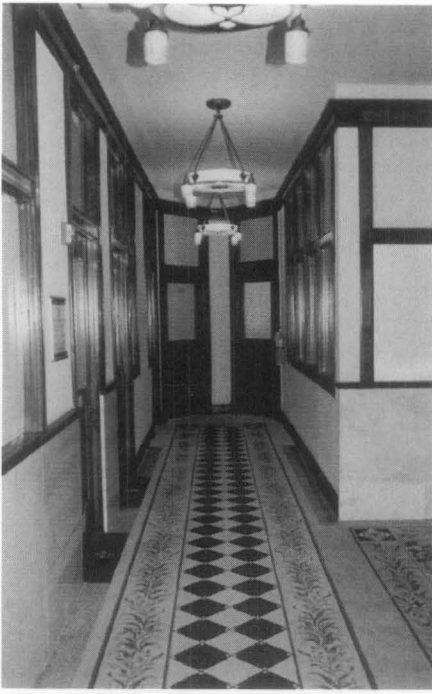
Figure 11. View of the completed Reliance Building corridor. Photo: McClier.

By introducing new fire resistant assemblies and mechanical upgrades in the already altered office spaces, there was no impact upon the scale of the corridors and the views along their length (see figure 11). Although the construction of new interior walls preserved the transoms and sidelights and the continued appearance of the corridor, it did obscure the glazed areas and their moldings from inside the former tenant space. Painting the inside face of the glass panels also resulted in a visual change in the corridor. Back painting was necessary in order to hide the gypsum infill panels, but the result lacked depth and failed to suggest the original office space within. The change was less noticeable in areas with patterned glass where the texture provided some relief from the flat, spandrel-like appearance of the new assembly. Covering the glazed panels with solid materials also darkened what were once daylight-flooded corridor spaces.
