# The Repair and Thermal Upgrading of Historic Steel Windows

[nps.gov/tps/how-to-preserve/briefs/13-steel-windows.htm](https://nps.gov/tps/how-to-preserve/briefs/13-steel-windows.htm)

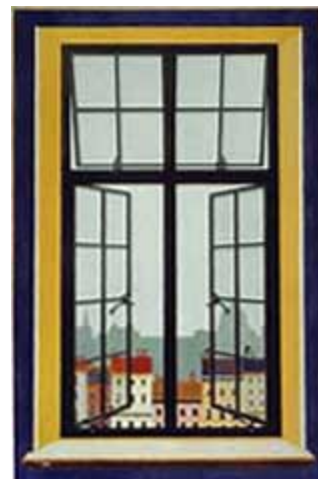
Metal casement window from "Hope's Metal Windows and Casements, 1818-1926." Photo: Courtesy, Hope's Windows, Inc.

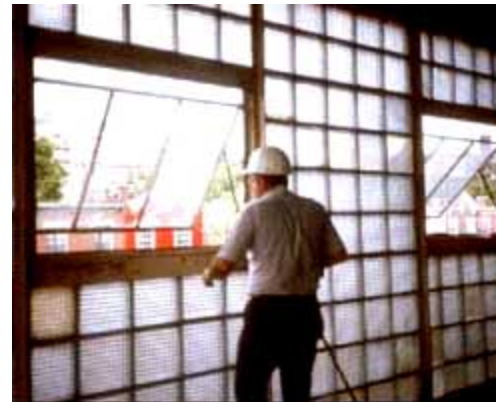
Maintaining historic steel windows for continued use is always recommended.

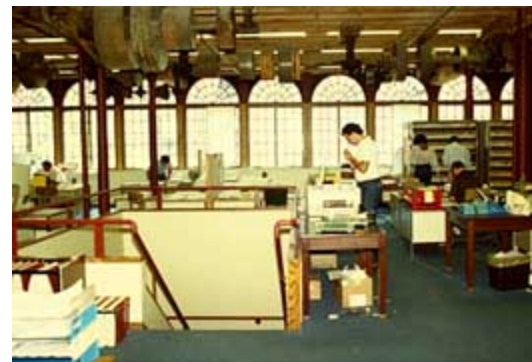
Historic metal windows provide abundant natural light in this rehabilitated industrial space. Photo: NPS files.

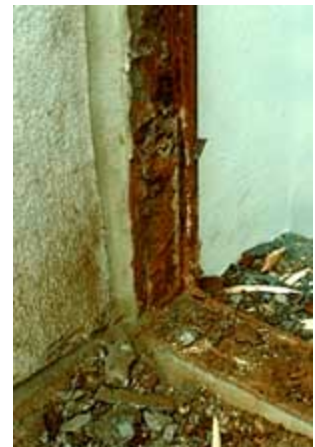
A severely deteriorated frame, such as this, can be replaced in kind.

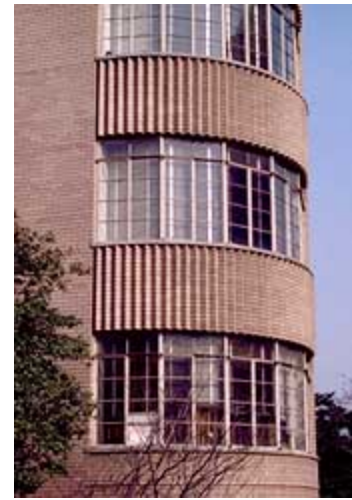
The historic steel sash is shown in place, prior to its removal and replacement with inappropriate aluminum sash (see below). Photo: NPS files.

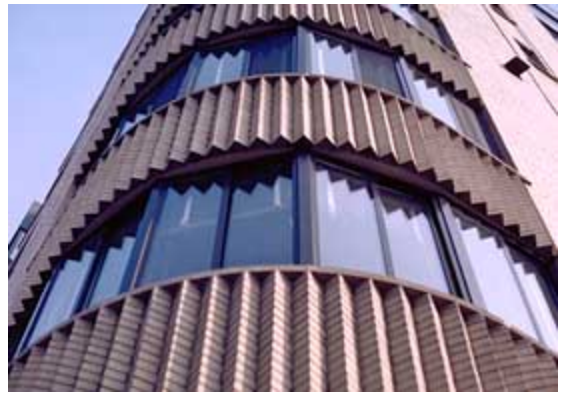
The historic steel sash (see photo above) was removed and replaced with modern aluminum sash, resulting in a negative visual impact on the building's historic character. Photo: NPS files.

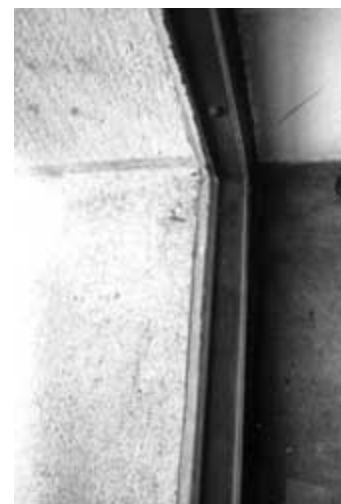
This is a successful replacement in kind of the deteriorated frame shown above. Photo: Henry Chambers, AIA.
