# Asbestos Cement Pipe Condition Assessment and Remaining Service Life Prediction

A thesis submitted in partial fulfillment  
of the requirements for the degree of  
Master of Science in Civil Engineering

Abiy Ghirmay  
University of Arkansas  
Bachelor of Science in Civil Engineering, 2014

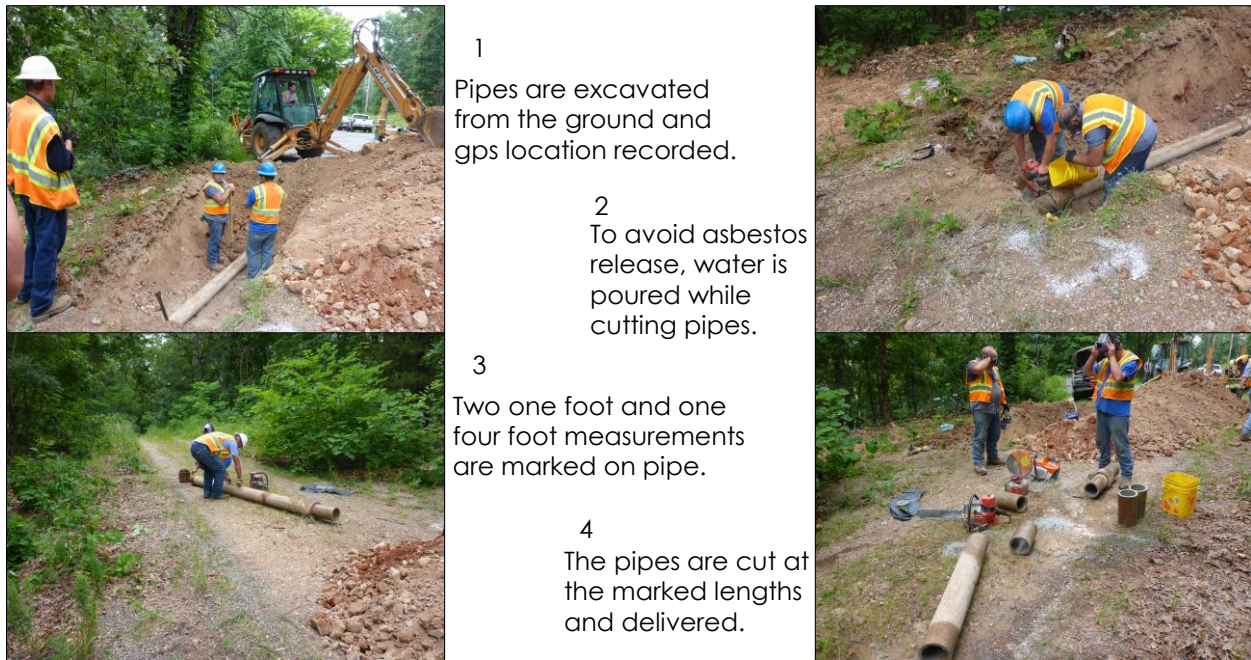
Figure 3-3. AC pipe sampling procedure

While there are no special licenses required to conduct AC pipe sampling, there are special trainings given to the technicians conducting the removal of these samples to ensure proper safety procedures. Although, AC pipes are considered non-friable, the sampling process presented in Figure 3-3 below can release asbestos fibers into the air.

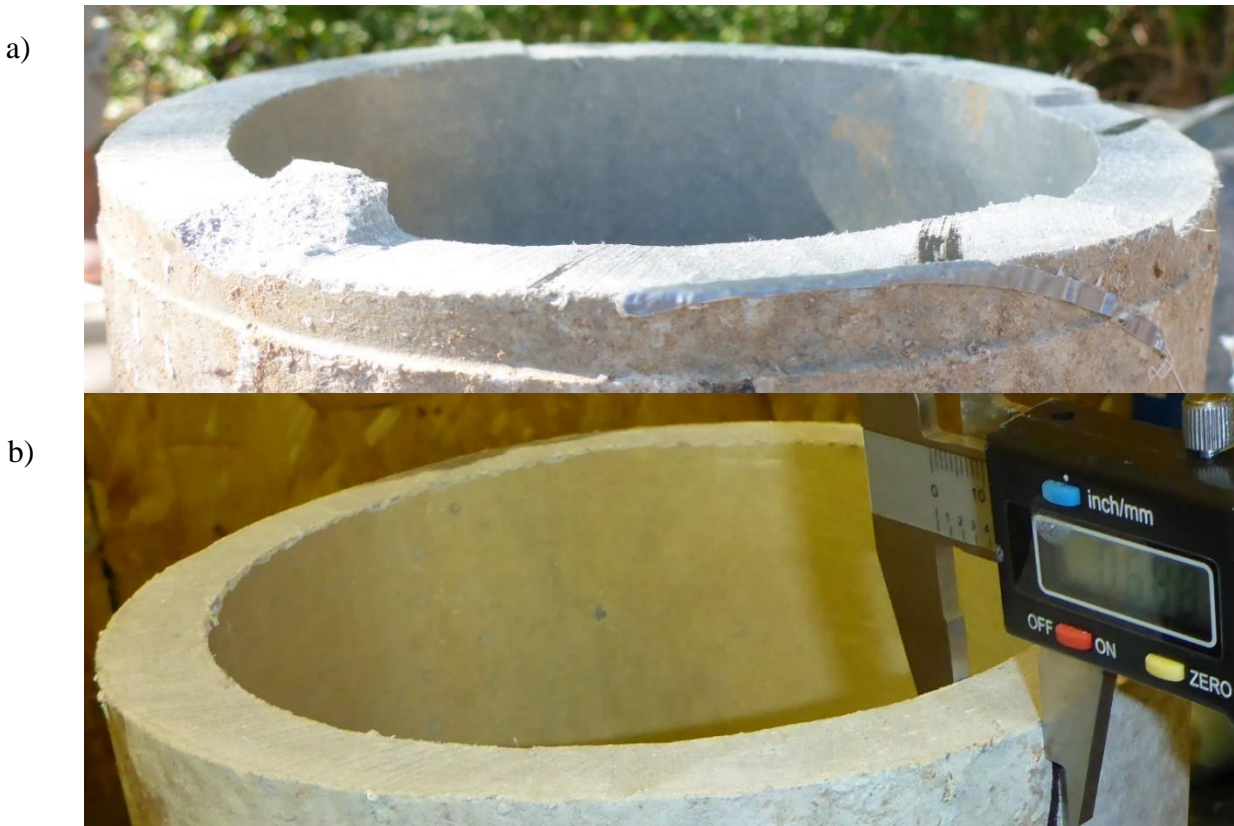
Figure 3-4. a) Surface before grinding; b) Measuring the pipe thickness after grinding

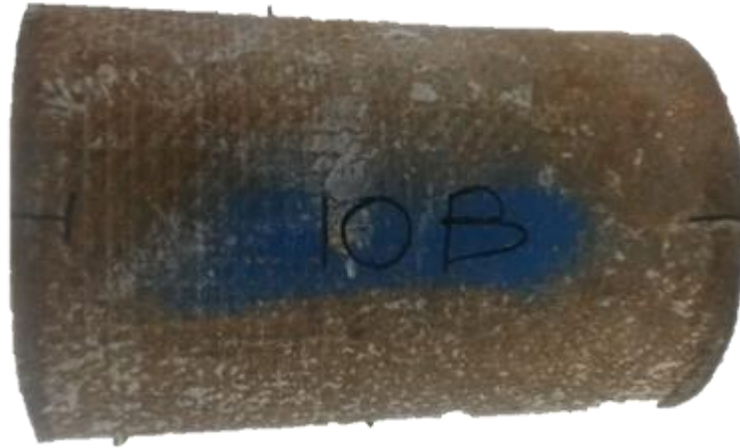
Figure 5-1. Sample 10B depicting the external surface of AC pipe

pattern is part of the manufacturing process of AC pipe. There were no samples with obvious signs of degradation that were visible to the naked eye.
