# Working Safely with Asbestos Cement

## ABSTRACT

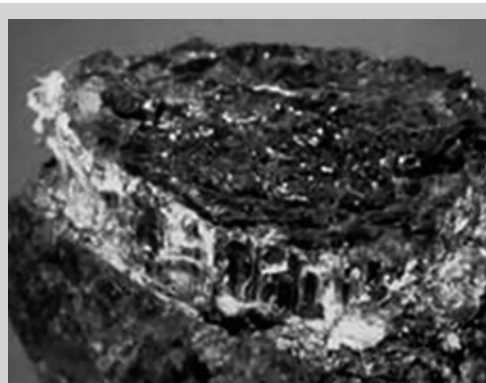
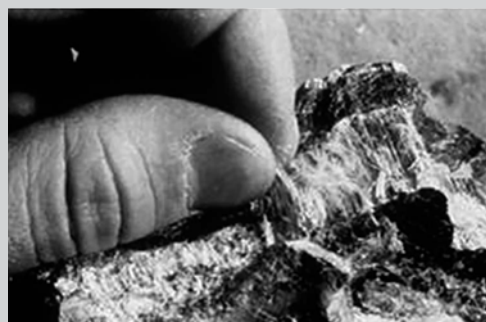
**Figure 1:** Asbestos is a naturally occurring fibrous mineral that was highly acclaimed and widely used because of its many advantageous properties.

Asbestos is a naturally occurring fibrous mineral this is mined and milled to extract the fibers from the ore.

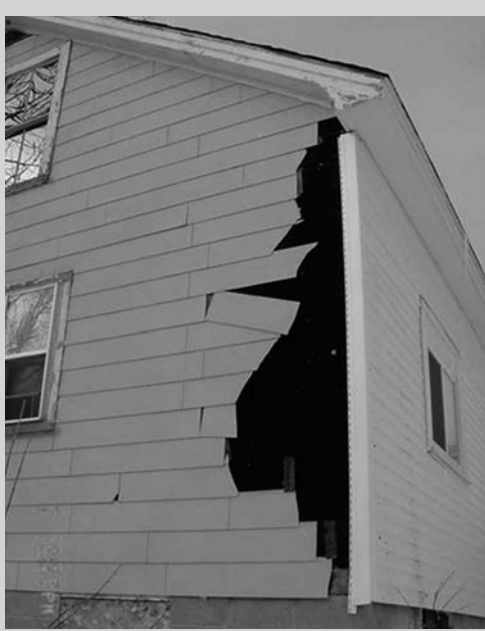
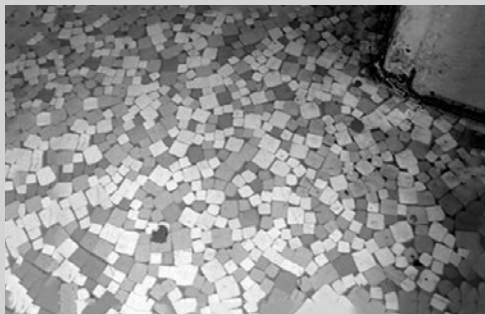
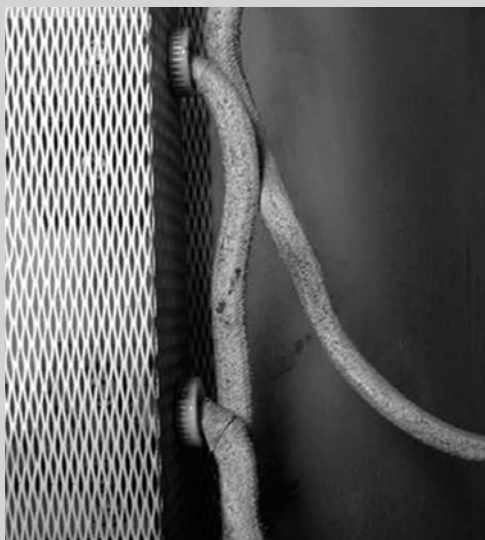
**Figure 2:** Asbestos fibers were mixed into thousands of products, notably those involved in construction, such as siding and flooring.

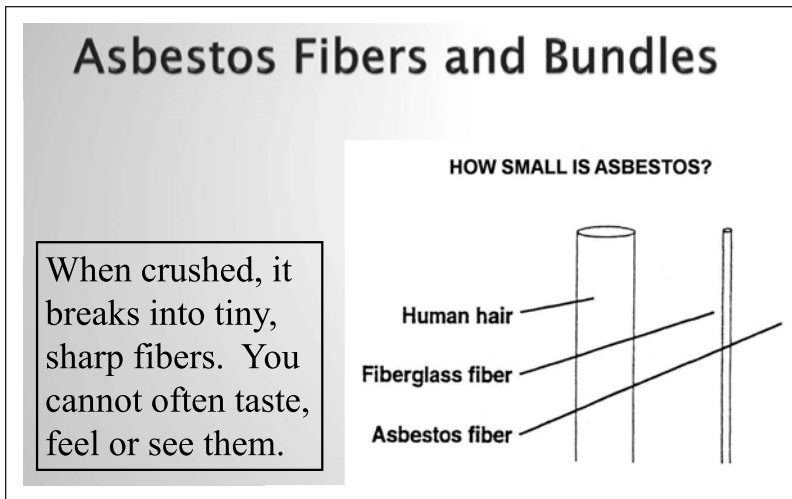
**Figure 3:** Asbestos fibers are microscopic and invisible to the naked eye. They are smaller than a human hair and a fiberglass fiber.

In spite of the unique benefits of asbestos fibers, medical researchers established a link between the inhalation of asbestos particles and lung-related ailments. Asbestos is now considered a carcinogen that is responsible for various cancers, including mesothelioma. The hidden dangers of asbestos are twofold: 1) people are unaware of the diverse products that can contain asbestos, and disturb them without proper training and equipment; 2) asbestos has no sensory trigger for exposure because the fibers cannot be seen with the naked eye, emit no odor, have no taste and are not irritating to the skin. Asbestos fibers are microscopic and are measured in micrometers, with tens of thousands of fibers measuring up to one grain of rice.

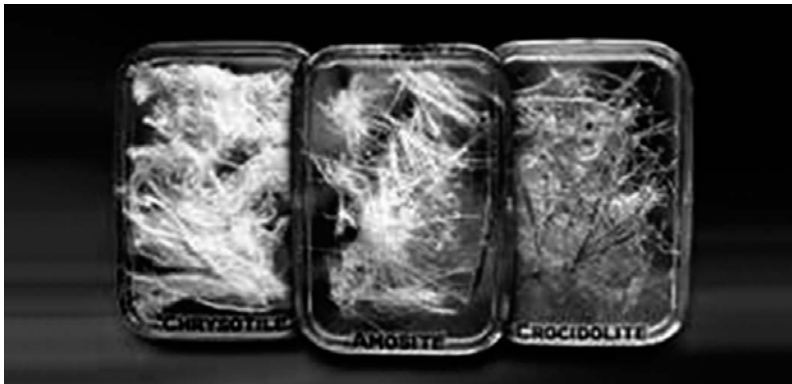
**Figure 4:** Three commonly found forms of asbestos are chrysotile, amosite and crocidolite.

There are six fibrous varieties of asbestos, with these three being the most commonly found in building products:

- Chrysotile, characterized by white, wavy fibers. Found in 90% of asbestos products.
- Amosite, characterized by short needle like fibers that break easily. Used largely in high heat applications.

- Crocidolite, a blue asbestos fiber, which is strong and stiff. Found in cement products where corrosion resistance is needed.

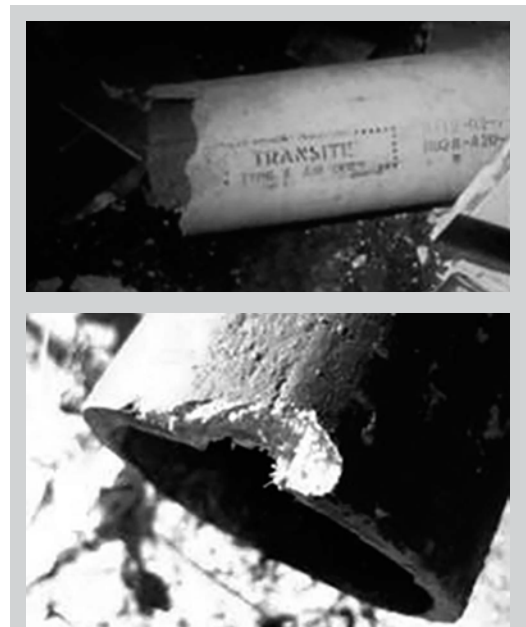
**Figure 5:** AC pipes usually contain anywhere from 10 to 75 percent asbestos.

AC pipe was typically made by adding chrysotile and/or crocidolite asbestos, ranging from 10 to 75 percent, to Portland cement, water and silica. The major manufacturers of AC pipe included the Cement-Asbestos Product Company, Certain-teed Products, Flintkote Company and the Johns-Manville Company. Today many lawsuits have been filed against several of these companies, resulting in large settlements.
