# Performance of Residential Buildings in Hurricane Prone Coastal Regions and Lessons Learned for Damage Mitigation

**Keywords: Hurricane Engineering, Residential Buildings, Wind/Flood-Induced Damage, Damage Mitigation Methods.**

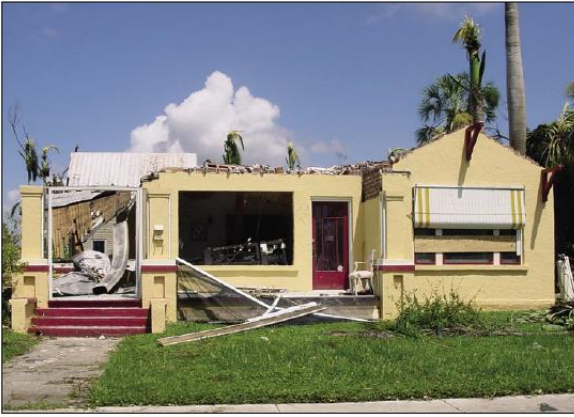
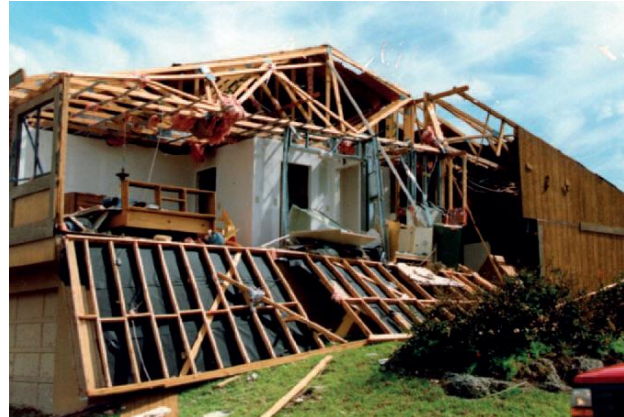
Figure 1. Wind-induced damage to structural members (FEMA P-488): (a) severe structural damage due to pressurization during Hurricane Charley, 2004; (b) severe damage to roof, structure, and gable end wall during Hurricane Andrew, 1992.

The lack of continuous load path from roof to the foundation is another important factor, which cause severe structural framing damage such as partial or even complete collapse of the building (FEMA P-55b). A building can have many continuous load paths, which can play an important role in resistance against various forces from hurricane hazards. It is important to mention that most load path failures occurred at connections such as roof sheathing to framing connection and roof framing to external walls other than failure of an individual structural members such as roof rafter or wall studs. Buildings can also suffer damage caused by pressurization and insufficient load path simultaneously, which is likely to result in a progressive sequence. Figure 1b shows a wood-frame house that experienced partial wall failures and severe damage to the roof and gable end wall due to lack of continuous load path. The partial wall failure can be considered as a trigger to initiate the internal pressurization, which caused additional damage to structural framing members leading to complete collapse of the building.

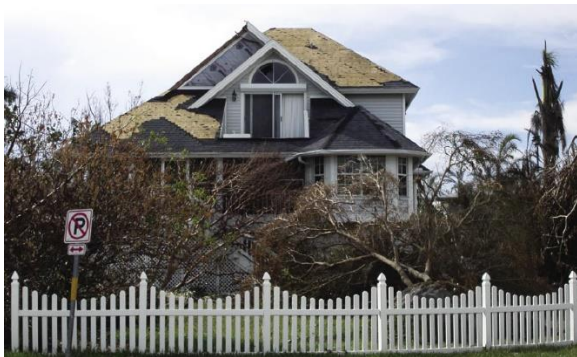
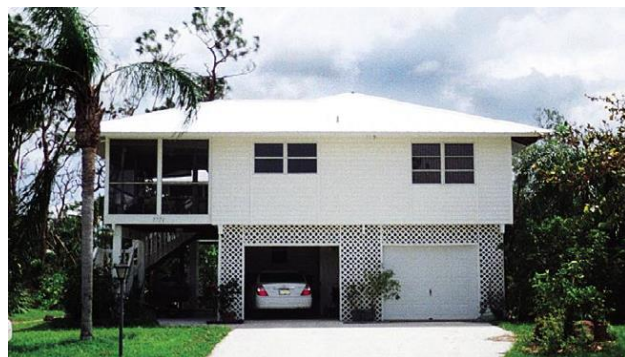
Figure 2. Typical roof covering loss during Hurricane Charley, 2004 (FEMA P-488): (a) asphalt shingle roof covering loss (Captiva Island); (b) undamaged metal panel roof (Pine Island).

Although the structural system suffered wind-induced damage, the building envelope system sustained more damage due to localized pressure along the edges and corners in hurricanes. Building components and cladding (C&C) consists of several elements, including roof and wall covering, sheathing, walls, windows, and doors. Additional observed damage was associated with wind-driven rain that entered and damaged building interiors through openings in the building envelope. As a result, significant increase in design loads for C&C has been considered in design standards and provisions over the past 20 years, such as the more recent editions of ASCE 7. Typical damage to residential houses during hurricanes occurred at or above the roof lines in terms of loss of asphalt shingles or tile roof coverings. However, houses with metal roof coverings had better performance during such hurricanes due to higher weight, longer and continuous length, and stronger connections. Figure 2 compares a typical asphalt shingle roof covering loss with an undamaged metal roof panel during Hurricane Charley (2004). The good performance of metal panels was also observed during Hurricanes Irma and Maria (2017). Furthermore, widespread loss of vinyl and aluminum soffit panels were observed, indicating that such panels were either pulled out by suction or pushed up by positive pressures. This type of damage can result in severe indirect damage due to wind driven rain to the interior components like drywall walls or ceilings.

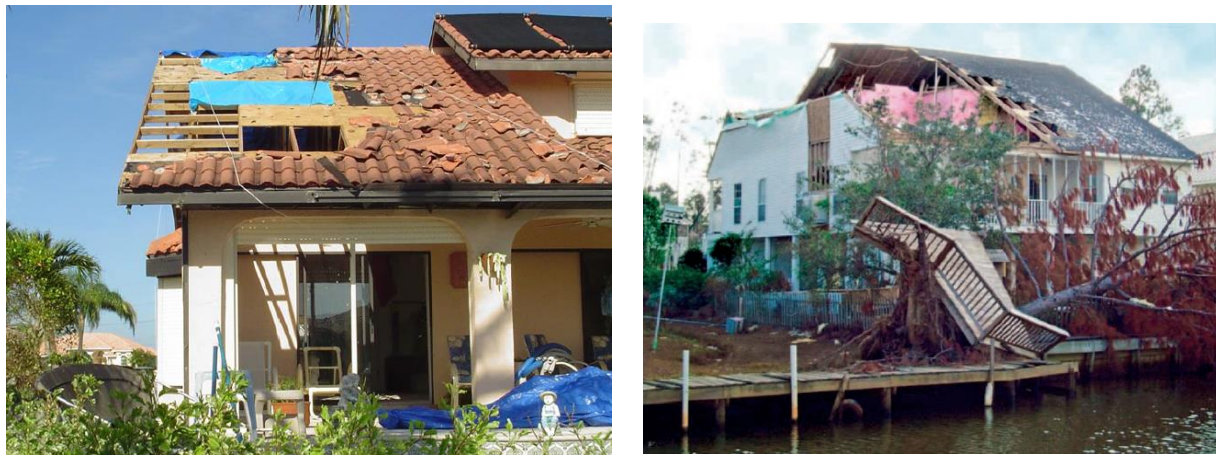
Figure 3. Sheathing loss and subsequent gable end wall and roof truss failure due to lack of lateral bracing during (FEMA P-488): (a) roof decking loss on one-story house, Hurricane Charley, 2004 (Punta Gorda); (b) wind damage to roof structure and gable end wall, Hurricane Katrina, 2005 (Pass Christian, MS).

Loss of roof sheathing is another common wind-induced failure in wood-frame houses during strong hurricanes due to lack of or inadequate connections between roof sheathing and roof structural frames. This type of damage has been observed in different building types with wooden roof structures. Figure 3 shows severe sheathing loss in the roof structure during Hurricane Charley (2004) and Katrina (2005). Moreover, extensive loss of roof sheathing resulted in lack of lateral bracing of the gable end wall from the top and subsequent partial or total collapse under high wind loadings. Lack of lateral support at the end gable wall can also be caused by the failure in unsupported rafter outriggers at overhangs, which lifts off by the wind and takes the roof sheathing with it. Therefore, the bottom or top chord can be pulled outward easily, twisting the truss and causing an inward collapse of the gable end wall. Last but not least, the gable end wall can also suffer serious damage when the wall sheathing fails as a result of poor connection to the wall framing system. It can be mentioned that failure of gable end walls during strong wind loads has been observed widely in residential buildings with wooden roof structural systems.

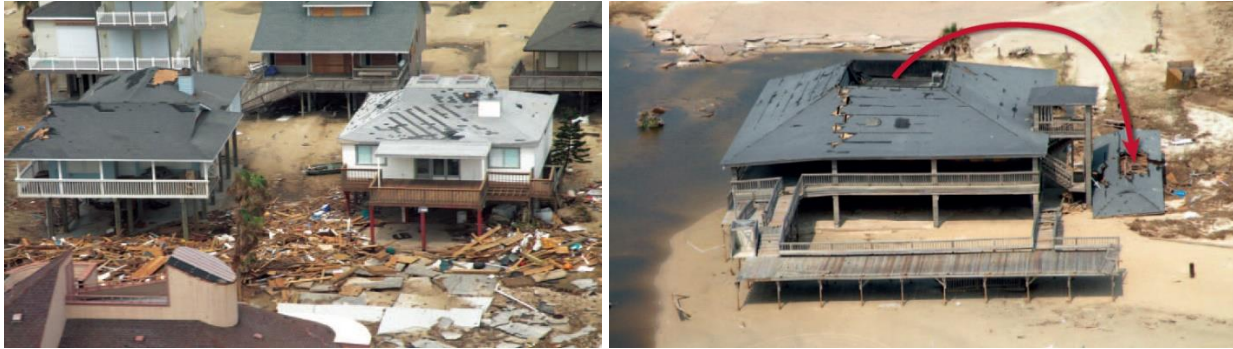
Figure 4. Wind-induced damage to the roof structure of elevated houses during Hurricane Ike, 2008 (FEMA P-55a): (a) roof covering and sheathing damage at roof edge and roof corners (Galveston, TX); (b) total collapse of the roof structure (Galveston, TX).

Figure 4 shows elevated houses sustained severe wind-induced damage in terms of loss of roof coverings, roof sheathings, and roof structural members during Hurricane Ike (2008). As shown in Figure 4a, roof envelope damage occurred at the roof edge and roof corners, where the wind flow separation is quite significant. This flow separation can cause small vortices that can cause much higher pressures in small localized areas. Inadequate connection between roof cover and roof sheathing, and between sheathing and roof framing such as truss members or rafters caused extensive roof damage and subsequent indirect damage. It should be noted that nonstructural (e.g., shingles) and structural (e.g., wood studs) components, which fail under direct wind pressure can potentially act as windborne or flood-borne debris to cause severe damage to other surrounding buildings. As shown in Figure 4b, the whole roof structure was blown out due to insufficient connections to resist high uplift wind loads. In addition, severe loss of roof covering, and sheathing was also observed at roof edges and roof corners.

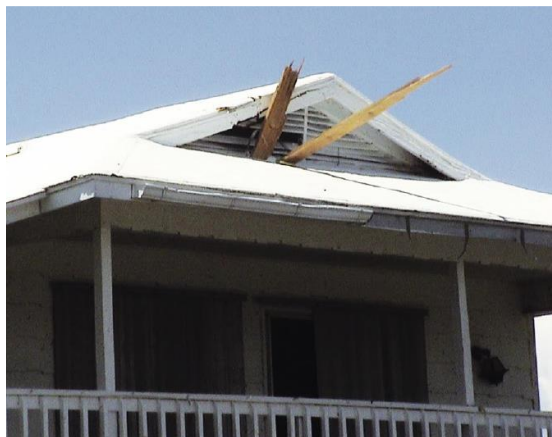
Figure 5. Damage due to windborne debris to building envelopes during Hurricane Charley, 2004 (FEMA P-488): (a) impact of structural wood members in the gable end, Pine Island; (b) a roof tile punctured the shutter, Punta Gorda.

Windborne debris is another important and widespread source that has caused serious damage to buildings during past hurricanes. The extent of damage is affected by several factors, including wind speed, debris source, debris elevation, and angle of impact. Windborne debris typically consists of several types, including roof coverings (tiles, shingles, metal panels, aggregate, etc.), damaged building components, trees, etc. It should be noted that windborne debris such as roof coverings that are detached from higher elevation can travel further with higher speed (one mile in some cases) than others from the ground, which can cause more severe damage to surrounding building envelopes (Figure 5a). As it was observed, use of appropriate laminated glass or shutter systems were the most effective ways to reduce such damage. However, protected building envelopes were still vulnerable to damage caused by windborne debris, which could initiate the pressurization and subsequent serious structural damage to the house (Figure 5b). Last but not least, buildings were observed to suffer severe damage by several types of falling objects such as trees, communications towers, rooftop equipment, etc. Therefore, corresponding measures, including bracing surrounding trees and anchoring outdoor equipment need to be considered in order to mitigate these types of damage to residual buildings.

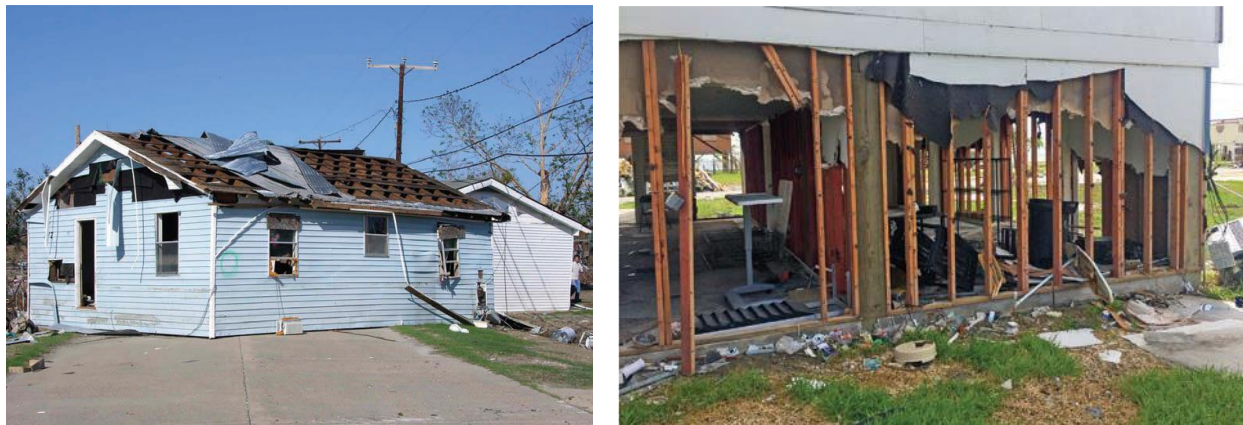
Figure 6. Typical damage to residential buildings due to hydrostatic and hydrodynamic forces: (a) building floating off its foundation during Hurricane Katrina, 2005 (FEMA P-550); (b) extensive damage to exterior walls due to 3 to 4 feet surge inundation during Hurricane Harvey, 2017 (FEMA P-2022).

Flood-induced damage to coastal residential buildings results from several hazards, including hydrostatic forces, hydrodynamic forces, waves, erosion, scour, and flood-borne debris. Hydrostatic pressures due to the weight of standing or slowly moving water, saturated soil, and water in the ground underneath a flooded building impose horizontal and vertical forces (buoyancy or floatation) on building components, which can also cause it to float off its foundation (Figure 6a). Moving floodwater generates hydrodynamic forces on submerged foundations, solid walls and building components, which can cause serious damage due to insufficient connections and lack of load path continuity (FEMA P-550). It should be noted that basement walls are more prone to failure due to the additional pressure from the saturated soil. Figure 6b shows typical damage to exterior walls due to hydrostatic and hydrodynamic forces during Hurricane Harvey (2017). It is important to mention that breaking waves are able to cause more severe damage to residential building in terms of damaging exterior walls or completely washing off houses elevated on piles or piers but with insufficient elevation, and also weak connections between the piers supporting floor beam and foundation.

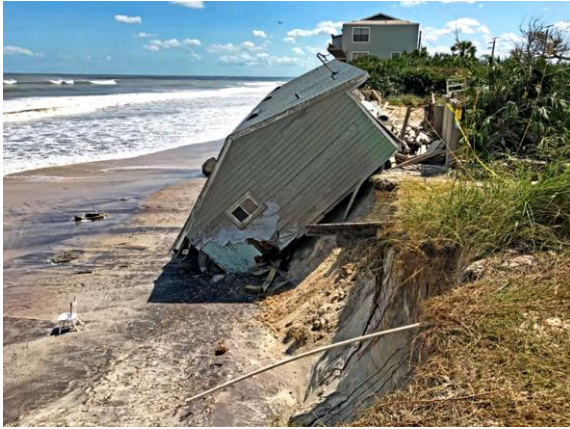
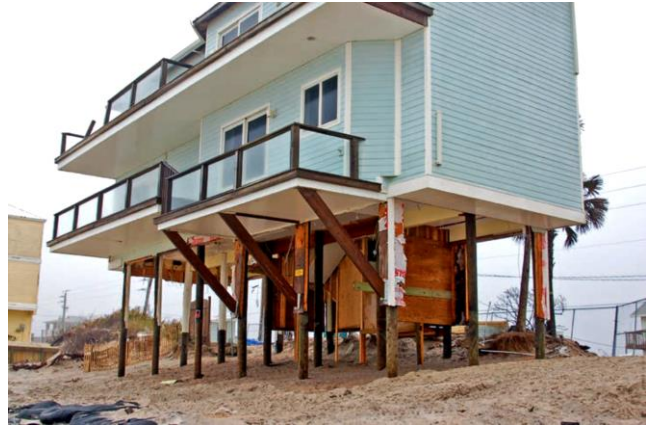
Figure 7. Performance of residential houses against erosion and scour effects during Hurricane Irma, 2017 (FEMA P-2023): (a) total collapse of the house with shallow foundation due to erosion in Vilano Beach, FL; (b) elevated house with deep pile foundation survived erosion in Vilano Beach, FL.

Erosion and localized scour can threaten the overall performance of coastal residential buildings in many different ways. Erosion and scour effects are usually likely due to combination of waves and high velocity flow, which can easily undermine shallow foundations, and reducing penetration depth of pile foundations resulting in partial or total collapse of buildings. It has been observed that buildings with deep pile foundations performed better than buildings with shallow foundations. In addition, failures of erosion control structures can result in severe unpredictable damage to residential buildings particularly the ones with shallow foundation systems. Figure 7 compares the performance of two residential buildings against erosion and localized scour during Hurricane Irma (2017). Study of damaged homes in such events has also shown that houses sustaining severe damage due to erosion and scour in terms of loss of soil supports are more vulnerable to lateral wind and flood loads acting on the structures during the time of hurricane.

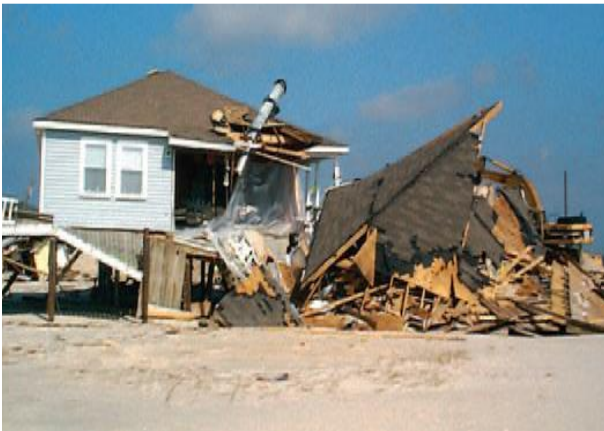
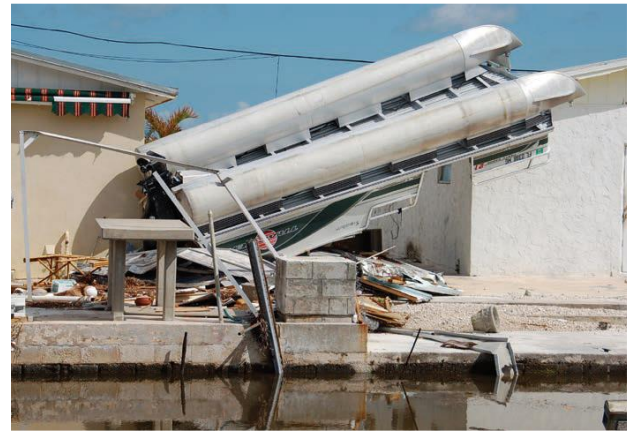
Figure 8. Damage to the coastal building due to floodborne debris (FEMA P-55a; FEMA P-2023): (a) pile supported house washed into another house at Dauphin Island, AL. during Hurricane Georges, 1998; (b) boat and small debris washed into a house in Big Pine Key, FL, during Hurricane Irma, 2017.

Floodborne debris produced by coastal flood events is often capable of destroying a wide variety of building types such as unreinforced masonry walls, light wood-frame construction, and small diameter posts and piles. In addition, debris trapped by structural components such as cross-bracing or closely spaced piles are capable of transferring flood and wave loads to the foundation of an elevated structure. Figure 8 shows damaged residential buildings in coastal areas due to flood-borne debris during different hurricanes. The impact loads resulting from floodborne debris can be estimated and applied based on the procedure in ASCE 7-16. There are some uncertainties which must be determined before estimating impact loadings, including physical characteristics of floating objects, flood velocity, most vulnerable portion of building, and duration of the impact. Therefore, the more reliable estimation will result in more accurate load calculation results.

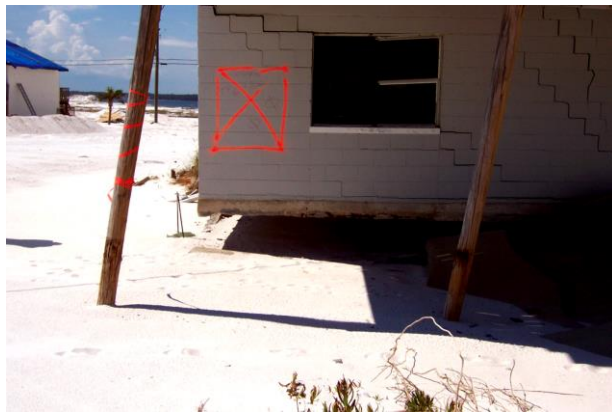
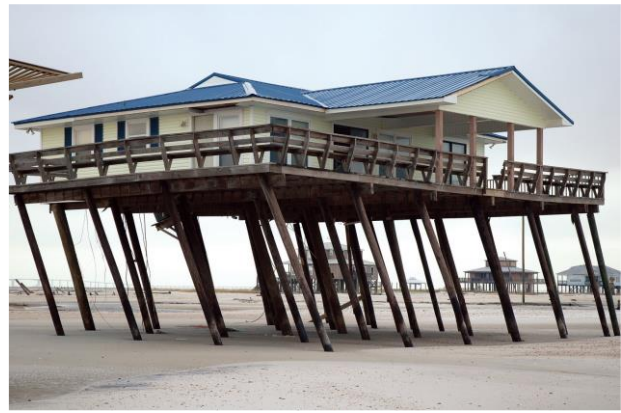
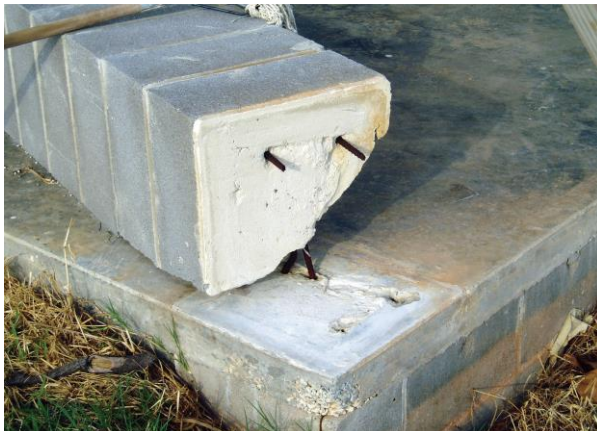
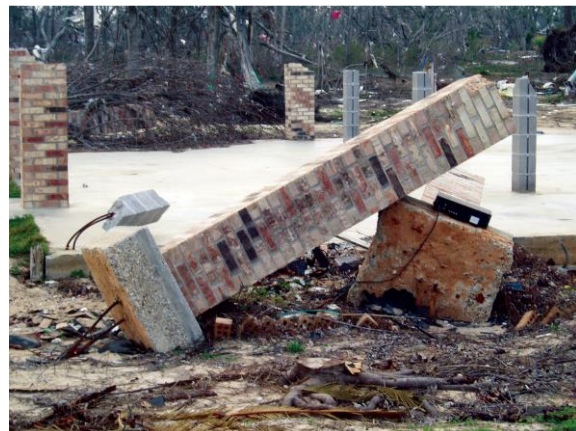
Figure 9. Typical damage to foundation systems of residential buildings in coastal areas (FEMA P-550): (a) slab-on-grade foundation failure due to erosion and scour from Hurricane Dennis, 2005 (Navarre Beach, FL); (b) partial collapse due to insufficient pile embedment during Hurricane Katrina, 2005 (Dauphin Island, AL); (c) column connection failure during Hurricane Katrina, 2005 (Jackson County, MS); (d) failure of pier on discrete footing due to overturning moment during Hurricane Katrina, 2005 (Pass Christian, MS).

Foundations in coastal areas must be able to perform several functions in order to ensure that buildings are able to resist various hurricane loads. The foundation system not only needs to provide a continuous path for vertical and lateral loads transferred from the building to the ground, it should also be able to directly resist different types of flood loads, including storm surge, wave, foodborne debris impact, erosion, and scour effects. For example, deeply embedded piles or other open foundation systems are required for V zones because of high waves and floodwaters. However, closed foundations are not recommended in coastal A zones and are not allowed in V zones due to the fact that these foundations provide a large surface area exposed to waves and flood forces. The performance of open/closed foundations rely on various factors, including sufficient load capacity of continuous foundation walls, piles, or piers against lateral loads (wind and flood), adequate connections between piles or piers with foundation and floor beams, and sufficient embedment length of piles. Figure 9 shows typical damage to different foundation systems of residential buildings in coastal areas in past hurricanes, including damage due to the erosion, scour, insufficient pile embedment, and lack of sufficient connections between piers and the foundation.

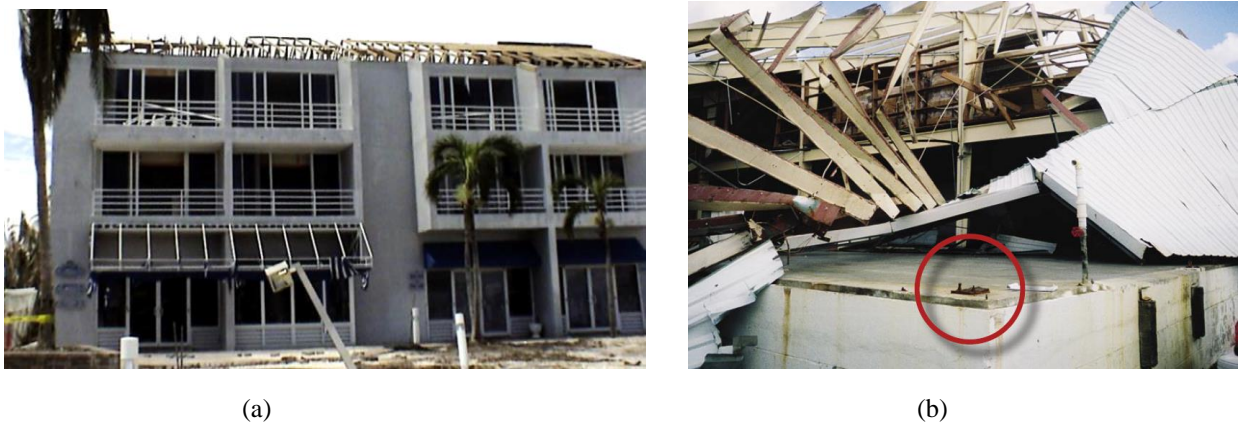
Figure 10. Wind-induced damage to concrete and steel frame buildings during Hurricane Charley, 2004 (FEMA P-488): (a) damage to a multi-family building roof deck with inadequately supported and braced overhang; (b) roof framing failure and gable end wall collapse due to insufficient lateral supports.

Steel frame buildings are more vulnerable compared to reinforced concrete buildings and have experienced more damage to the structure and envelope system during strong hurricanes mainly due to poor and corroded connections. Several types of failure were observed, including loss of roof and wall panels, partial/complete collapse of structural frames, and damage to gable end walls due to inadequate lateral bracing. Steel frame buildings are more vulnerable to windborne debris so that subsequent pressurization due to possible breach to envelope system can also cause severe damage to the structure. Figure 10b shows partial and complete structural damage due to failures in connections between roof members and base plate for the gable end wall column.

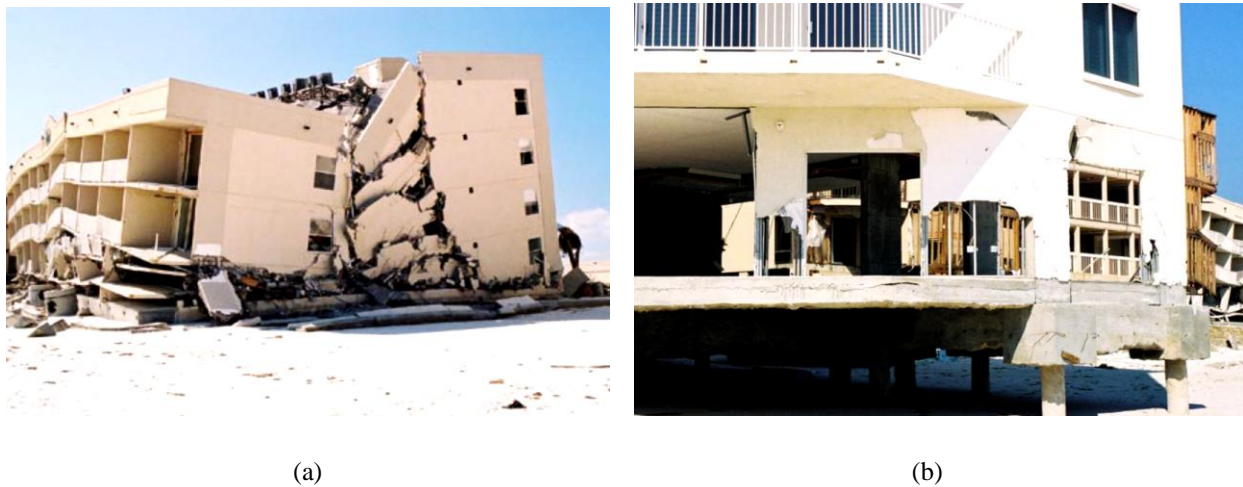
Figure 11. Several flood-induced damage to concrete buildings during Hurricane Ivan, 2004 (FEMA P-550): (a) severe structural damage to the building with shallow foundation due to surge, wave, and floodborne debris; (b) partial/complete collapse of exterior walls below the BFE for a concrete building elevated on deep piles.

Regardless of the material used for the structural system, even fully engineered residential buildings but with elevated floors below the BFE with deep foundation systems (Zone V or A) have also sustained flood and erosion damage. Figure 11a shows a 5-story concrete building with shallow foundation system, which sustained severe damage due to surge, debris, and erosion effects during Hurricane Ivan (2004). In addition, exterior walls below the BFE regardless of material mostly suffered severe flood-induced damage particularly in V and A coastal zones. Figure 11b shows a concrete building elevated on deep piles, but with low elevation living unit that was destroyed due to surge, high waves, and subsequent flood debris. Based on observations during Hurricane Ivan (2004), regardless of material, almost 80 percent of lowest floor living units were destroyed by flood and erosion effects, despite the fact that most of buildings were constructed on pile foundation above the estimated BFEs selected from available DFIRMs.
