Straw Bale Building as a Low-Tech Solution: A Case Study in Northern Poland

Abstract: There is a growing interest in low-tech technologies, drawing on the tradition of building with organic and unprocessed materials. One such technology is straw bale constructions. This paper presents an example of a timber-frame building in which straw bales were used as wall filling. The building is located in northern Poland and is a small, year-round single-family dwelling. Based on the available literature and experimental studies, it can be concluded that straw bale technology carries several potential threats related to the selected technology, quality of workmanship, and climatic conditions. The article describes the measurements of the air tightness of the building, the heat transfer coefficient U and the analysis of the humidity of straw walls. The study results confirm the risks related to the low air tightness of the building and the risk of water vapour condensation in the external partitions.

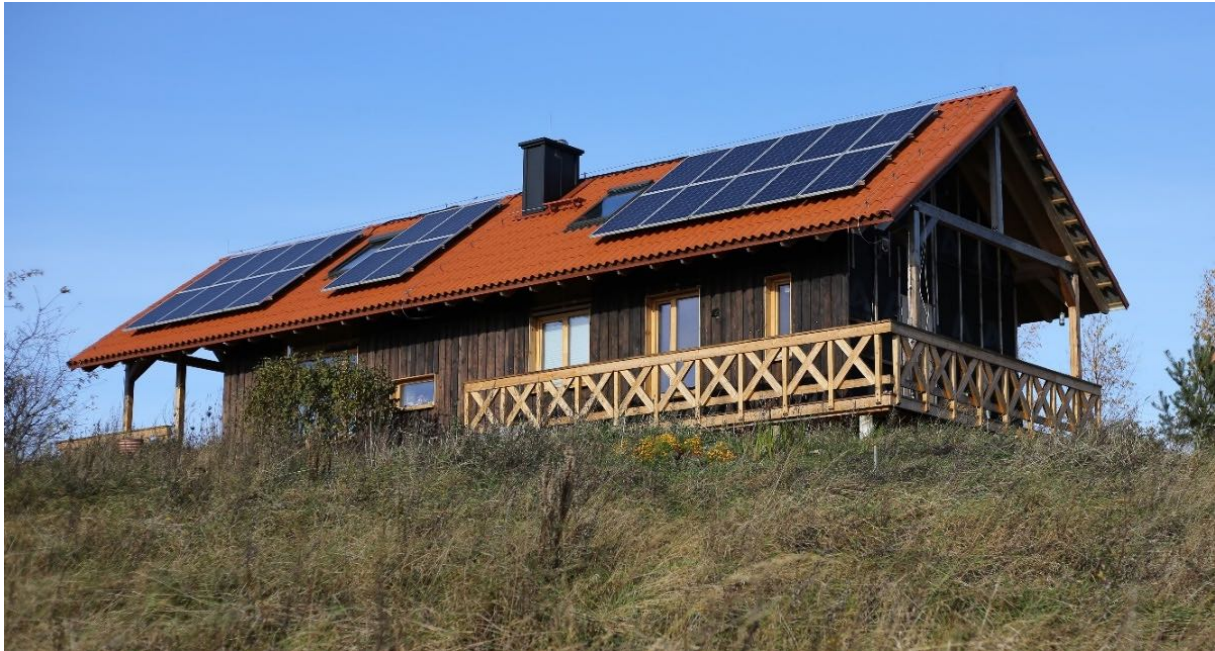
Figure 1. Single-family straw bale dwelling under study. Photo: Michał Pierzchalski.

The object of the research is a building constructed in the village of Zyndaki in the Warmińsko-Mazurskie Voivodeship in northern Poland. The building is a single-family dwelling which can be used all year round. The building is shown in Figure 1.

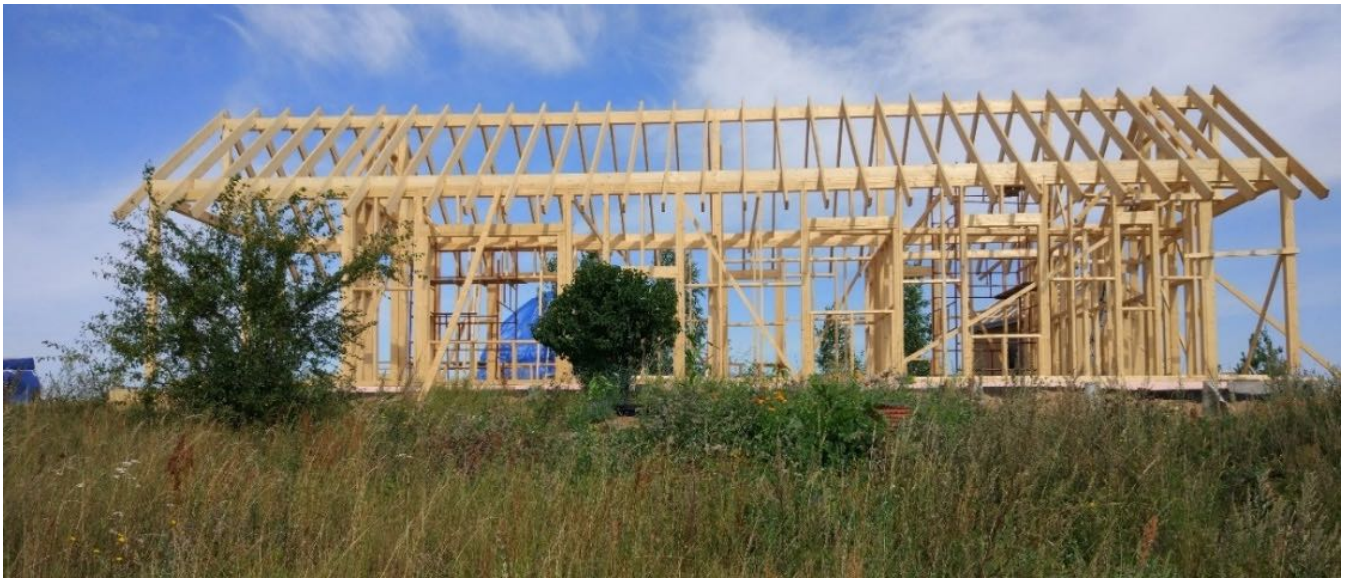
Figure 5. The timber structure of the building. Photo: Michał Pierzchalski.

For buildings used irregularly, such as holiday homes, straw bale technology is better than the most commonly used masonry technology in Poland. This is because it takes a relatively long time for the perceptible temperature to stabilise after a prolonged period of absence. The house used in this study is situated in the open on a small hill—this location exacerbates the effect of wind on the building's performance. The building's structure is based on double-beam timber columns spaced at intervals of 62 cm. The building structure can be seen in Figure 5.

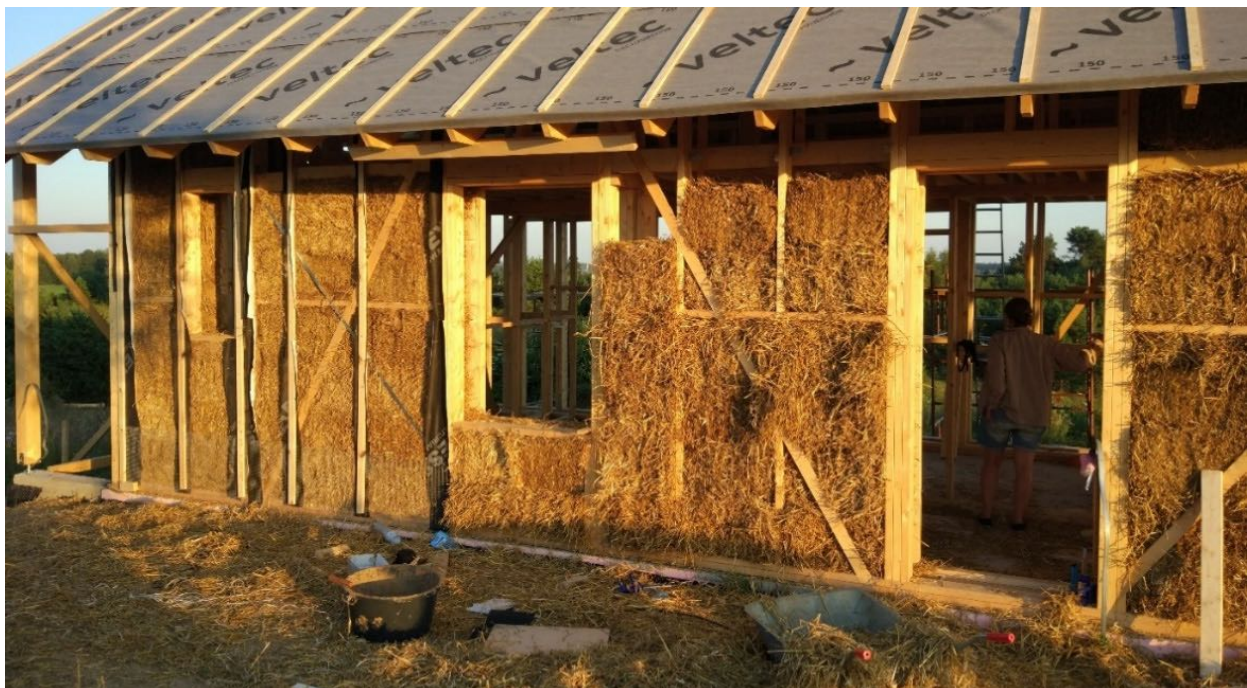
Figure 6. Outer wall filled with bales of compressed straw. Photo: Michał Pierzchalski.

Wheat straw bales were placed between the structural posts of the walls and compressed on-site with straps and tensioners. The walls were then plastered on both sides with clay, which was obtained on-site. The process of stacking the straw can be seen in Figure 6, and the plastering with clay can be seen in Figure 7.

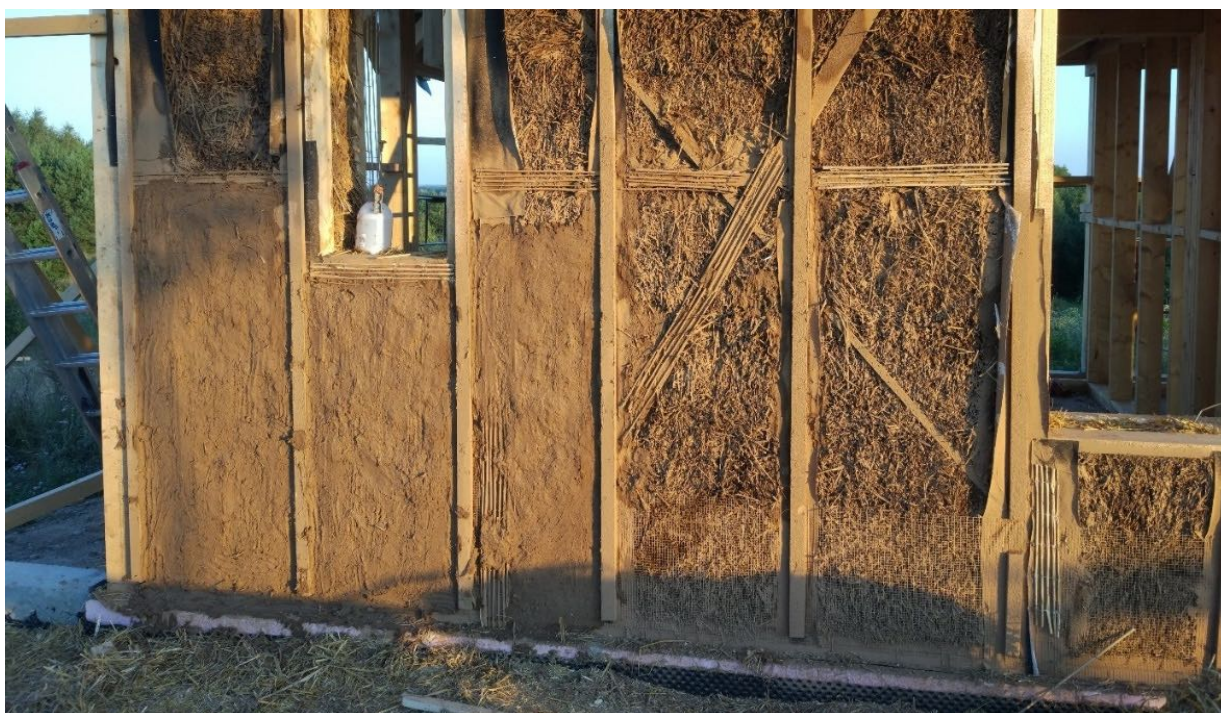
Figure 7. Exterior wall in the process of being plastered with clay. Photo: Michał Pierzchalski.

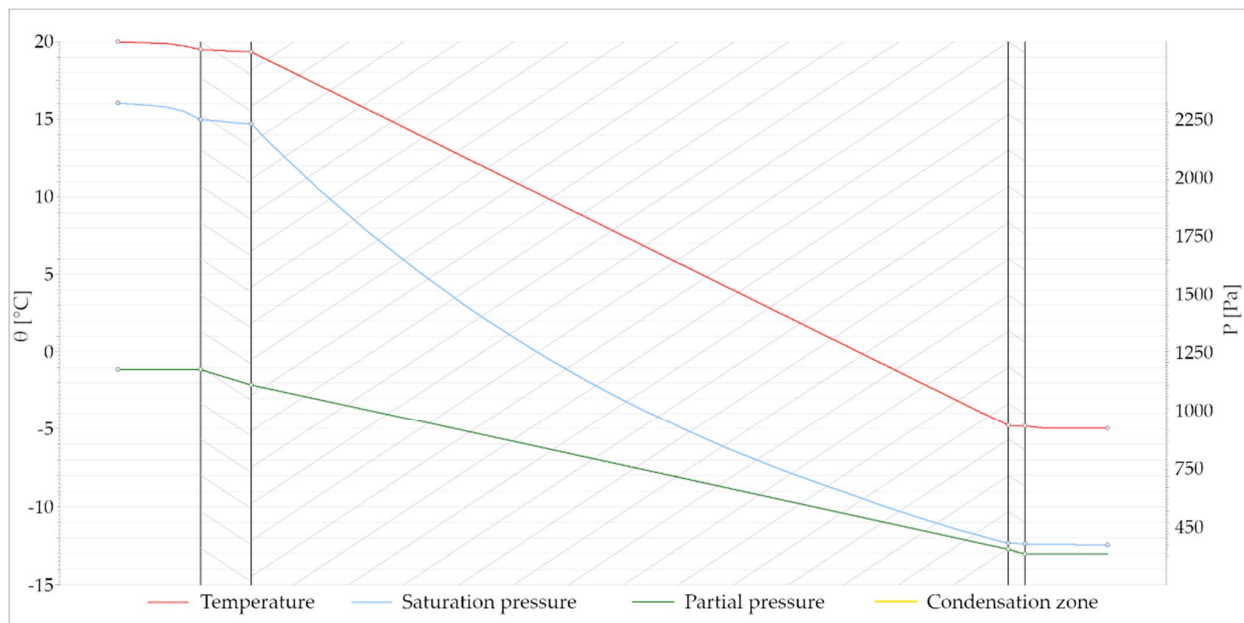
Figure 10. Water vapour pressure distribution in the partition. Reference variant. Internal temperature $\theta_{\text{int}} = 20\text{ }^{\circ}\text{C}$, internal relative humidity $\varphi_{\text{int}} = 50\%$, outdoor temperature $\theta_{\text{ext}} = -5\text{ }^{\circ}\text{C}$, outdoor relative humidity $\varphi_{\text{ext}} = 90\%$. Red—temperature distribution θ ($^{\circ}\text{C}$), blue—distribution of water vapour saturation pressure P_{sat} (Pa), green—distribution of partial pressure P (Pa). Source: Analysis performed with the AudytorOZC 7.0 Pro.

Based on the above data, a moisture analysis was carried out in accordance with PN-EN ISO 13788:2013-05. The analysis was carried out using AudytorOZC 7.0 Pro software. The analysis showed no risk of condensation. However, the month of January can be risky, with condensation occurring under unfavourable conditions. The distribution of water vapour pressure in the partition during the month of January is shown in Figure 10.

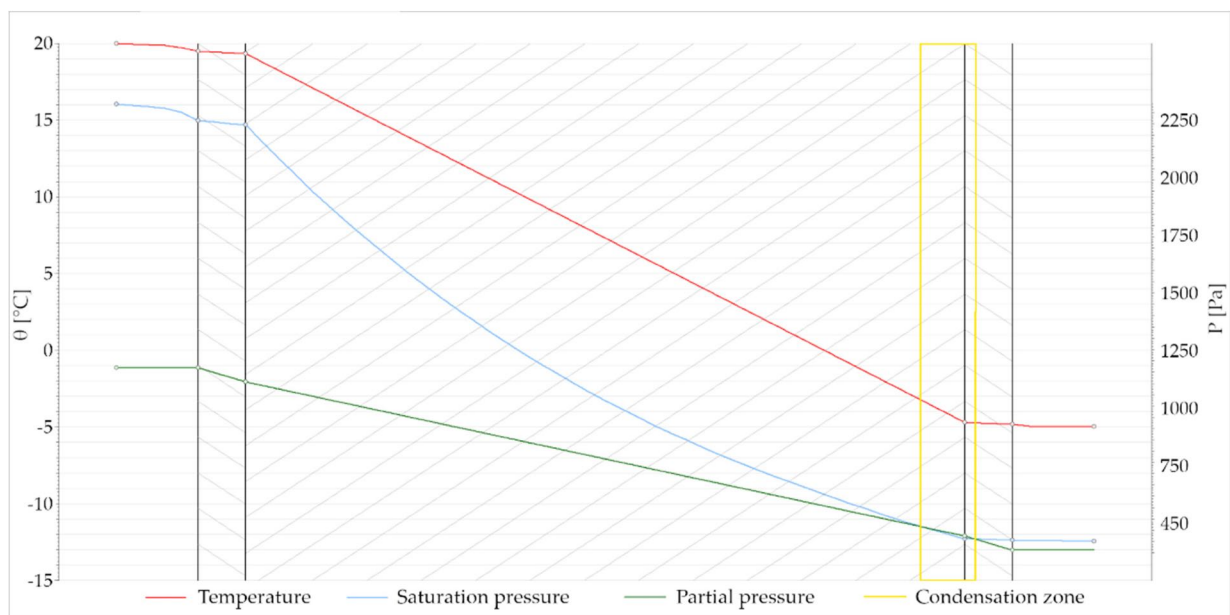
Figure 11. Water vapour pressure distribution in the partition. A variant with a 3 cm thick external clay render. The distance between the blue and green lines has decreased than in the reference variant—so the risk of condensation inside the partition has increased. Internal temperature $\theta_{\text{int}} = 20\text{ }^{\circ}\text{C}$, internal relative humidity $\varphi_{\text{int}} = 50\%$, outdoor temperature $\theta_{\text{ext}} = -5\text{ }^{\circ}\text{C}$, outdoor relative humidity $\varphi_{\text{ext}} = 90\%$. Red—temperature distribution θ ($^{\circ}\text{C}$), blue—distribution of water vapour saturation pressure P_{sat} (Pa), green—distribution of partial pressure P (Pa), yellow—condensation zone. Source: Analysis performed with the AudytorOZC 7.0 Pro.

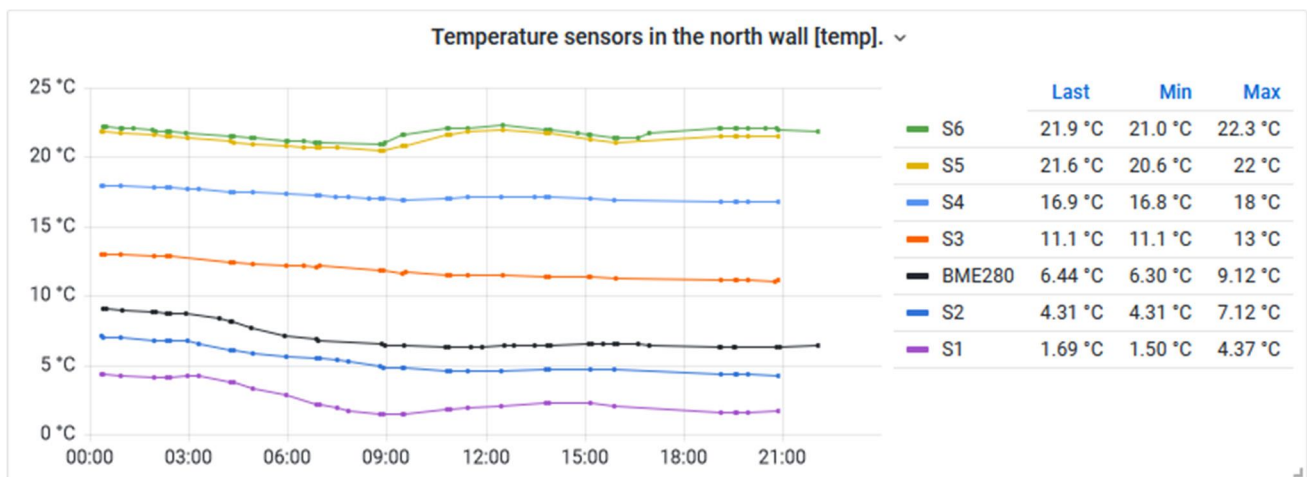
Figure 13. Temperature sensors (DS18B20) show the temperature distribution inside the wall on 5 January 2022. Sensors are distributed evenly throughout the thickness of the wall (45 cm). S1—sensor on the outside of the wall, S6—sensor on the interior plaster layer. The black colour (BME280) is the temperature and humidity sensor used to analyse the moisture content of the straw. Source: Author’s analysis using Grafana web application.

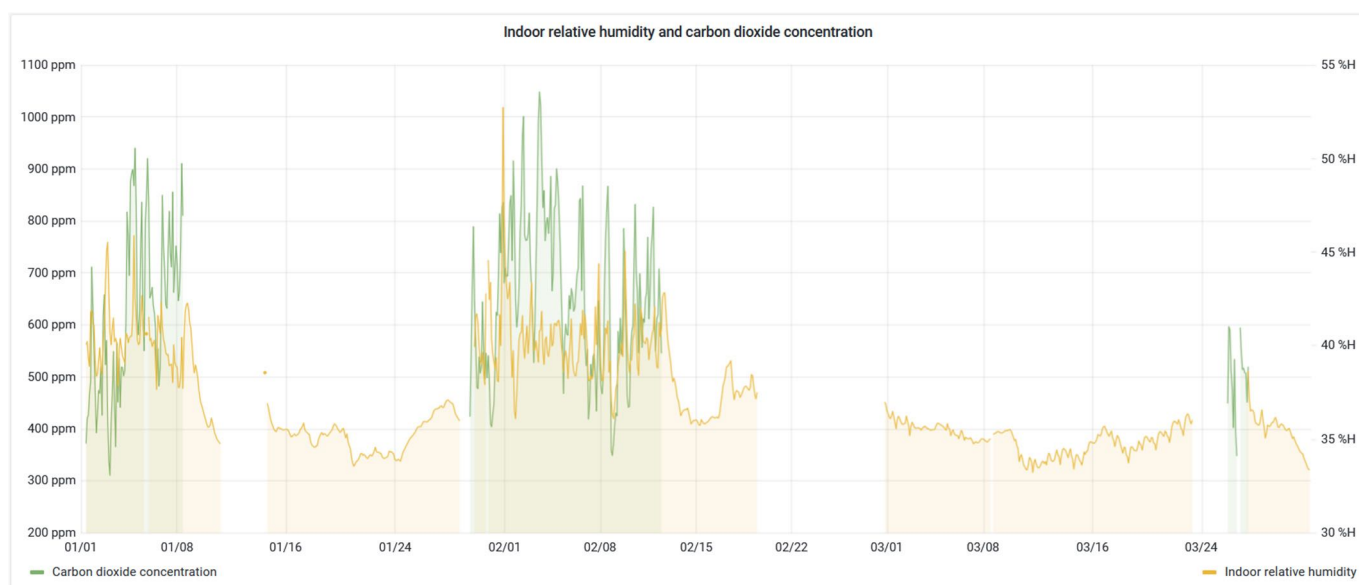
Figure 14. Visualised measurements of indoor relative humidity and carbon dioxide concentration. Carbon concentration measurements indicate periods of occupant presence. Author's analysis using Grafana web application.

The time interval from 1 January to 31 March 2022 was analysed. Below is a graph (Figure 14) showing occupant presence (carbon dioxide concentration measurement) and indoor relative humidity. It can be seen that humidity increases when there are occupants in the building. Therefore, this period was of particular interest to the study.

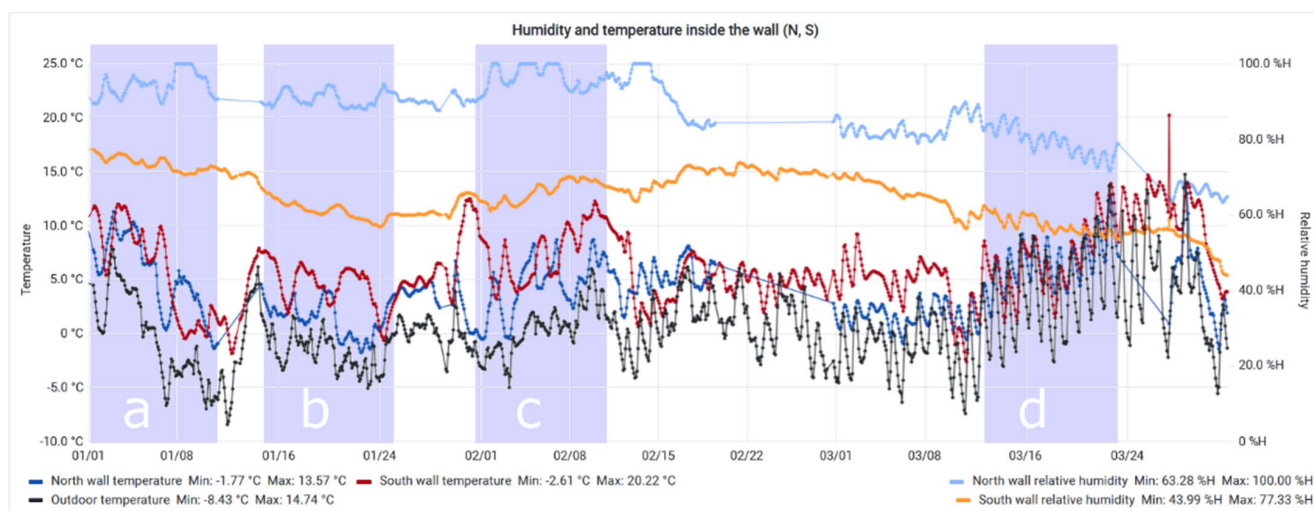
Figure 15. Visualisation of temperature and relative humidity measurements inside the partition. Measurements were recorded from two BME280 sensors mounted in the exterior walls on the south and north sides. The vertical axis on the left is temperature ($^{\circ}\text{C}$), and the axis on the right is relative humidity (%). Measurements from 1 January 2022 to 31 March 2022. Source: Author’s analysis using Grafana web application.

Subsequently, the external and internal temperatures and the humidity inside the two external walls—north and south—were checked over the same period. The graph in Figure 15 shows periods (straight sections) where data were not recorded (probably due to an error in the measuring apparatus). Four periods were selected for further analysis: (a) 2 January 2022–10 January 2022; during this period, the occupants were present, and the outside temperature fell from about 5 °C to −5 °C. (b) 15 January 2022–24 January 2022, no occupants stayed during this period. The outdoor temperature was slightly higher, from 1 °C to −3 °C. (c) 31 January 2022–10 February 2022, occupants stayed during this period. Internal humidity was higher, and the temperature was between −5 °C and 6 °C. (d) 13 March 2022–22 March 2022, a period when no occupants were present, and the outside temperature rose, reaching up to 13 °C during the day and dropping below 0 °C at night.

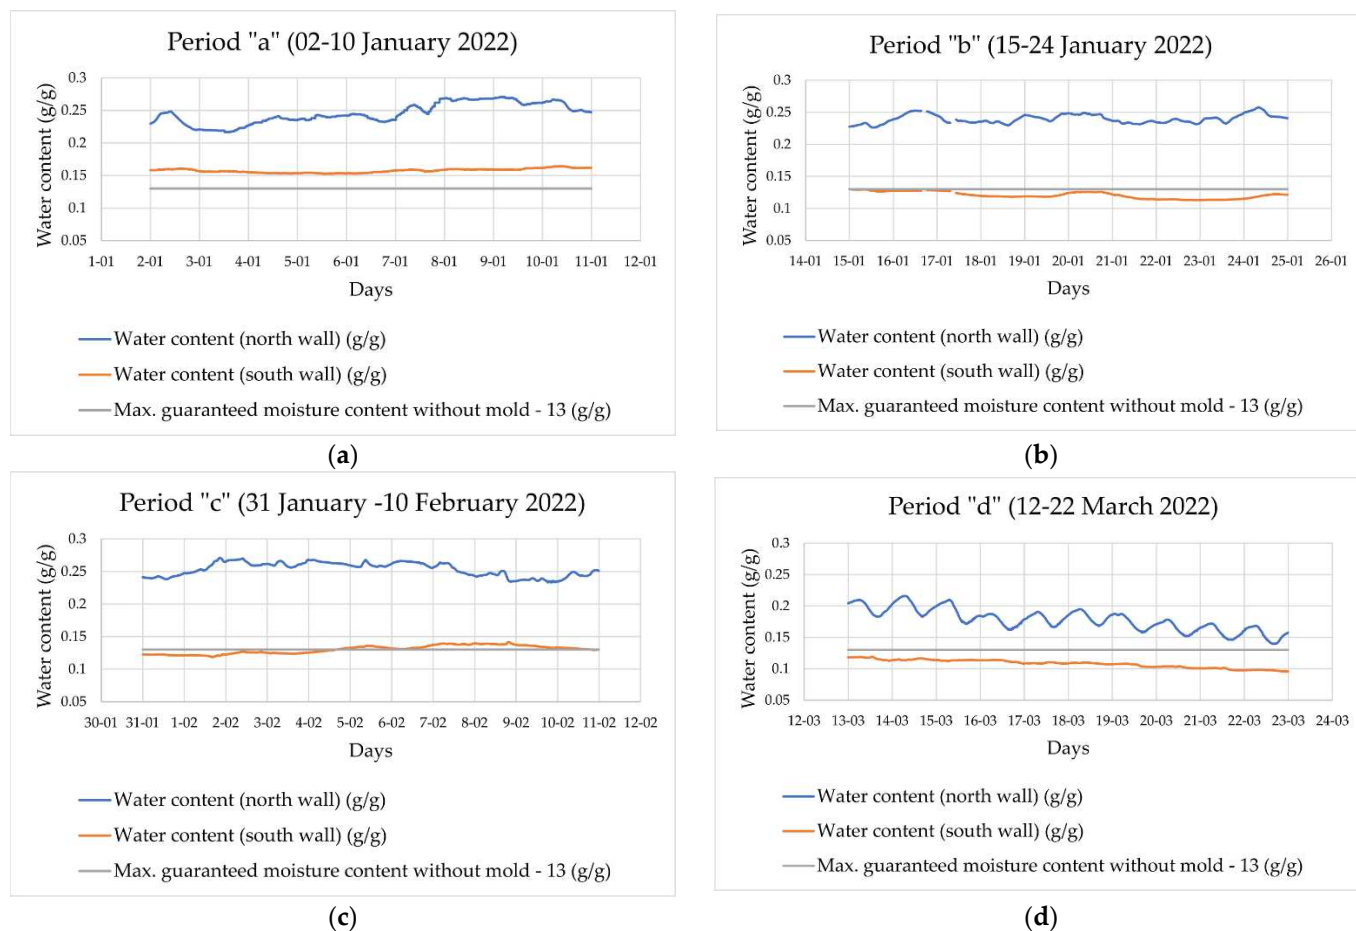
Figure 19. Analysis charts showing the water content of straw in g/g for selected time periods: (a) 2 January 2022–10 January 2022, (b) 15 January 2022–24 January 2022, (c) 31 January 2022–10 February 2022, (d) 13 March 2022–22 March 2022. Source: own calculations.

During the periods analysed at the measurement site, the water content of the straw on the north side far exceeded the limits considered safe. The excess water gradually began to evaporate in the spring months, as can be seen in the graph in period 'd'. It is not entirely clear what the cause is and why there is such a large difference between the north and south walls. The most likely cause is air leakage in the building, both inside and outside, and the prevailing southward winds. In addition, the loss of external plaster at the sensor location could additionally contribute to increased air flows near the sensor. January is a month with prevailing winds from the south and south-westerly direction. These are characterised by low temperatures, high humidity, and high speed. In addition, the building is situated on a hill. This may indicate why the north wall was at particular risk of condensation occurring. A wind diagram based on a typical meteorological year at the station in Kętrzyn (22 km away) is shown in the Figure 20.
