# **Final Report on Electric Clothes Dryers and Lint Ignition Characteristics May 2003**

In FY 2002, U.S. Consumer Product Safety Commission staff completed a test program to evaluate residential electric clothes dryers under various test conditions. The test program included measurements of temperature and airflow characteristics for different electric clothes dryer designs under normal operating conditions and conditions of partially-blocked and fully-blocked exhaust ducting. The ignition characteristics of lint in relation to electric clothes dryer operation were also evaluated. The test program produced data on different dryer operating and design characteristics that can be used to help reduce the risk of lint ignition in a clothes dryer and help prevent fires.

DIRECTORATE FOR ENGINEERING SCIENCES

Arthur Lee  
Electrical Engineer

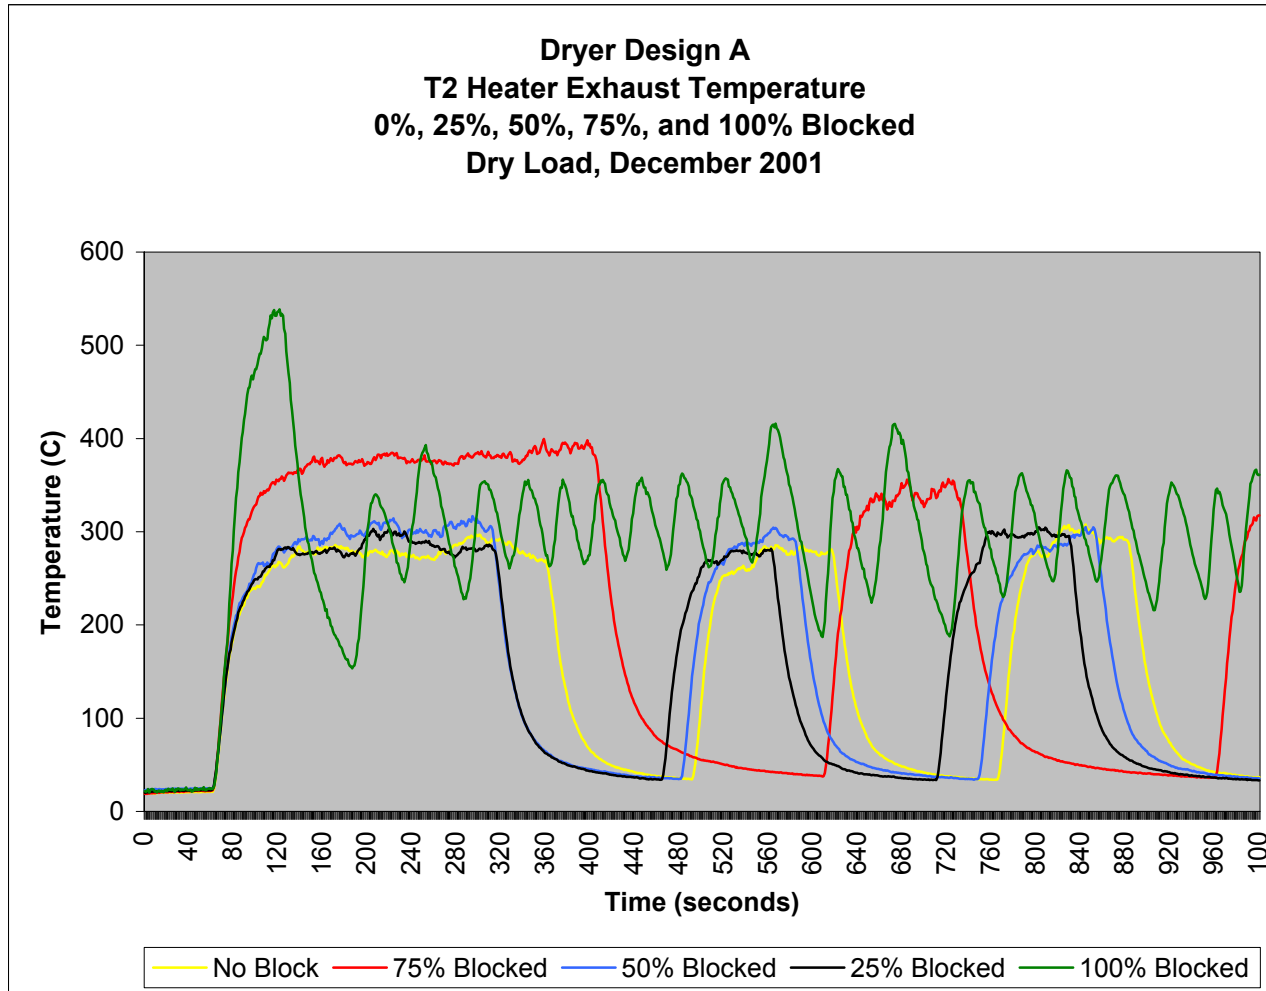
Figure 12. Dryer Design A – T2 Heater Exhaust Comparison

At exhaust vent blockages of 100% and 75%, the peak heater exhaust temperatures were similar – around 325°C to 375°C – as shown in Figure 12. However, the period during which the heater exhaust operated near the peak temperature differed for the two conditions. At 100% blockage, the temperature was not maintained at the peak temperature very long because the high limit thermostat cycled the heating element more rapidly. At 75% blockage, the duration the heater exhaust stayed near the peak temperature was approximately 100 to 300 seconds – until the primary thermostat switched the heating element off

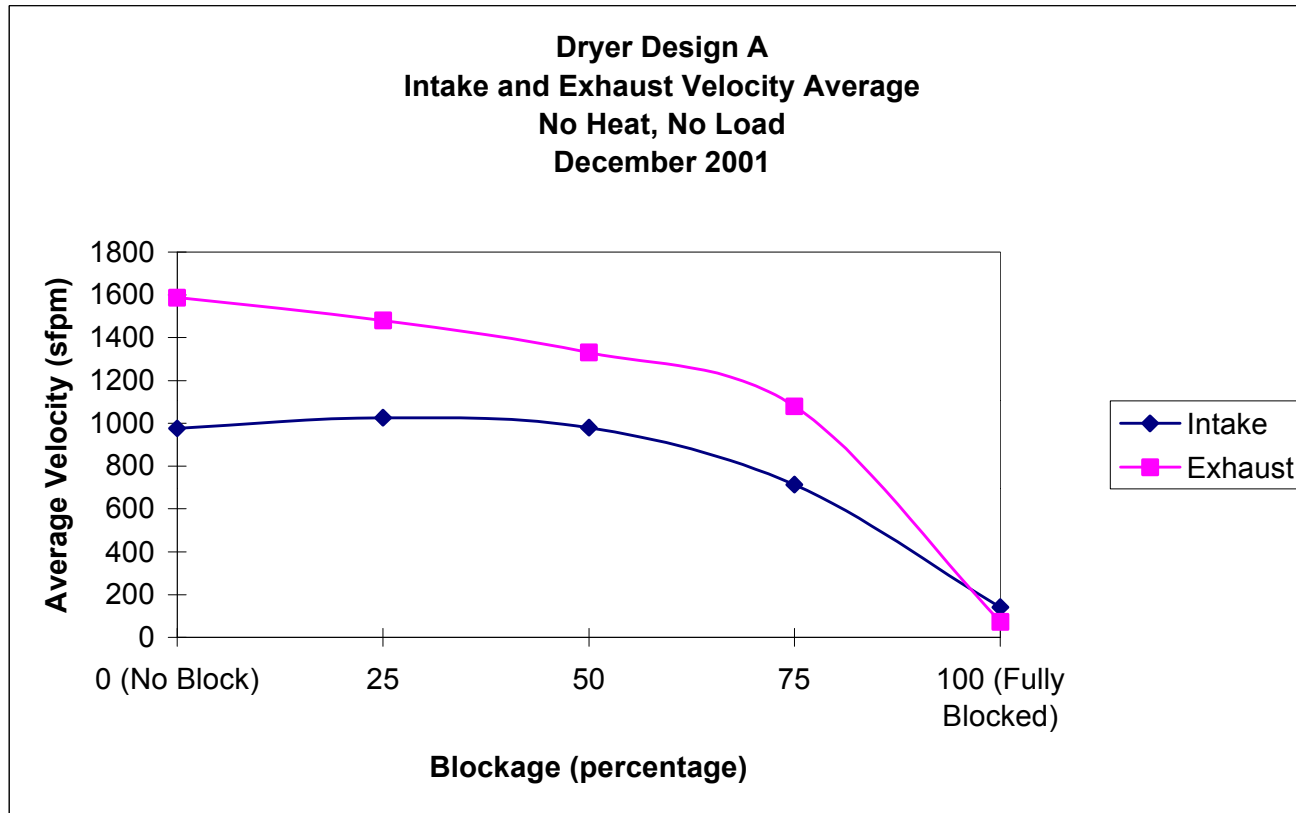
Figure 16. Dryer Design A – Average Airflow Velocities (No Heat and No Load)

Figure 16 is a graph similar to Figure 15 except that the dryer was operated with no test load and with no heat. The graph shows increased intake and exhaust air velocities when the tumbler was not filled as expected. Compared to Figure 15, there was a slightly more dramatic effect in the decrease of the air velocities as the exhaust vent was progressively blocked.

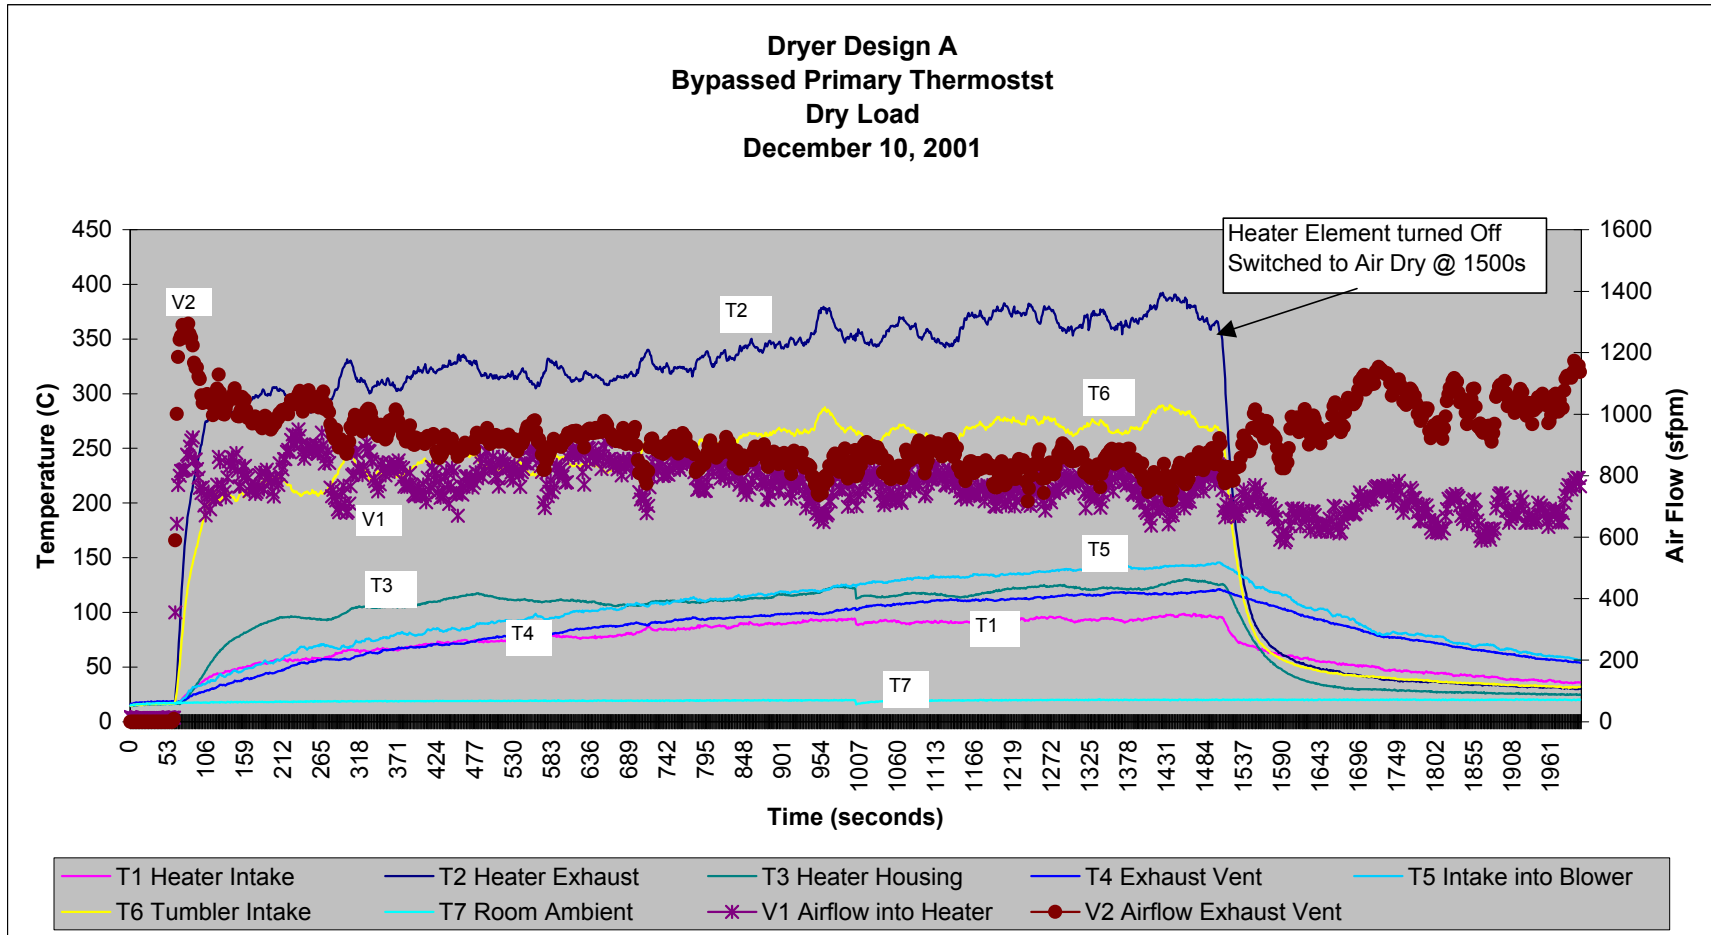
Figure 17. Dryer Design A – Primary Thermostat Bypassed

Figure 17 shows the temperature and airflow data for Dryer Design A with a bypassed thermostat. The dryer was switched to Air Dry at approximately 1500 seconds into the test. The temperature at the heater intake appeared to level out at 95° C and would not have triggered the High-Limit Thermostat.

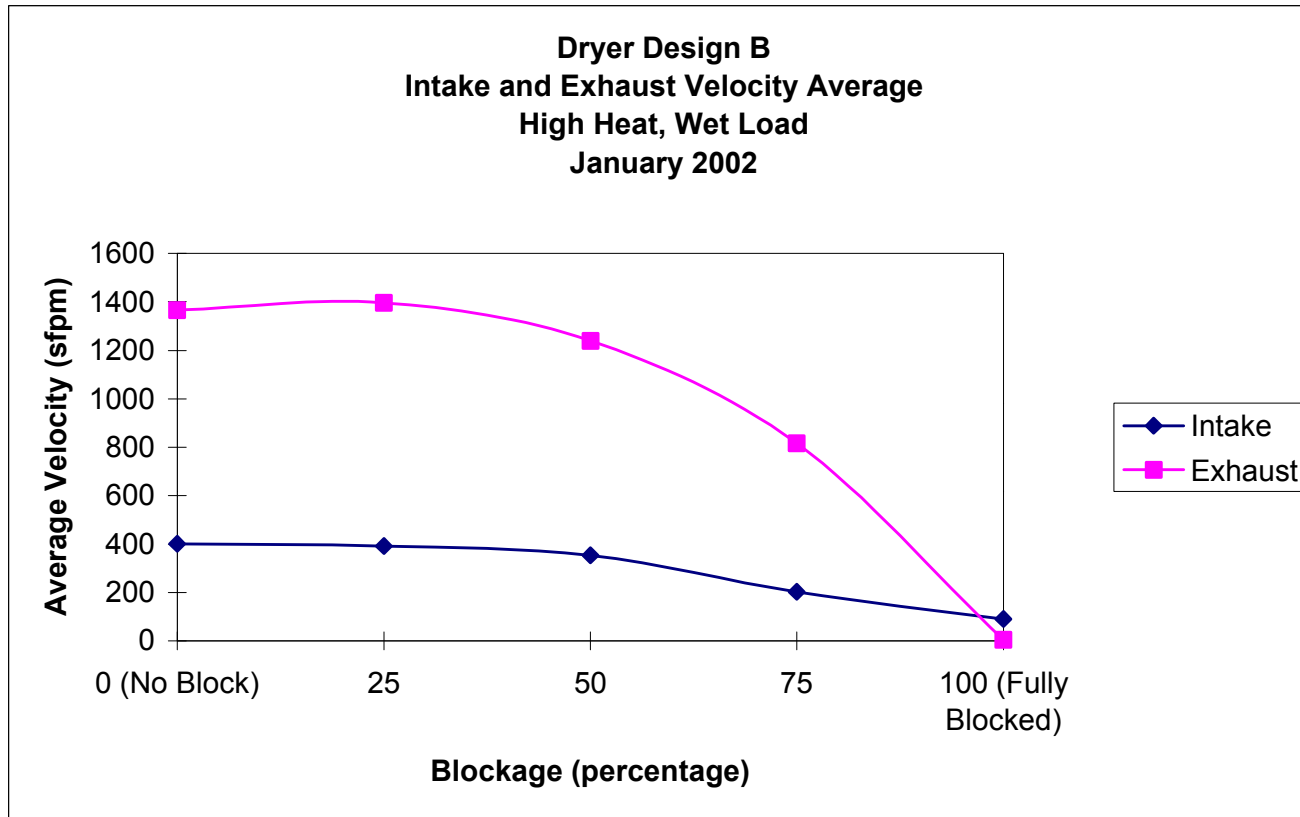
Figure 25. Dryer Design B – Average Airflow Velocities (High Heat and Wet Load)

Figure 25 shows the average intake and exhaust air velocities for the different blockage conditions. The data from 120 seconds to 1000 seconds were averaged. This avoided the initial overshoot when the blower was first powered. The intake velocity stayed steady until the exhaust vent was 25% blocked, and it began to decrease more rapidly between 25% and 50% blockage. When the exhaust vent was 100% blocked, the exhaust velocity was near zero, as expected, and the average intake air velocity was 90 sfpm.

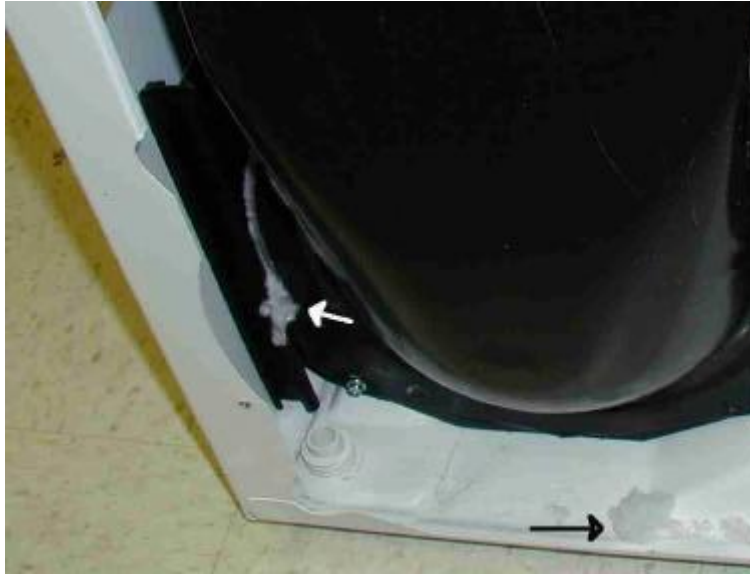
Figure 50. Lint Build-up at Blower Housing Seal and Dryer Floor

Figure 50 shows an area of the blower fan housing after 100 cycles. A significant accumulation of lint was observed at a sealed joint for the blower housing (shown by white arrow), and a lint ball was observed on the dryer floor (shown by black arrow). This accumulation was not apparent at the start of Task 3 testing or after 48 cycles.

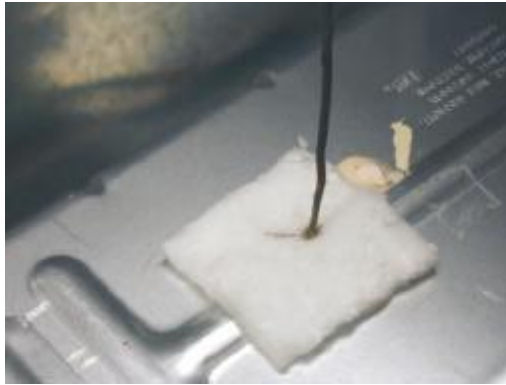
Figure 55. Sample Smoldering at Location A

The samples either smoldered or charred during the tests, as shown in Figure 55. In the first three tests (Sample Numbers s1-1, s1-2, and s1-3), the power to the heater was incrementally increased. In the next three tests (s1-4, s1-5a, s2-8), power was applied instantaneously to the heating element. In all these tests, the samples smoldered but did not ignite. In test s5-1, the airflow through the heater was initially 650 sfpm until 400 seconds when it was decreased to zero sfpm. The sample charred and smoldered.

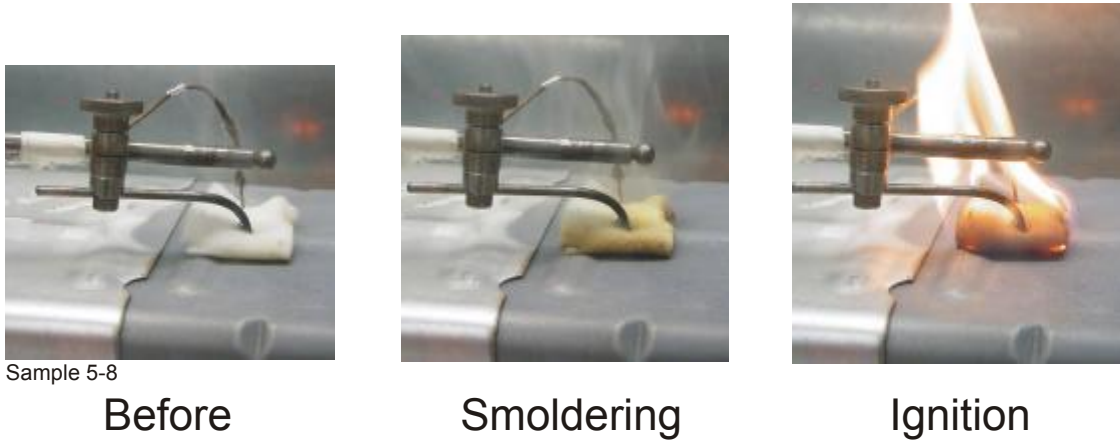
Figure 56. Sample s5-8 at Location B

In three of the six tests conducted at location B, the high-limit thermostat was bypassed; in the other three, the high-limit thermostat was connected in series with the heating element. The airflow through the heater was set at either 200 or 300 sfpm in the last two tests. In the first three tests at location B (s5-8, s5-9, and s5-10), the samples ignited. Figure 56 shows sample s5-8 igniting during the test. Figure 57 shows a graph of the thermocouple data for sample s5-8. The sample ignited approximately 30 seconds after power was applied to the heating element.

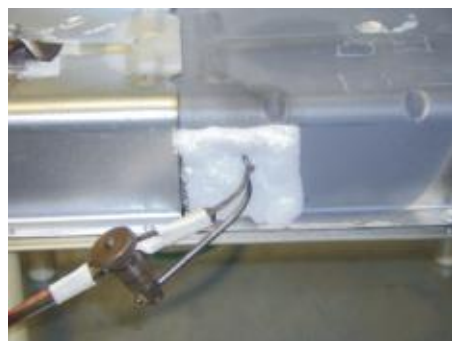
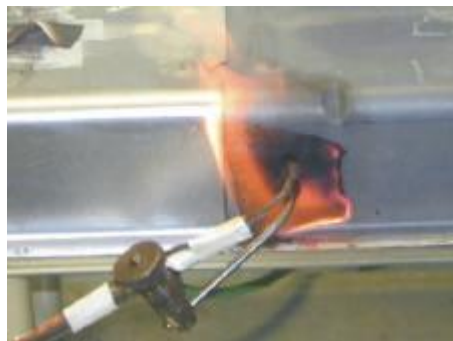
Figure 61. Sample s2-6 Tested at Location E

Figure 61 shows sample s2-6 before and after it ignited. Figure 62 shows the thermocouple traces for sample s2-6. The T3 thermocouple shows when the lint sample ignited by the rapid increase in temperature. The sample ignited approximately 60 seconds after the blower was turned off.

Three tests were conducted with the airflow initially set at 650 sfpm; and at 400 seconds, airflow was dropped to 0 sfpm. Two samples (s2-5, s2-6) ignited, and the consumer lint sample (hl1-3) smoldered.

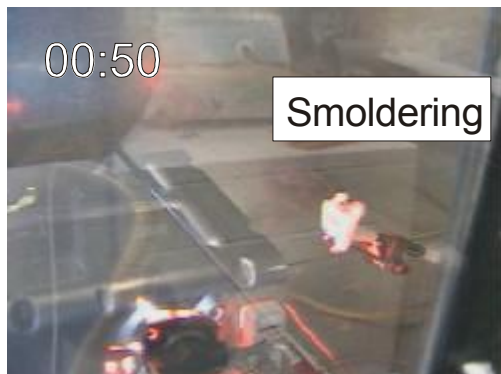
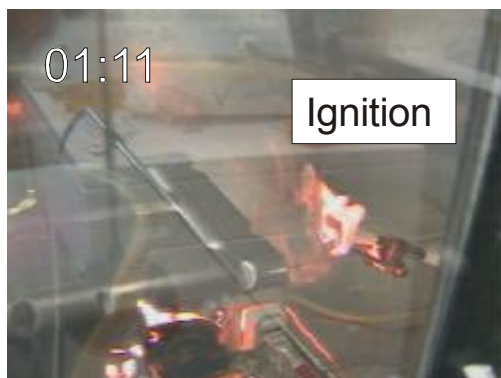
Figure 65. Sample s3-10, Video Camera and Infrared Camera

Figure 65 shows a sequence of images from the infrared camera and a video camera for Sample s3-10. The figure shows the lint sample began to ignite at approximately 452° C. Figure 66 shows the thermocouple data for sample s3-10. The sample ignited 1 minute 11 seconds into the test. The sample ignited approximately 40 seconds after the heater was energized.

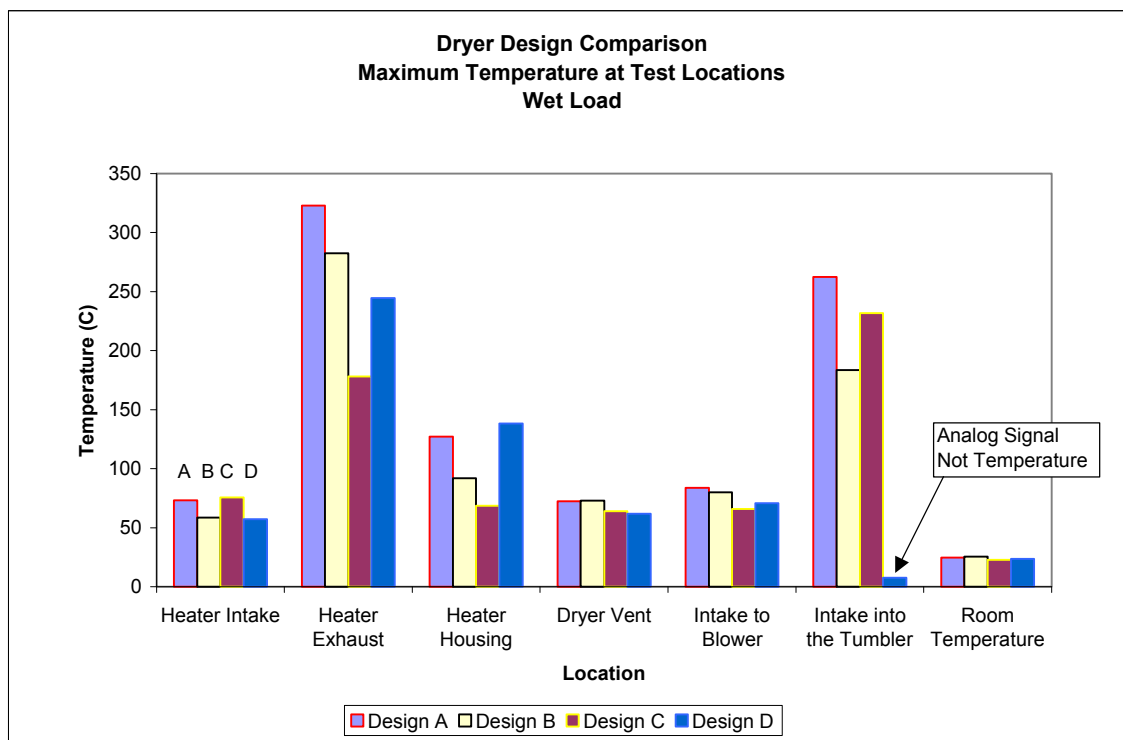
Figure 75. Maximum Temperatures Measured at Location

Figure 75 shows the maximum temperatures measured at each thermocouple location for each dryer design. All the dryers had similar temperatures at each thermocouple location, except at the heater exhaust and tumbler intake. Design characteristics had a contributing factor on temperatures at these locations. Dryer Design C had an increase in temperature from the heater exhaust to the tumbler intake, which was also observed during testing in Task 2. The louvers on the side of the heater housing may have contributed to the higher temperature readings at T6, but it has not yet been determined why this actually occurred.

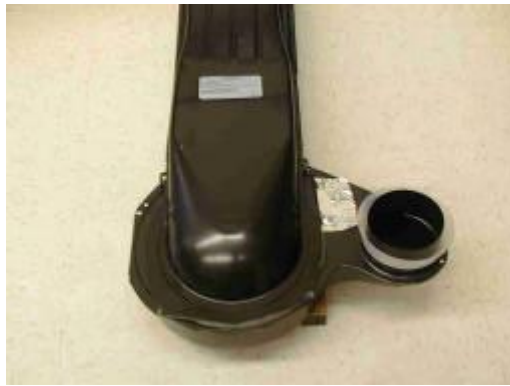
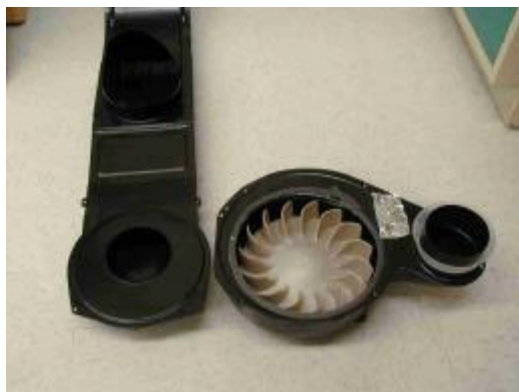
Figures 85 (a) and (b). Dryer Design A – Blower Assembly

Examination of Dryer Design A showed that lint/air can leak through a sealed joint in the blower housing. To examine more closely the nature of the origin of the lint/air leak, the blower fan compartment was opened on a blower from another dryer of Design A. Figures 85(a) and (b) show the blower housing assembled and opened, respectively.

(a) Blower removed from the dryer

(b) Blower housing separated
