Wood and Timber Condition Assessment Manual

Second Edition

General Technical Report
FPL-GTR-234

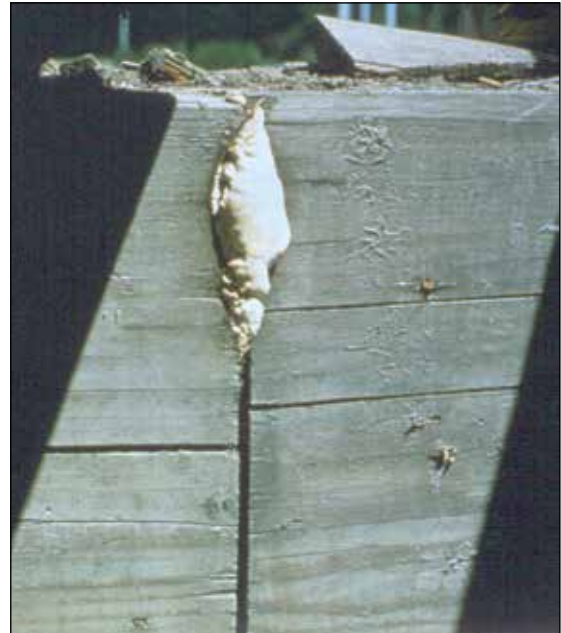
Figure 1.1—Fruiting body between two beams.

Figures 1.1 and 1.2 show fruiting bodies that were observed during inspection of Washington State University's football stadium. Figure 1.2 shows the extent of deterioration inside the beam. Note that in Figure 1.1, the fruiting body is located where two timber beams (placed end-to-end) rest on a column. Exposed end grain allows for moisture accumulation and subsequent absorption by the timbers. Figure 1.3 illustrates the potential extent of deterioration in both beams.

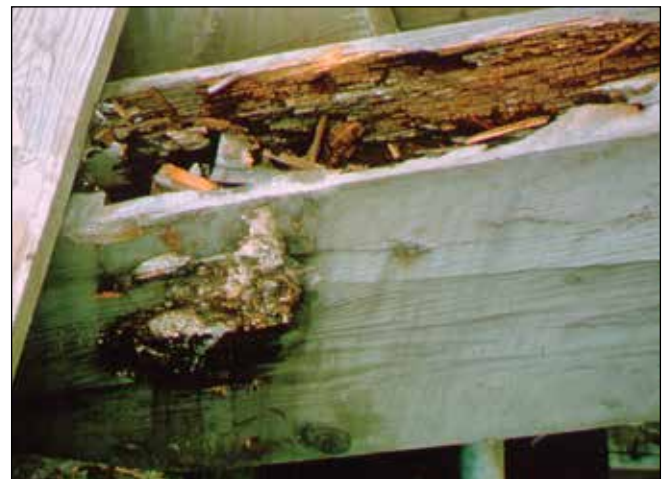
Figure 1.2—Fruiting bodies can indicate extensive damage inside the beam.

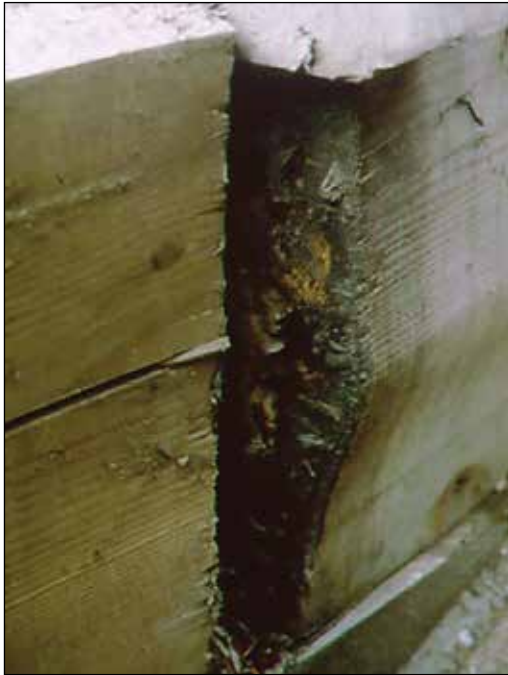
Figure 1.4—The timber beam's outer shell buckled as a result of interior deterioration.

Figure 1.4 shows a timber beam that failed in bearing (compression perpendicular to grain). Such collapse indicates that the inner portion of the timber is severely deteriorated. Figure 1.5 illustrates that when the inner portion of the timber is severely deteriorated, the outer shell can collapse when the timber is stressed in bearing.

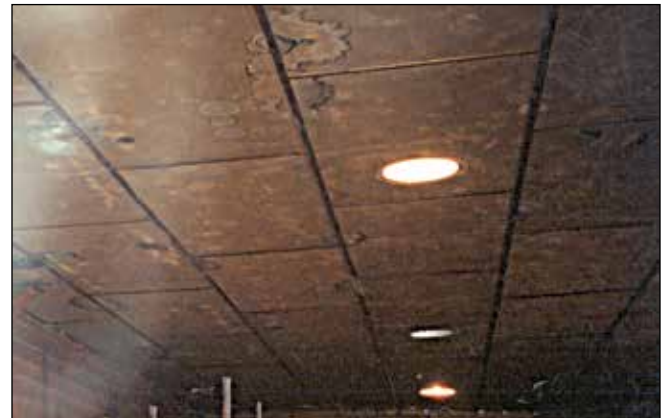
Figure 1.6—The ceiling panels were stained and discolored.

Inspection of the Red Cliff Recreation Hall near Bayfield, Wisconsin, revealed severe staining and discoloration of the fiberboard product used in the ceiling (Figs. 1.6 and 1.7). Discoloration and mold indicated that the structure had been exposed to moisture and the wood could possibly be deteriorated. Removal of several ceiling panels revealed that the fiberglass insulation above them was saturated with water (Fig. 1.8). This moisture provided an ideal environment for the growth of mold and decay fungi. As a consequence of

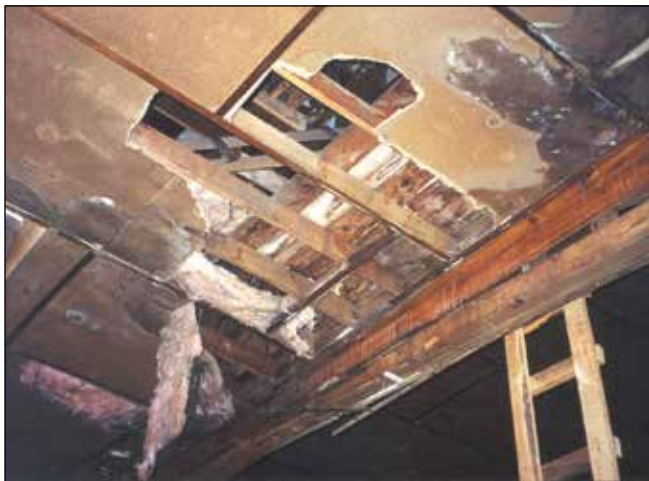
Figure 1.8—Removing the ceiling panels revealed that the fiberglass insulation was saturated with water.

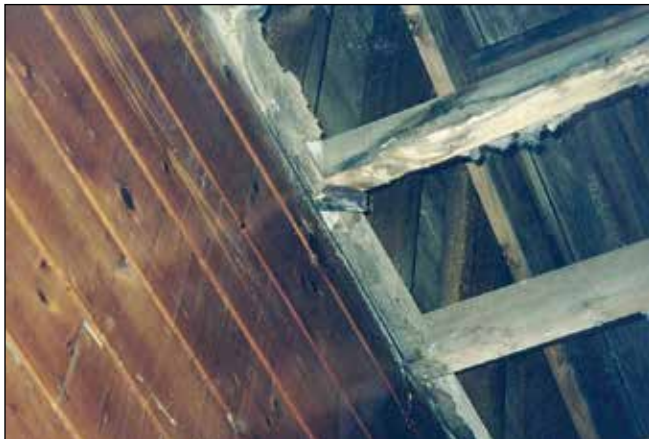
Figure 1.9—As a consequence of the moisture exposure, wood members in the roof and walls also contained areas of deterioration.

this moisture exposure, wood members in the roof and walls also contained areas of deterioration (Fig. 1.9).

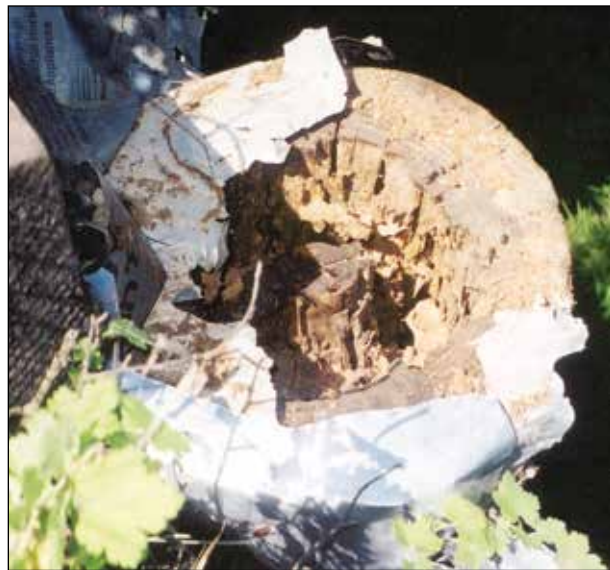
Figure 1.10—Damage to a bridge piling.

Figure 1.10 is a piling from a bridge. Initially deteriorated by decay, carpenter ants were attracted to the softened wood and continued to destroy the piling. Once the flashing was removed, the severe deterioration could be readily observed.

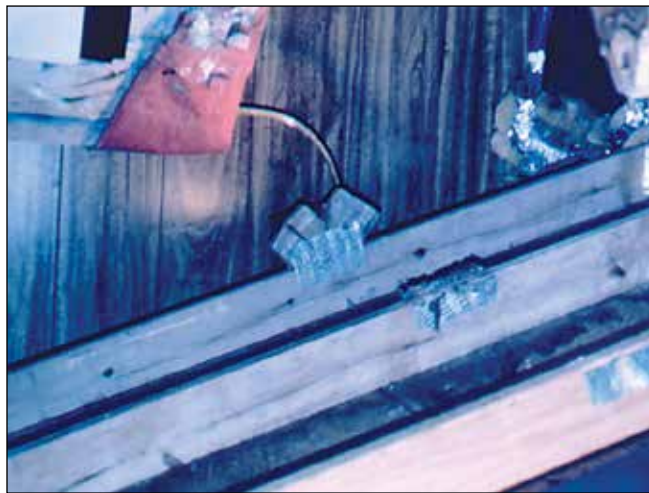
Figure 1.11—Metal plate connectors were cut and bent so that the webs could be removed. This should never be done.

Frequently, it is observed that entire structural members have been removed. Figures 1.11 and 1.12 show an in-service wood truss that had its webs removed by the homeowner with the intent of creating living space in the attic.

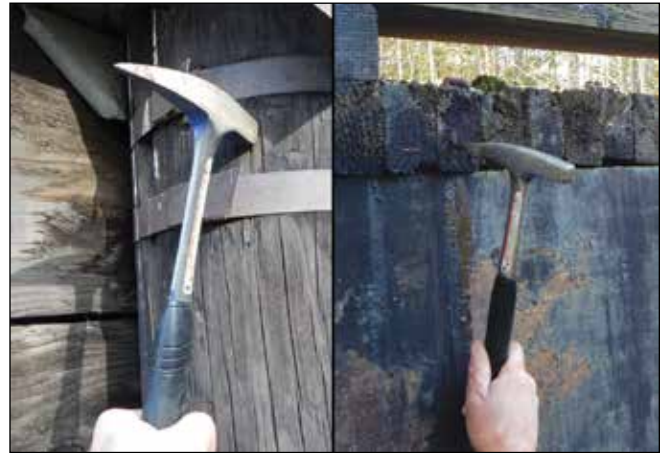
Figure 2.1—A hammer pick is an effective tool for initial assessments of timber bridge elements.

One of the most commonly used techniques for detecting deterioration is to hit the surface of a member with a hammer or other object. Based on the sound quality or surface condition, an inspector can identify areas of concern for further investigation using advanced tools like a stress wave timer or resistance microdrill. Deteriorated areas typically have a hollow or dull sound that may indicate internal decay. A pick hammer commonly used by geologists is recommended for use in timber structures because it allows inspectors to combine the use of sound and the pick end to probe the element (Fig. 2.1).

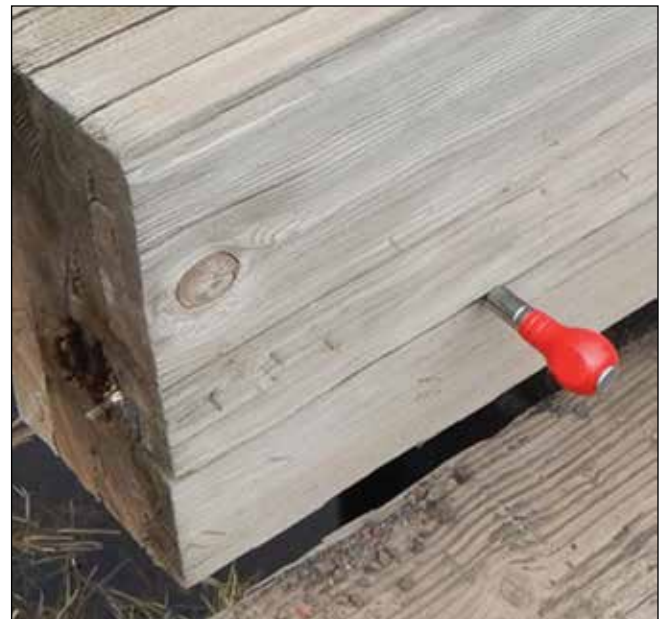
Figure 2.2—An awl is used to assess depth and presence of decay in a horizontal split.

Probing with a moderately pointed tool, such as an awl or knife, locates decay near the wood surface as indicated by excessive softness or a lack of resistance to probe penetration and the breakage pattern of the splinters. A brash, or brittle break indicates decayed wood, whereas a splintered break indicates sound wood. Although probing is a simple inspection method, experience is required to interpret results. Care must be taken to differentiate between decay and water-softened wood, which may be sound but somewhat softer than dry wood. Assessing damage in soft-textured woods, such as western redcedar, is sometimes difficult. Figure 2.2 shows an awl probe inserted into a split to assess decay that is visible on the railing end.

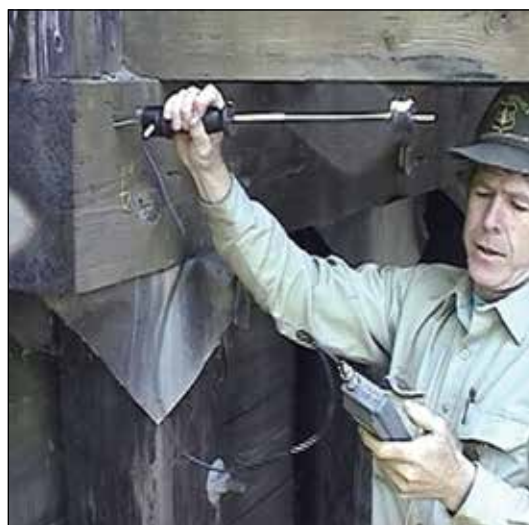
Figure 2.7—A pin-style moisture meter is used to determine moisture content of timber elements.

(75 mm) long) to assess moisture content of timber abutment caps. Pin-style moisture meters measure electrical resistance between two metal pins that are driven into the member and use this measurement to determine moisture content.

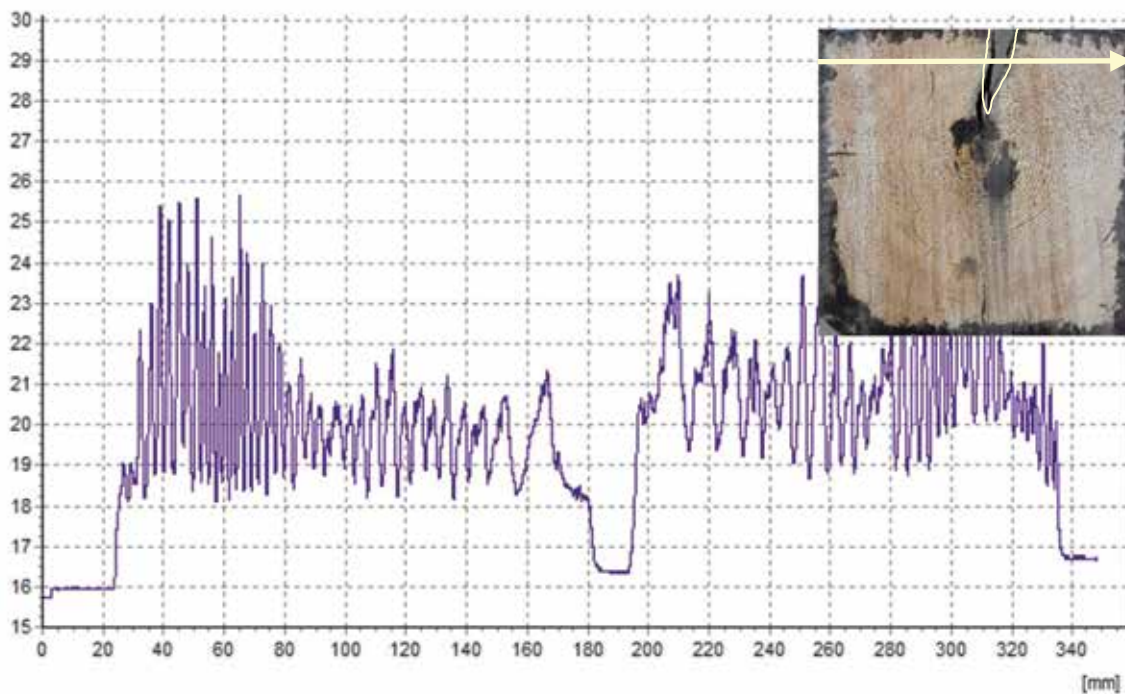
Figure 2.16—Electronic resistance chart of a Douglas-fir pile cap showing a large crack between 180 and 200 mm along the drilling path.

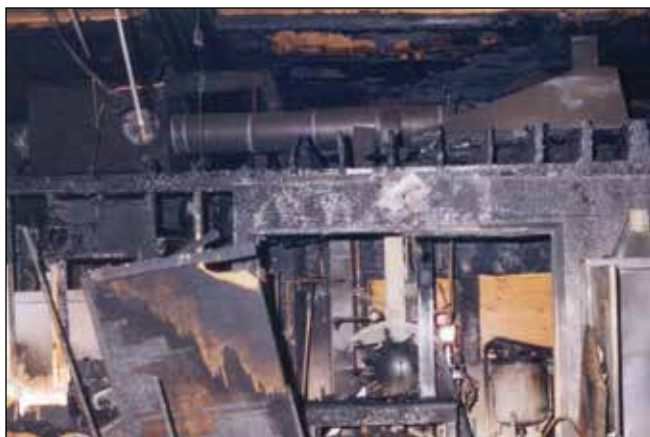
Figure 5.3—Area of fire origin in Building 2 fire at the Forest Products Laboratory.

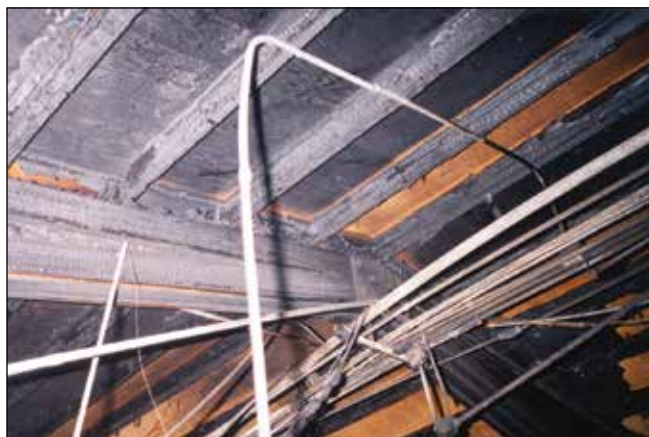
Figure 5.4—Charred and uncharred wood members in the Building 2 fire at the Forest Products Laboratory.

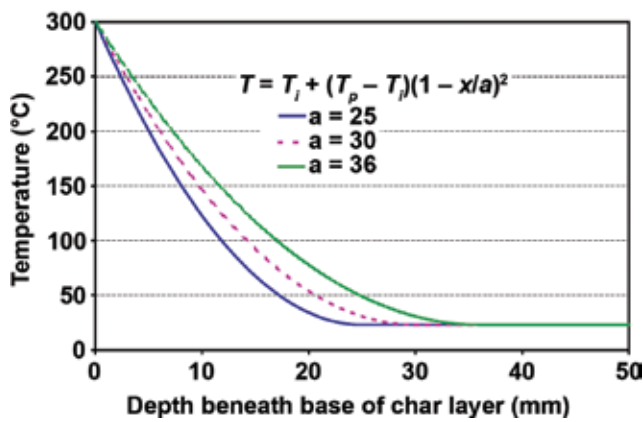
Figure 5.6—Temperature profile beneath the base of the char layer of a semi-infinite wood slab directly exposed to the ASTM E 119 standard fire exposure.

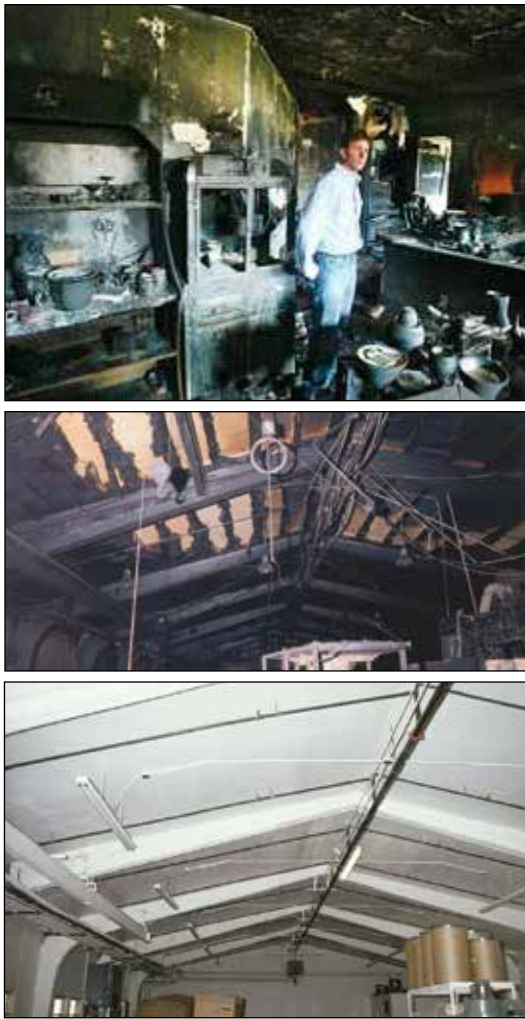
Figure 5.10—Post-fire inspection (top) of residence; post-fire (middle) and post-repair (bottom) of Building 2 at the Forest Products Laboratory. Top photo courtesy Montana Standard; www.mtstandard.com.

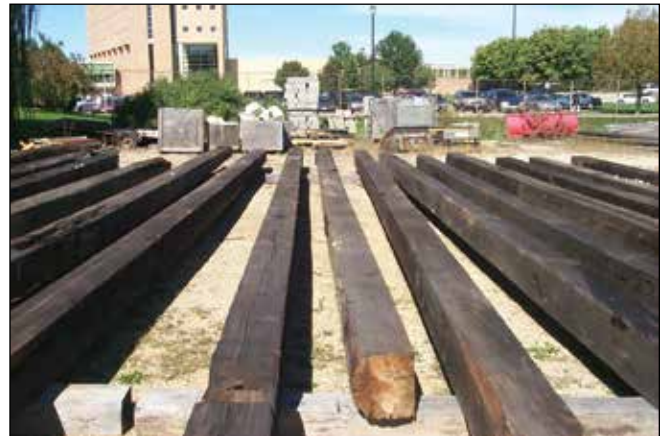
Figure 7.1—Fifteen 12- by 12-in. white pine timbers removed from the Quincy Mine Blacksmith Shop.

The Quincy Mining Company's Drill and Blacksmith Shop, located in the Keweenaw National Historical Park, was constructed in 1900 by the Quincy Mining Company. Of great interest is the preservation and use of the remaining roof trusses and floor joists. The 12- by 12-in. white pine roof truss timbers had been exposed to weather for several years. These structural members, manufactured from old-growth timber, are a tremendous resource that should be appropriately used in the renovation of the Drill and Blacksmith Shop.

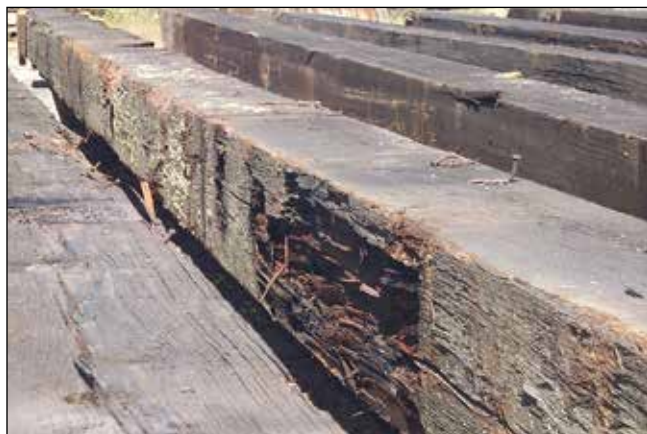
Surface decay

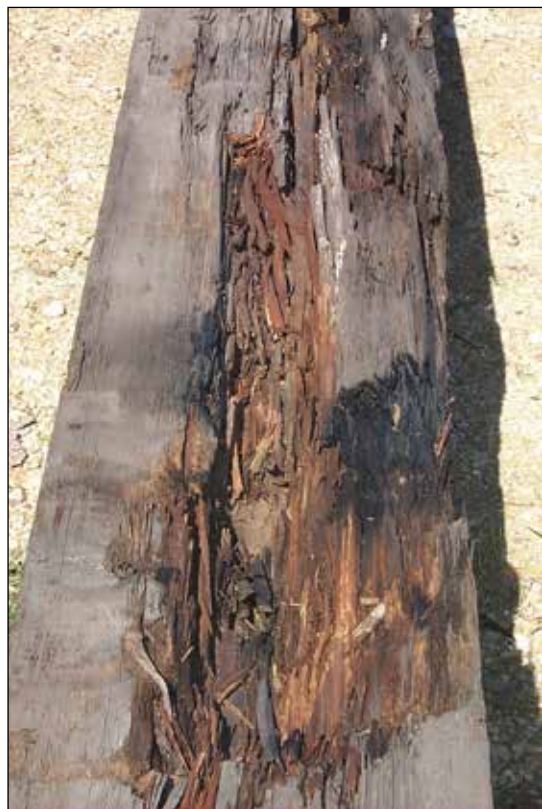
Severe decay damage

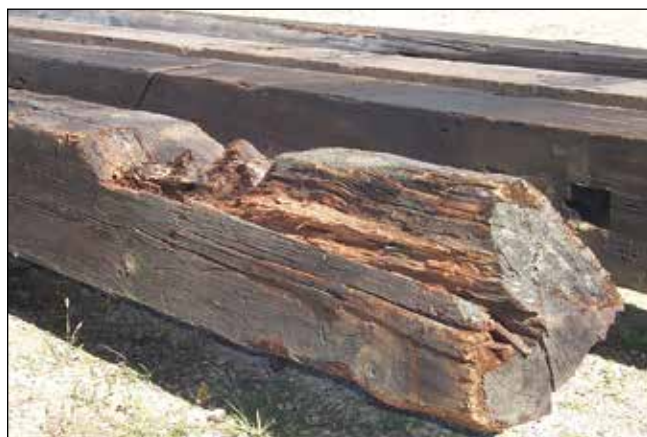
End decay

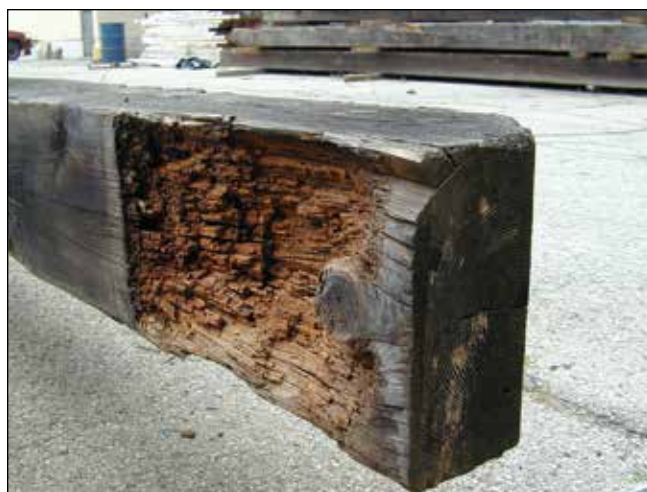
End decay

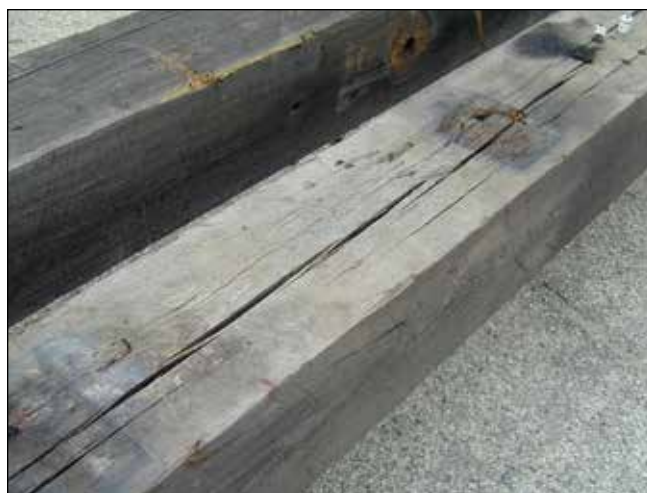
Large, deep check

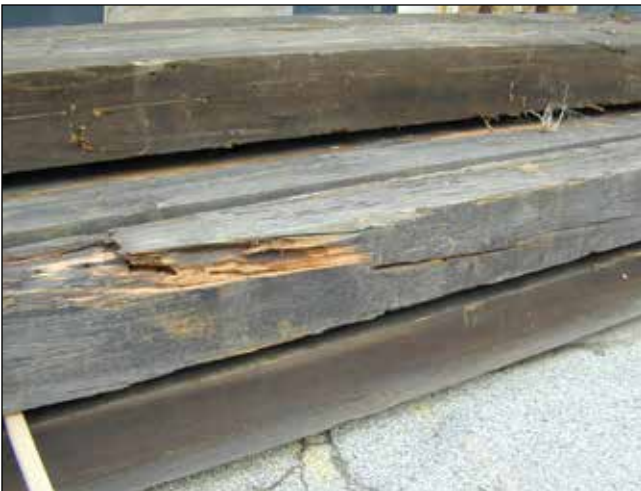
Mechanical damage

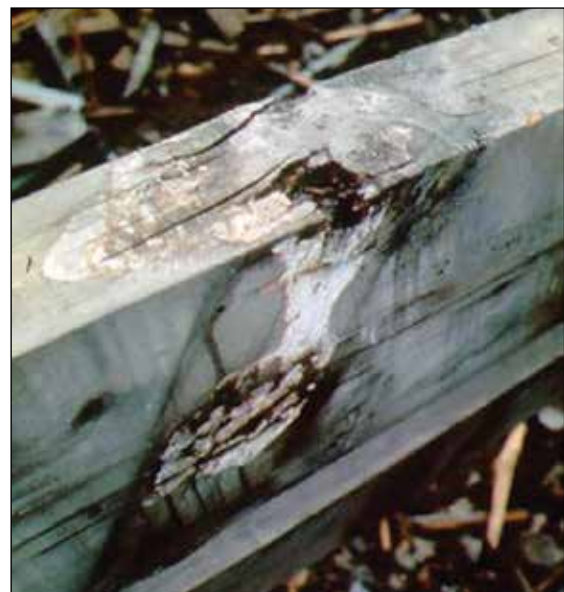
Washington State University's football stadium was inspected using visual, coring, and stress wave timing techniques. This stadium was originally constructed in the 1930s; the north and south grandstands were replaced after a fire in the 1960s. In the early 1980s, the structural integrity of the horseshoe section that joined the north and south grandstands was inspected. This horseshoe section was part of the original stadium and was constructed from large solid-sawn timbers. An informal inspection revealed that the structural members in the horseshoe section were badly decayed. Further evaluation using stress wave timing equipment showed that speed-of-sound transmission was significantly lower in decayed members than in sound wood. Subsequent probing of those areas indicated that the decay was so extensive that only a thin shell of sound wood remained. These results led to the dismantling of the horseshoe section of the stadium.

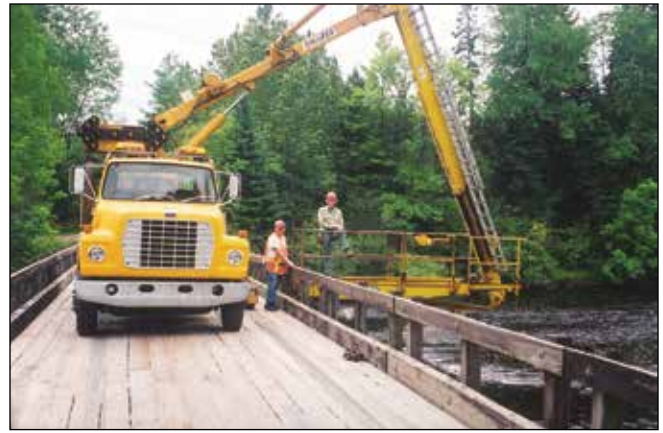
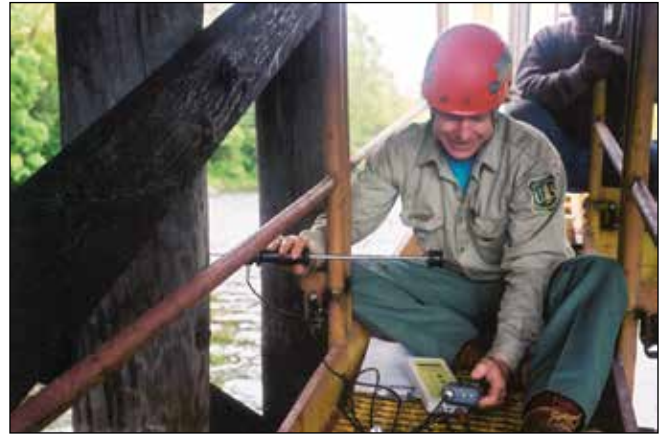
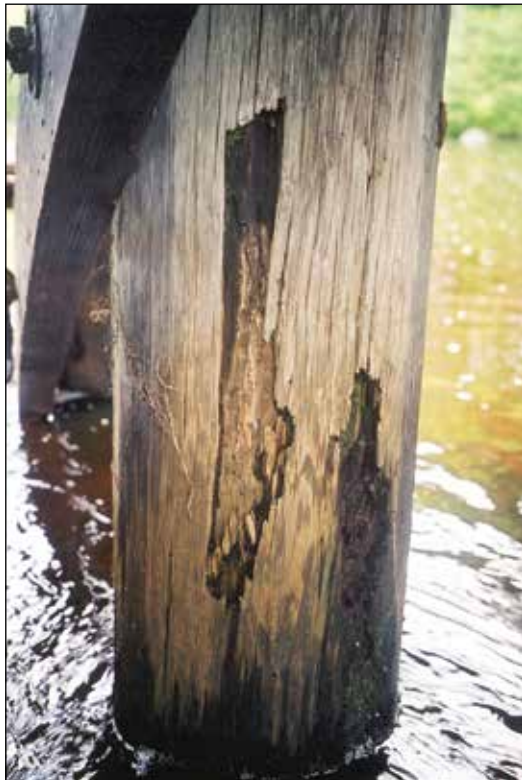
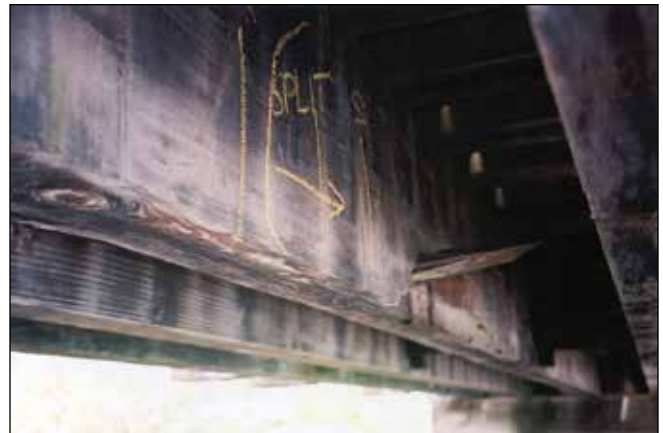
A detailed inspection of this traditional heavy timber bridge was completed to evaluate the quality of individual members as part of the bridge inspection system. Visual inspection, sounding, and moisture content techniques were used to identify decay and subsequent carpenter ant damage to timber piles on the bridge abutment. The Southern Pine pilings showed shell damage caused by ice and damage due to flotsam. The use of a snooper vehicle allowed for detailed inspection of individual girders, pile caps, and pilings in each of the five spans. Two exterior girders and one pile cap with substantial decay were located and mapped using sounding, stress wave timing, and moisture content techniques. Confirmation of shell thickness was completed using increment coring. Members were identified for replacement.
