An Analytical Study of Some Physical Properties of Wire and Cable Samples Collected from Older Homes

Underwriters Laboratories Inc.
333 Pfingsten Road, Northbrook, IL 60062

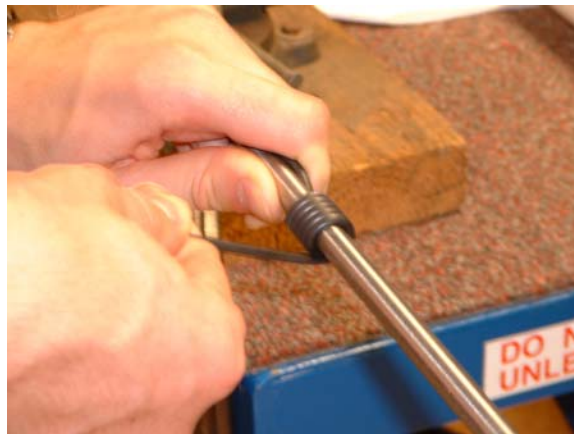
2. Bend / Dielectric Test - Bend tests were conducted to analyze the brittleness of the insulation as may have occurred because of the natural aging process and exposure to the ambient environment. Two feet of unaltered wire was used. For this test, the wire was bent around a mandrel of a diameter as indicated in table 1. Each specimen was tightly wound for six complete turns onto the mandrel. The winding was done at a rate of about 3 seconds per turn, and successive turns were in contact with one another. Following this the wire was examined under a microscope to check for crazing lines and stress whitening, which are precursors to cracking and embrittlement. The two-foot sample was then immersed in steel shot and subjected to an ac dielectric test between the conductor and the shot. The voltage was first increased from zero to 1.5 kV at a rate of 150 Volts per second, and then held constant for one minute. If no breakdown occurred, the voltage was then increased from zero to 20 kV at a rate of 500 Volts per second. If dielectric breakdown occurred at less than 20 kV, the potential at dielectric breakdown was noted.

Bend Test Sample

Table 1

Conductor Size (AWG)	Dia. of Mandrel (Inches)
14	0.313
12	0.375
10	0.563
8	0.688
6	1.250

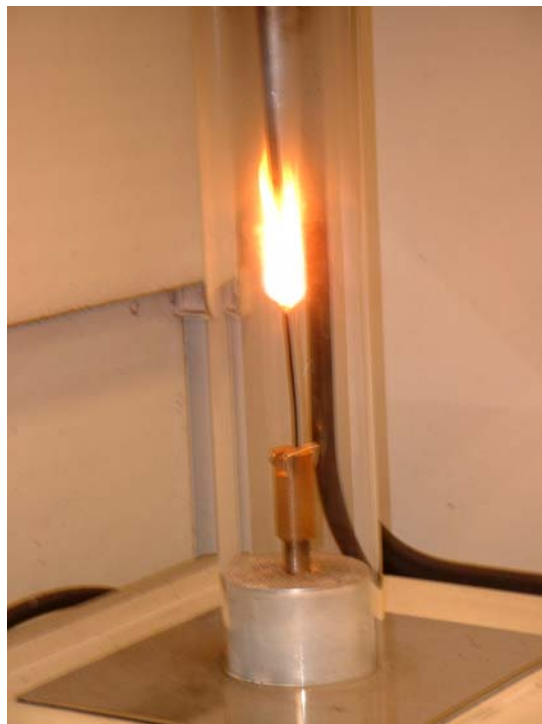
4. Limiting Oxygen Index - Limiting oxygen index (LOI) tests were conducted to determine the minimum oxygen concentration necessary to support combustion in accordance with ASTM D2863 [1]. Ambient oxygen concentration was varied by precisely controlled combination with nitrogen. LOI tests were conducted on unaltered wire by using a methane torch to ignite the wire. If the flame produced a candle-like burn that did not appear as though it would extinguish, the concentration of oxygen was reduced by 1%. If the flame extinguished itself, the concentration of oxygen was increased by 1%. The critical value for the oxygen index concentration was determined to be the oxygen concentration range where the flame extinguished at the lower concentration and produced a candle-like burn at the higher concentration. The conductor was left in the insulation to maintain sample rigidity.

Oxygen Index Apparatus

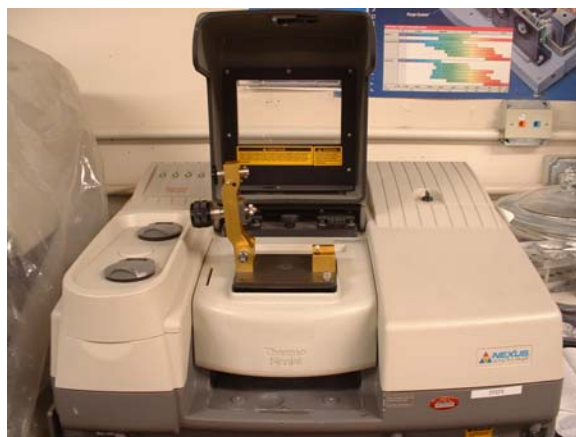
6. FT-IR Measurements – Chemical composition information of the wire insulation was characterized in the solid state using a Nicolet Nexus 470 FT-IR (Fourier transform infrared) with a Golden Gate KRS-5 diamond ATR accessory. Spectral response of the materials was measured from $400 - 4000 \text{ cm}^{-1}$ wavenumber range with a 4 cm^{-1} resolution; 32 scans were averaged per recorded spectra.

Nexus 470 FT-IR

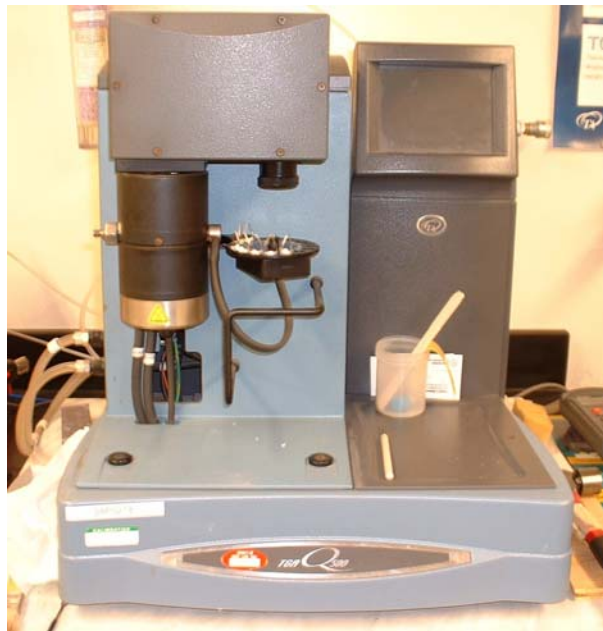
7. Thermogravimetric Analysis - Thermogravimetric analysis (TGA) is a technique used to measure changes in the weight (mass) of a sample as a function of temperature. TGA is commonly used to determine polymer degradation temperatures, loss of plasticizer from the conductor insulation, and non-combustible content (typically inorganic filler material). For this analysis, a 40 - 50 mg sample of insulation was placed into a tared pan that is attached to a sensitive microbalance assembly. The sample holder portion of the TGA balance assembly was then placed into a precisely controlled furnace. The balance assembly measured the initial sample weight at room temperature and then continuously monitored changes in sample weight as heat was applied to the sample (to 850°C at a constant rate of 10°C /min).

Thermogravimetric Analyzer (TGA)

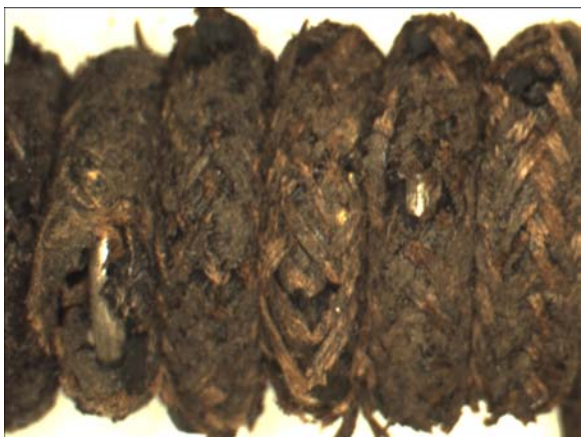
The bend test added another element to the dielectric test in that the sample was bent (wrapped) around a mandrel prior to the dielectric test. A common occurrence with older wires is that throughout the years they may get manipulated and bent when receptacles, switches, luminaires, etc. are replaced. As expected, breakdown potentials were lower because of the bending, although many samples, especially the thermoplastics, performed very well even after almost 50 years of service in the field. Only one sample experienced a breakdown at less than 2 kV as a result of the bend test. That sample, P-2-1, was from an 80 year old knob-and-tube system found in an attic in Alabama. That sample had visible signs of exposed conductor after the bending. However, another approximate 80 year old knob-and-tube system, sample SP-1-14, withstood over 20 kV as a result of the bend test. The following photos illustrate this occurrence.

Sample P-2-1

Samples P-2 were taken from a house in the Birmingham, Alabama area that was built in 1925. Sample P-2-1 was from a knob-and-tube system approximately 81 years old recovered from the attic. Samples P-2-2 and P-2-3 were from nonmetallic cables approximately 45 years old recovered from the attic and an unknown location respectively.

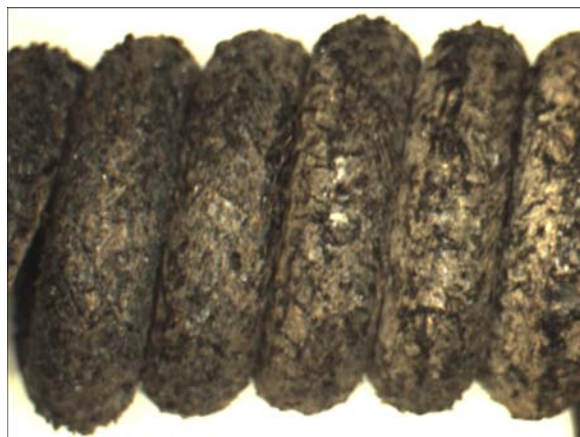
Sample SP-1-14

Samples SP-1 were obtained from St. Paul Travelers Insurance and were taken from various older houses that had been involved in insurance claims investigations. Sample SP-1-1 was from a nonmetallic cable approximately 40 years old recovered from a basement. Sample SP-1-2 was from a nonmetallic cable approximately 25 years old recovered from an attic. Sample SP-1-3 was from a nonmetallic cable approximately 35 years old recovered from a basement. Sample SP-1-4 was from a nonmetallic cable, Type UF, approximately 40 years old recovered from the exterior. Sample SP-1-5 was from a nonmetallic cable approximately 50 years old recovered from the interior. Sample SP-1-6 was from a nonmetallic cable approximately 40 years old recovered from a basement. Sample SP-1-7 was from a nonmetallic cable approximately 50 years old recovered from the interior. Sample SP-1-8 was from a nonmetallic cable, Type UF, approximately 30 years old recovered from a basement. Sample SP-1-9 was from an armored cable approximately 40 years old recovered from the interior. Sample SP-1-10 was from an armored cable approximately 55 years old recovered from a basement. Sample SP-1-11 was from an armored cable approximately 60 years old recovered from the interior. Sample SP-1-12 was from an armored cable approximately 55 years old recovered from a basement. Sample SP-1-13 was from an armored cable approximately 40 years old recovered from the interior. Sample SP-1-14 was from a knob-and-tube system approximately 77 years old recovered from the interior.

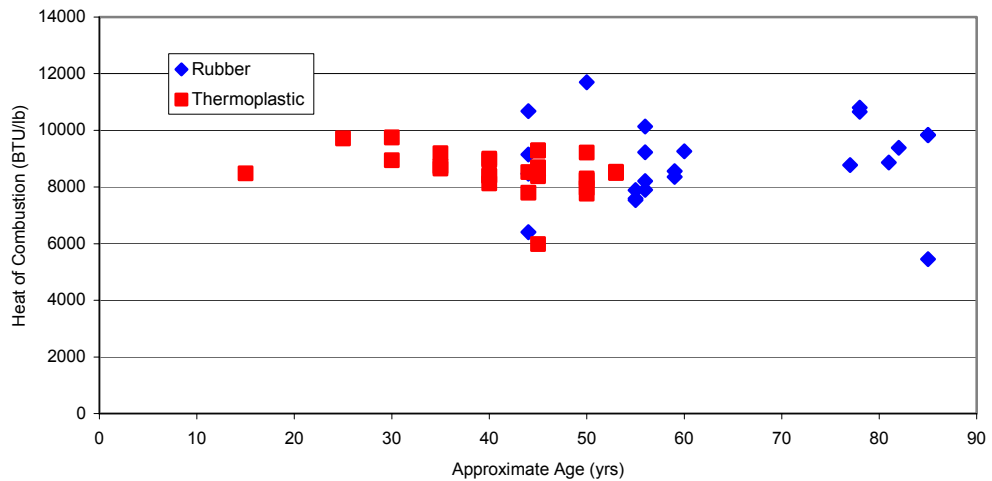
Figures 5 and 6 show the results of the limiting oxygen index measurement and oxygen bomb calorimeter test when plotted versus age of the wire. Trends in this combustibility data are less conclusive than with the electrical and mechanical response data. Differences between the thermoplastic and rubber samples may again be due to the inherent differences in the physical properties of the two different materials.

Fig. 6 - Heat of Combustion vs Age
