# 16 Preservation Briefs

## The Use of Substitute Materials on Historic Building Exteriors

Sharon C. Park, AIA

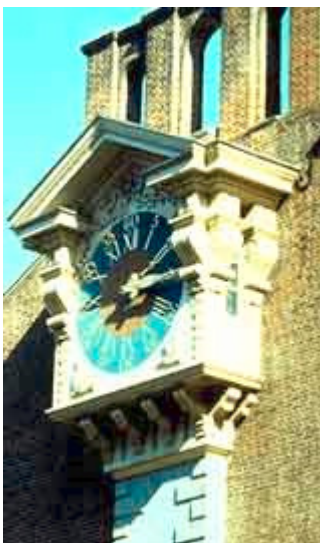
**In the reconstruction of the clock tower at Independence Hall, the substitute materials used were cast stone and wood with fiberglass and polyester bronze ornamentation. Photo: NPS files.**

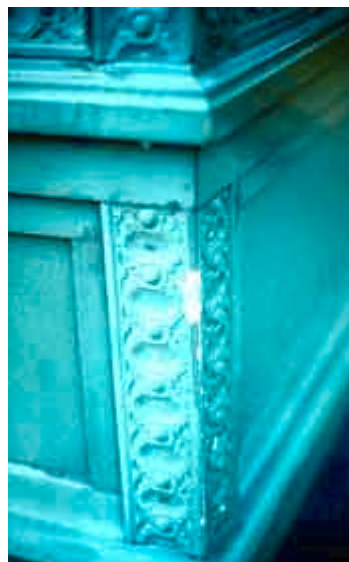
**Substitute materials need to be located with care to avoid damage. The fiberglass column base has chipped, whereas the historic cast iron would have remained sound. Photo: NPS files.**

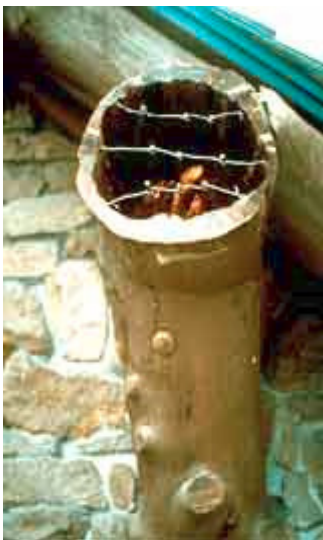
The core of a deteriorated wood outrigger was first drilled out. Photos (left and right): Courtesy, Harrison Goodall.

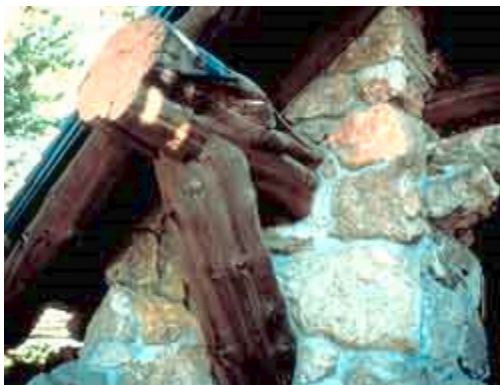
An inert material was injected into the hollow outrigger, permitting the outer wood to be retained and preserved.

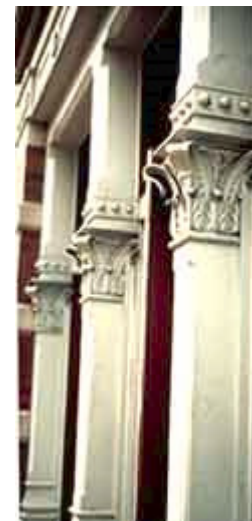
Cast aluminum has been used as a replacement material for cast iron. Photo: NPS files.

**Application:** Cast aluminum can be a substitute for cast iron or other decorative elements. This would include grillwork, roof crestings, cornices, ornamental spandrels, storefront elements, columns, capitals, and column bases and plinth blocks. If not self-supporting, elements are generally screwed or bolted to a structural frame. As a result of galvanic corrosion problems with dissimilar metals, joint details are very important.

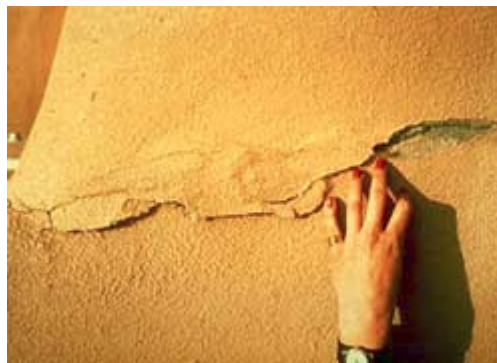
**A waterproof coating is an inappropriate substitute material to apply to adobe as it seals in moisture and may result in spalling. Photo: NPS files.**

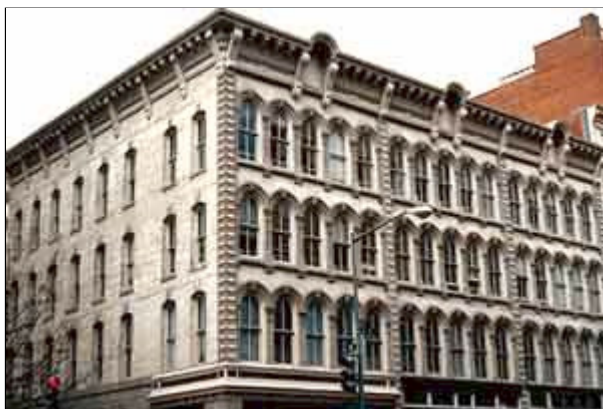
The historic cornice was successfully replaced with a fiberglass cornice. Photo: NPS files.
