PRESERVATION BRIEFS

22

The Preservation and Repair of Historic Stucco

Anne E. Grimmer

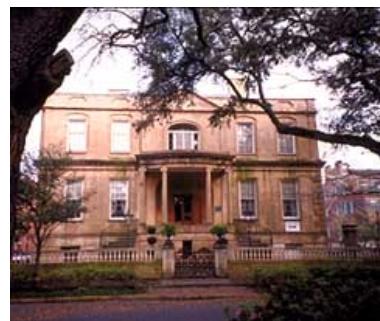
The stucco on the early-19th century Richardson-Owens-Thomas House in Savannah, Georgia, is a type of natural cement. Photo: NPS files.

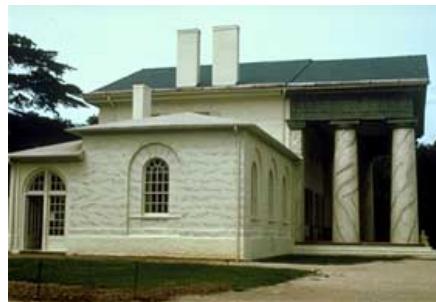
The stucco finish on Arlington House, Arlington, Virginia, was marbleized in the 1850s, approximately 30 years after it was built. Photo: NPS files.

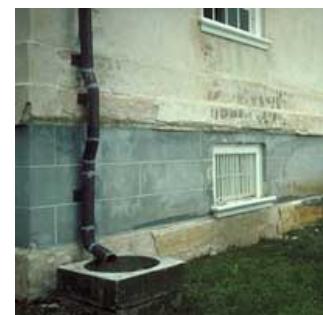
The damage to this stucco appears to be caused by moisture infiltration. Photo: NPS files.

Most stucco deterioration is the result of water infiltration into the building structure, either through the roof, around chimneys, window and door openings, or excessive ground water or moisture penetrating through, or splashing up from the foundation. Potential causes of deterioration include: ground settlement lintel and door frame settlement, inadequate or leaking gutters and downspouts, intrusive vegetation, moisture migration within walls due to interior condensation and humidity, vapor drive problems caused by furnace, bathroom and kitchen vents, and rising damp resulting from excessive ground water and poor drainage around the foundation. Water infiltration will cause wood lath to rot, and metal lath and nails to rust, which eventually will cause stucco to lose its bond and pull away from its substrate.

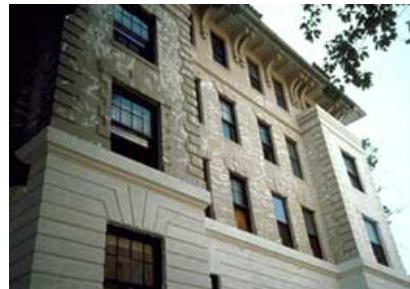
Caulking is not an appropriate method for repairing cracks in historic stucco. Photo: NPS files.

Commercially available caulking compounds are not suitable materials for patching hairline cracks. Because their consistency and texture is unlike that of stucco, they tend to weather differently, and attract more dirt; as a result, repairs made with caulking compounds may be highly visible, and unsightly. Larger cracks will have to be cut out in preparation for more extensive repair. Most stucco repairs will require the skill and expertise of a professional plasterer.

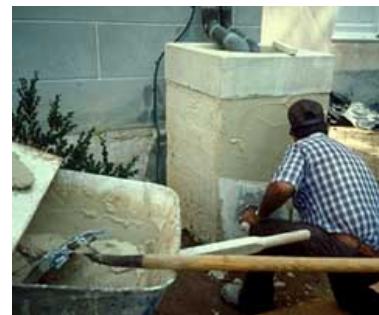
The deteriorated surface of this catch basin is being re-stuccoed. Photo: NPS files.

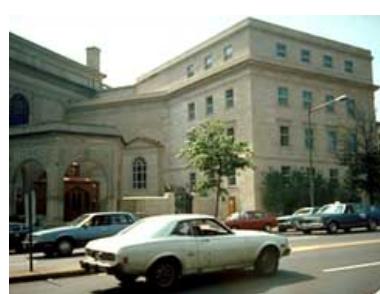
The new addition on the right is stucco scored to imitate the limestone of the historic building on the left. Photo: NPS files.
