## **FAIRSTED** **Frederick Law Olmsted** **National Historic Site** **Brookline, Massachusetts**

## **PRESERVATION** **Tech Notes**

### **NUMBER 1**

## **Restoring Vine Coverage to Historic Buildings**

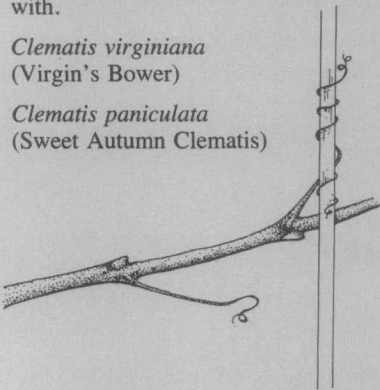
### Tendrils

The tendrils wrap themselves around anything that they come in contact with.

Like twining vines, *tendrils* vines wrap around objects for support. Because they are actually extended leaves, tendrils do not grow in width, only in length. Both twining and tendrils vines, however, can break weather seals on wooden facades, separating wood shingles and siding, as well as fascia and soffit boards on porches. Other vine types include *Aerial* vines which grow small roots along the length of the stem. These rootlets cling to the wall and can force their way into crevices. The fineness and density of the rootlets makes

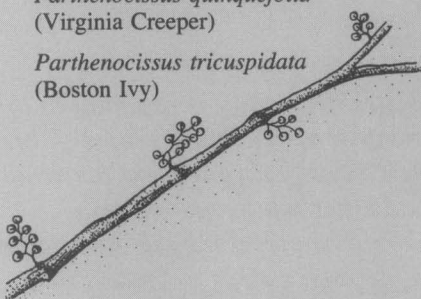
### Creeper

This vine clings by sending out small tendrils with adhesive discs that attach themselves to surfaces.

removal difficult. *Creeping* vines have tiny adhesive pads that cling to the building surface. Commonly found on masonry brick buildings, creeping vines do not generally cause extensive damage to structures while growing, although they may abrade softer mortar. However, they attach themselves so thoroughly to the building surface that paint, mortar, and brick are likely to be damaged when the vines are removed.

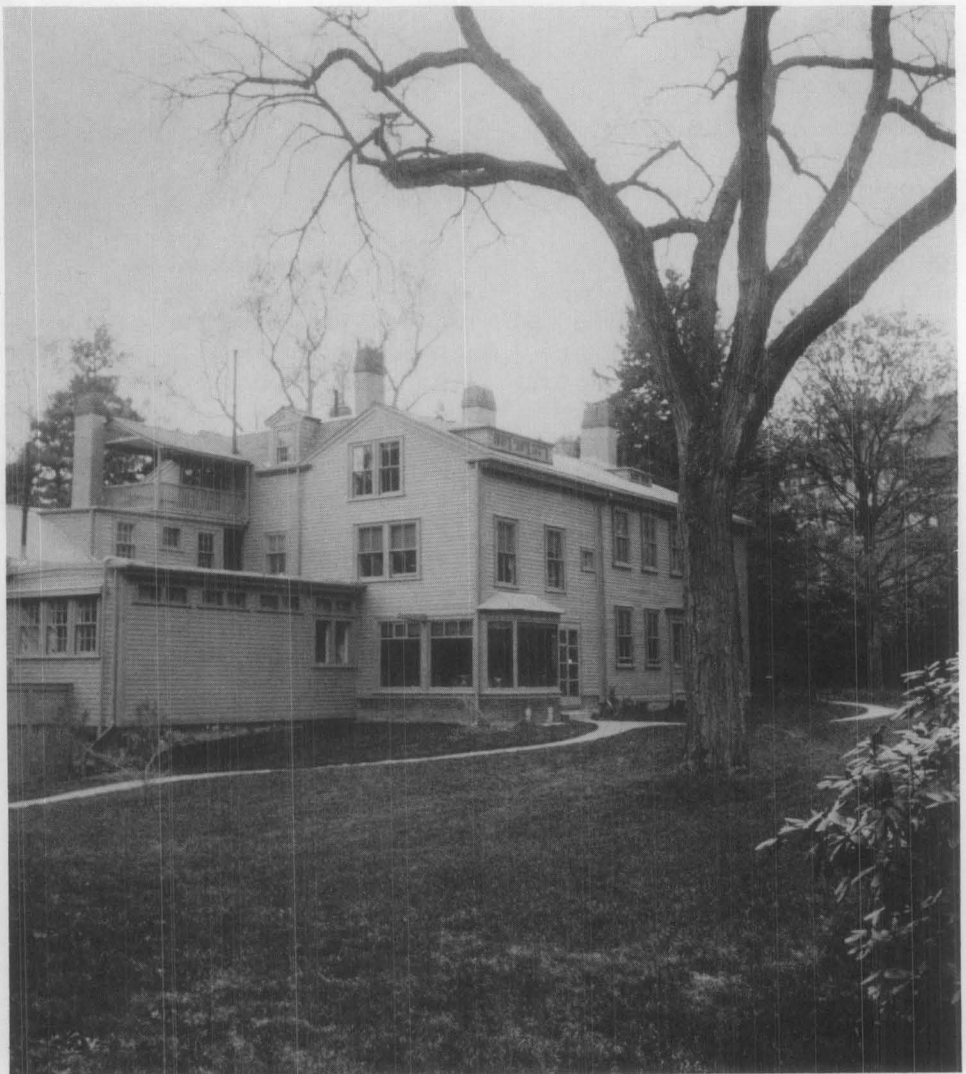
Figure 1. Historic plant materials can be retained while restoration of the historic structure is underway. The *Wisteria* and *Actinidia* vines that were historically used by Olmsted, were cut back during the restoration of Fairsted in 1988. Photo by Charles Pepper, courtesy of the Olmsted National Historic Site.

In 1980, The National Park Service began structural restoration of the house at Fairsted. To facilitate this work, the historic vines were removed from the facade and cut back to the ground. Since the vines were both historic plant material and an important feature of the property, complete removal was avoided. The vines were kept at ground level, but pruned frequently to prevent reattachment to the house. This situation resulted in weakened plant growth and an appearance quite different from

Olmsted's intention (*see figure 1*). Furthermore, long-term frequent pruning risked a higher incidence of pest-related problems to the plants and restricted their natural climbing habit. It was therefore important to the public site that a new trellis system be devised that would protect both the historic vegetation and the historic structure, while re-establishing the appearance of a "vine clad mansion."

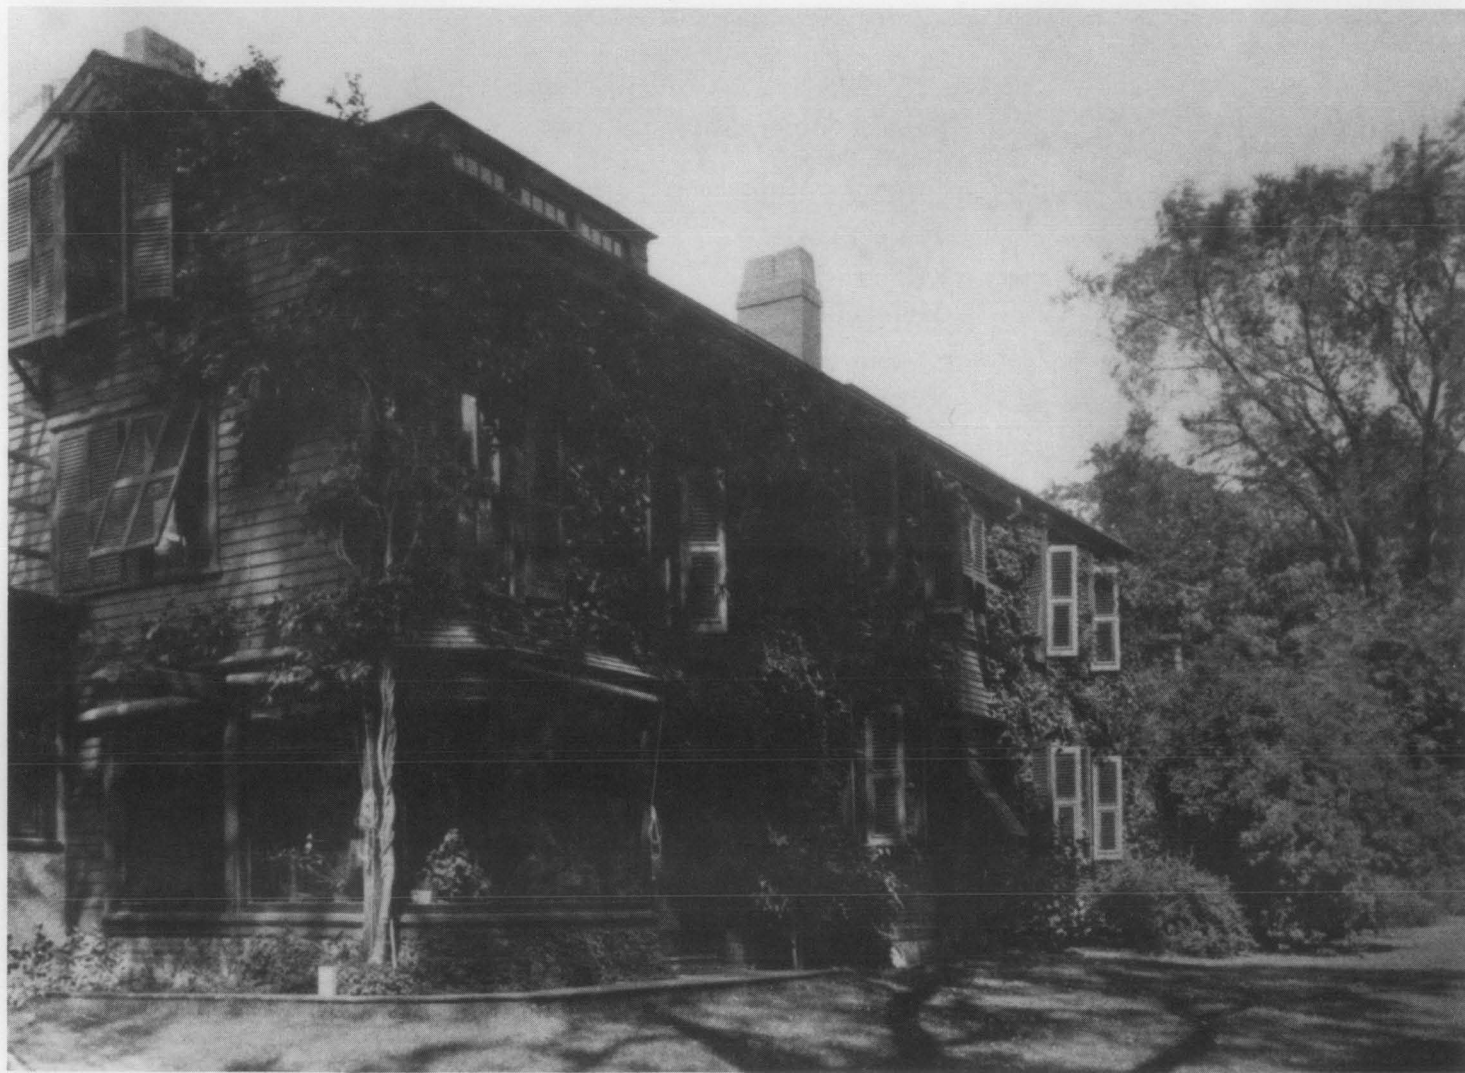
Figure 2. View of the west elevation at Fairsted which shows a steel strapping trellis system built as early as 1884. Photo courtesy of Olmsted National Historic Site.

Development of a new trellis system began with research into the materials, techniques and hardware used in New England between 1880 and 1930, as well as specific investigation into the various techniques used at Fairsted during those years. Historically, the east elevation of the house had two trellis structures supporting *Wisteria sinensis* (Chinese Wisteria). Photographs from as early as 1884 show a wooden trellis system at the entry porch and a spiraled steel strapping system along the house facade (*see figure 2*). Remnants of these

systems, such as eyebolts and hooks, were found intact at several locations on the structure. The kitchen wall had an interesting trellis consisting of posts with protruding pegs located between windows. Holes in the post indicated that pegs could be added or removed depending on the growth of the plant.

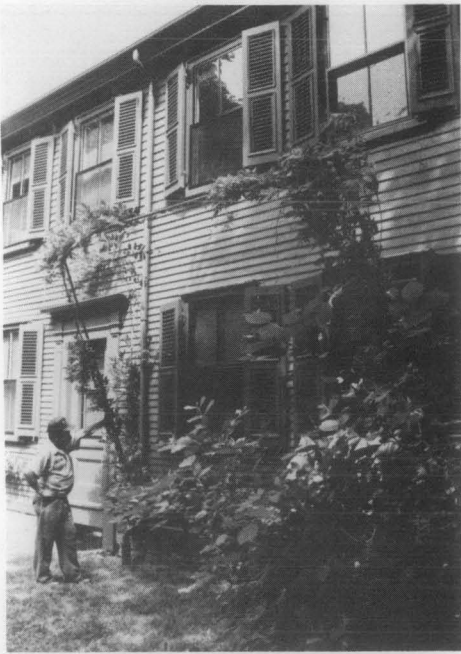
**Figure 4.** The pipe and strapping system, constructed with swivel sockets, allows the rigid support system to fold down away from the house. The strapping can also be removed from the pipe support for limited maintenance. Photo by Karen Day.

More than one person is required to remove this system. The rigid system folds out away from the house on the swivel sockets near the base of the house (see figure 4).

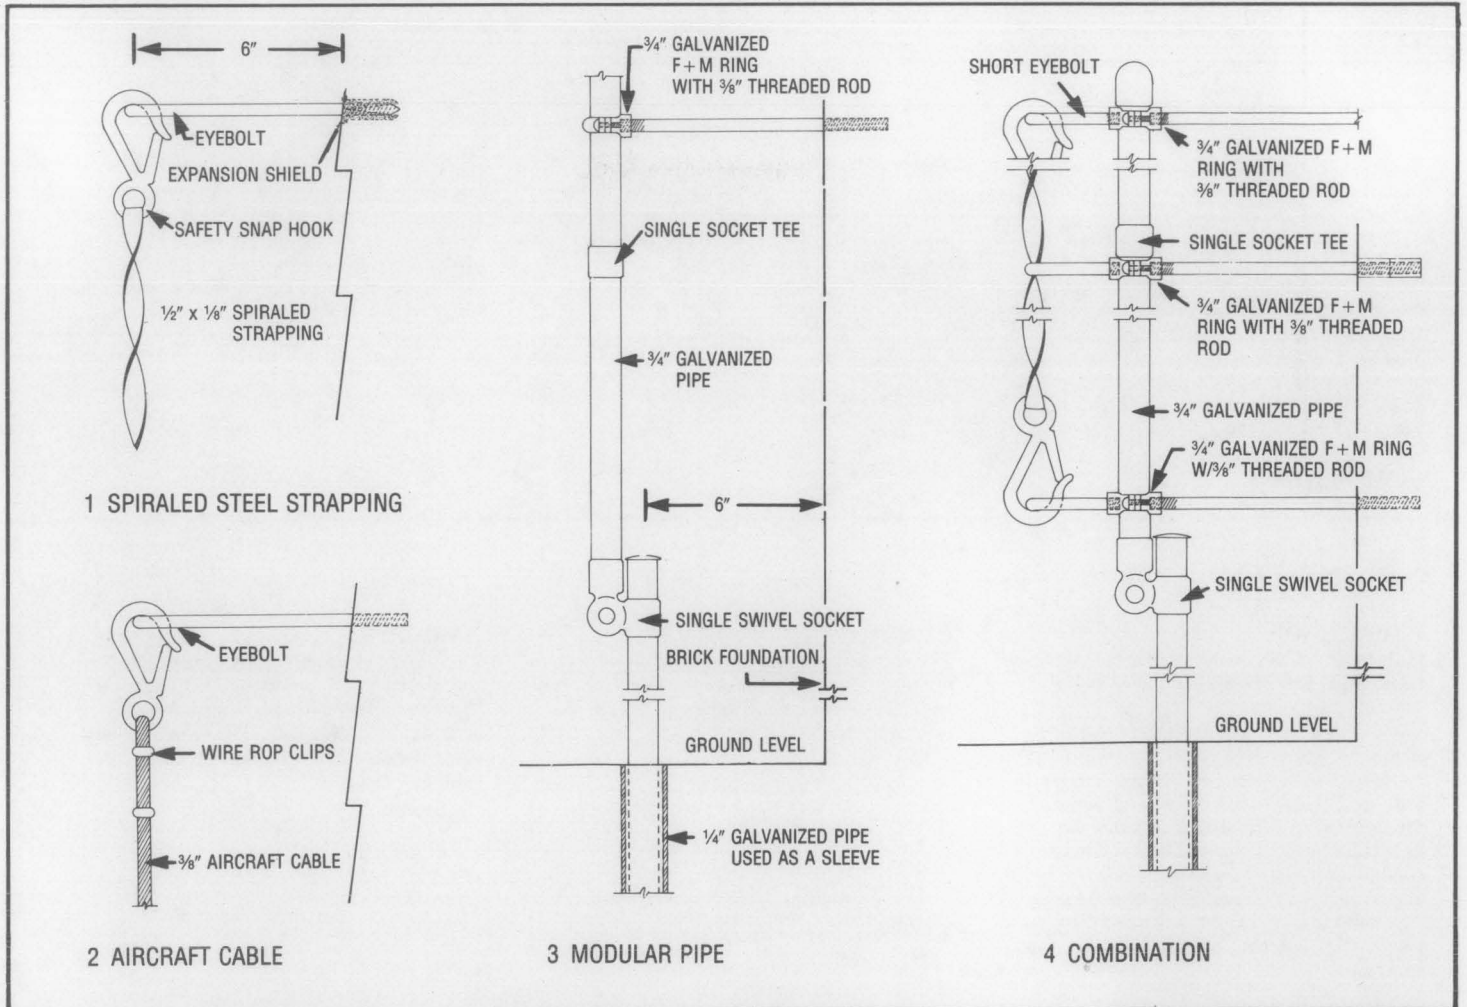
**Figure 5.** Details of the four experimental trellis systems. Drawings by Sharon Runner, National Park Service.

Materials:  $\frac{1}{8}$ " x  $\frac{1}{2}$ " spiraled steel strapping, hooks, snap hooks, eyebolts, and F & M rings. The steel strapping trellis is modeled after the historic design (c. 1885) developed by Olmsted. Spiraled metal strapping were attached to the house by a series of hooks and metal eyebolts. The eyebolts for this system, as well as the attachment devices for the other trellis systems, are held at least 6" away from the house to allow for air circulation between the plant material, trellis system and building facade. The strapping was fed through intermediate F & M rings located at regular intervals vertically and horizontally along the side of the house.

Materials:  $\frac{3}{8}$ " aircraft cable, eyebolts, and hooks.  $\frac{3}{8}$ " aircraft cable was substituted for the spiraled strapping in the first system. A system of eyebolts and hooks was used to secure the aircraft cable to the house.

Materials: galvanized metal pipe, fittings, eyebolts, and swivel sockets. This modular pipe system is composed of galvanized metal pipe and a series of pipe fittings. This system was hinged at the base to allow the rigid trellis structure to be tilted away from the house. The support pipes were anchored in the ground by inserting them in galvanized metal sleeves that were placed 4' below the ground surface and 6" away from the house. The top portion of the trellis structure was secured to the house by a bolt and clamp combination.

Materials: spiraled steel strapping, galvanized metal pipe, fittings, eyebolts, and swivel sockets. This solution is a combination of spiraled strapping, galvanized metal pipe and fittings. Eyebolts will separate the strapping from the supporting pipe structure. Swivel sockets near the base of the pipe structure allow the trellis to be tilted away from the house. This combination system provides a historic trellis appearance with the addition of rigid support. The vines are physically separated from the house, thus reducing potential damage to the facade.

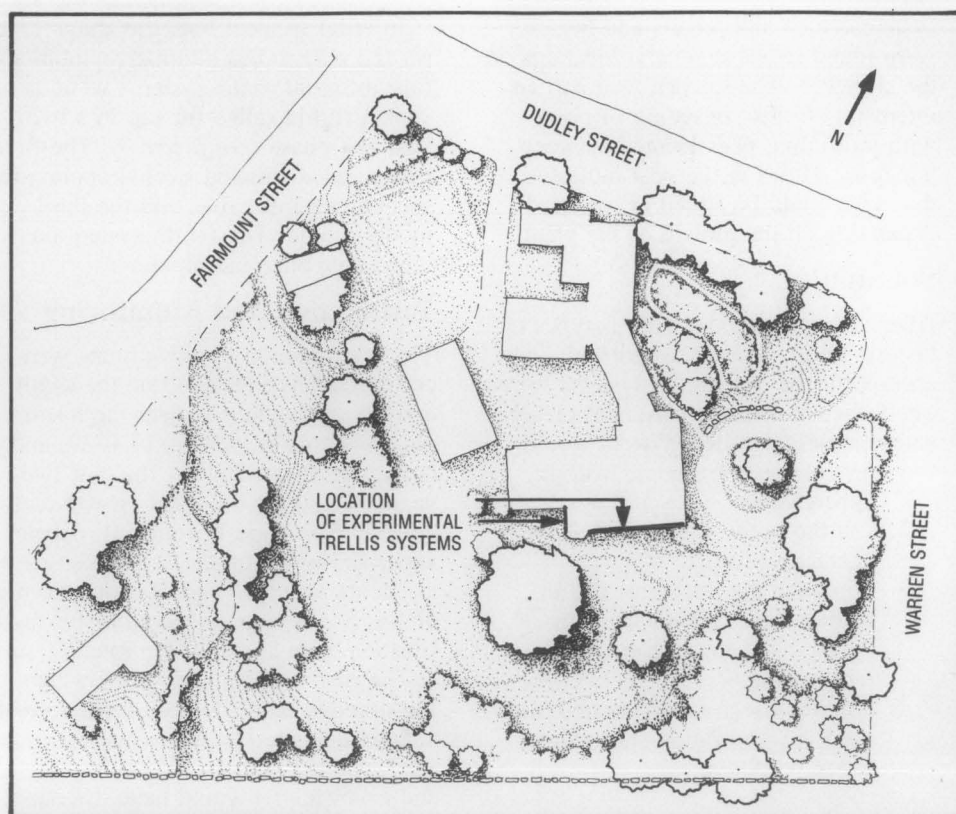
Figure 6. Site plan of Fairsted; the experimental trellis systems were installed on the south and west elevations. Drawing by Karen Day.

The experimental trellis systems were constructed and installed on the south and west elevations (where the historic plant material is located) in 1989, and have been monitored for the past two years (*see figure 6*). Plant growth and development, ease of removal, appearance, and effect on the historic structure are being observed and documented regularly. Some recommendations for modification have already been made.

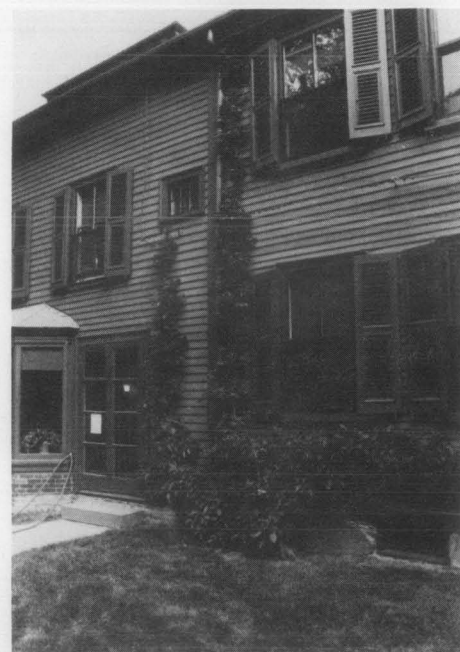
Figure 7. View of south facade, the experimental trellis systems have been in place for two growing seasons. Photo by Karen Day.

aged rapid rusting. The flexible aircraft cable (system 2), with the added weight of a mature vine will make removal and replacement difficult for one person. A temporary pulley system is recommended to aid in hoisting the vines back into place. The third design is a rigid modular pipe system (system 3). Although the rigidity of the system is advantageous to the stability of the vegetation, the weight of the vines may also be prohibitive for easy removal and replacement. The combination strapping and pipe system (system 4) does not recreate a historically accurate appearance. The system was designed in order to remove the vines on the strapping without removing the pipe supporting system. The vines growing on the strapping do not provide sufficient coverage to hide the pipe system behind. Furthermore, additional maintenance is required to keep the vines from growing on the pipe. After the multi-year test period is complete, one of the four systems will be selected, modified as needed, and installed to the east, south and west facades of the house (see figure 7).
