# Asbestos in Carpet Underlay

The Department of Health continues its investigation into the possibility of asbestos in some types of old carpet underlay

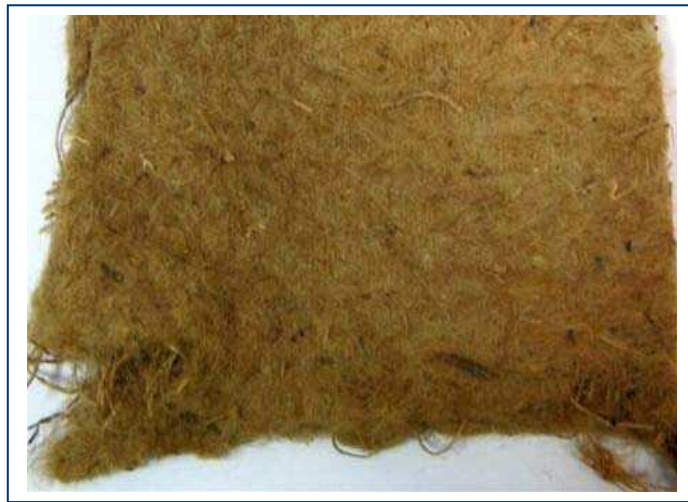
*A picture of typical hair felt underlay.*

The EHD has ascertained that up until the early 1970s, a significant quantity of hessian bags used to transport asbestos, wool, superphosphate and produce were recycled with other material such as jute and goat hair, to manufacture carpet hair felt underlay. It is possible that some of the bags were imported from other countries.

Therefore DOH invites anyone with 'original' carpet underlay (installed prior to the early 1970s) who is considering replacing their carpet to contact the EHD on 9388 4999 to discuss whether their carpet underlay is of the type and age that may have included asbestos-contaminated hessian material. An image showing an example of hair felt underlay is shown on the last page of this fact sheet.
