## Subject: Deteriorated Plaster Finishes

- Applicable Standards:**
2. Retention of Historic Character
  5. Preservation of Distinctive Features, Finishes and Craftsmanship
  6. Repair/Replacement of Deteriorated or Missing Features Based on Evidence

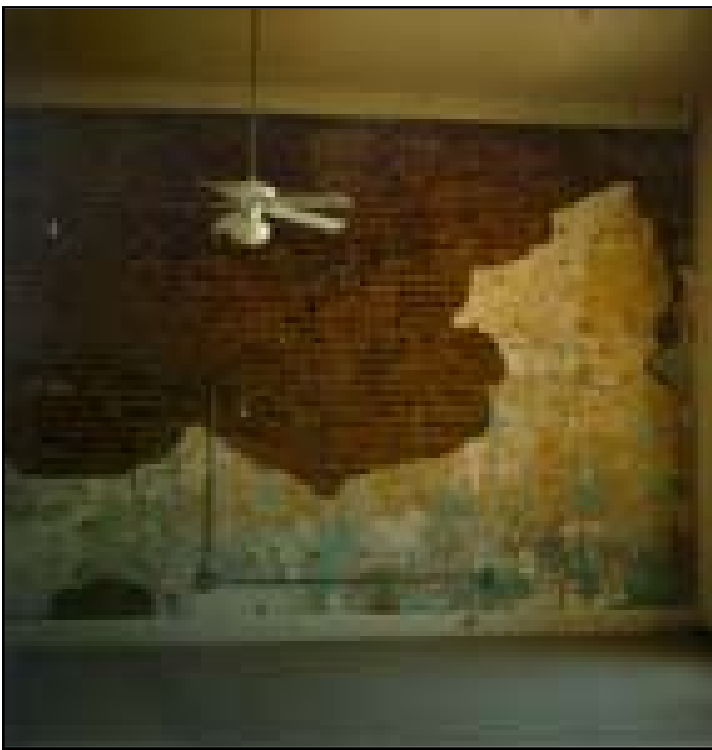
*Keeping deteriorated plaster fragments as found without repairing the plaster finish is not an appropriate rehabilitation treatment for most historic building interiors.*
