THE WOODEN DOOR IN THE EX-ABBEY OF SAINT SECONDO IDENTIFICATION OF THE BOTANICAL SPECIES

In this contribution, the wooden door of the ex-Abbey of Saint Secondo in Amelia (province of Terni, Italy) has been investigated with the main objective to gather information of its state of conservation to supply information for the restoration process. After restoration, samples from replaced boards were also examined. The investigation was performed through direct observation and analysis of wood micro-samples in the laboratory for characterising the species.

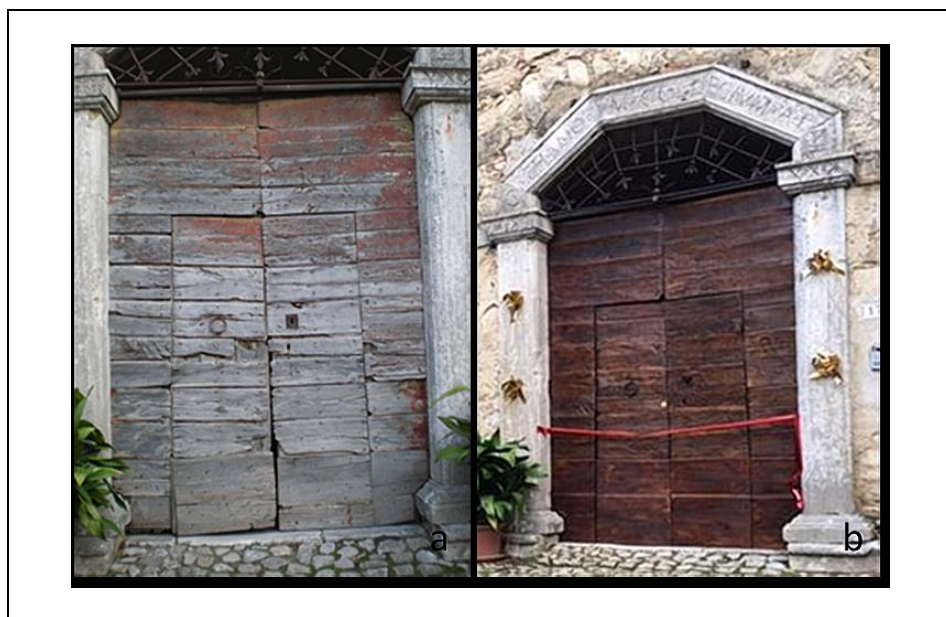
Figure 1. The door in the ex-Abbey of Saint Secondo: (a) before and (b) after the intervention. A smaller door is opened within the main one.

The door is characterised by a 'mercantile' style, with a double lining, which can be described as a medieval model of frame, still maintaining its features along the centuries. The door could be dated back to the same period of the portal. It consists of two major wings with transom window and grate in wrought-iron. Into the larger wings, two smaller wings are opened (Figure 1). On the internal side, the boards are vertically disposed (Figure 2a) while in the outer side they are arranged horizontally (Figure 1). The two layers are joined together with glue and nails ordered in staggered pitch and riveted on the inner side so as not to be removed.

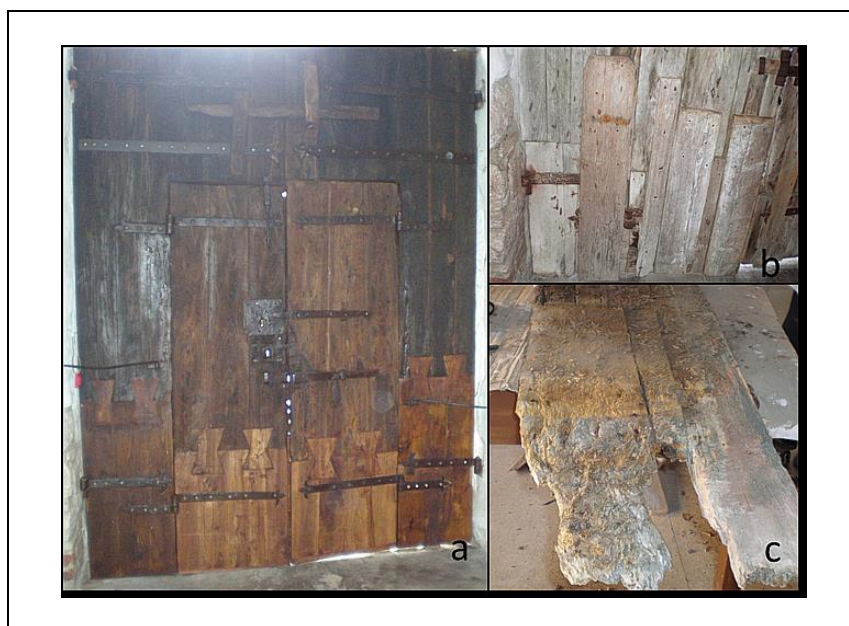
Figure 2. (a) Vertical board assembly in the inner side, after the intervention. (b) Detail of the conservation state before the intervention and (c) decayed boards in the lower zone, inner side, during restoration.

The evaluation of the conservation state, which preceded the restoration, highlighted the presence of gaps in the outer part in correspondence of the joints.

The lower side appeared extremely deteriorated (Figure 2b and 2c), the left door was remarkably warped as well as some of the boards of the outer layer and the surface protection was missing. In the lower part new boards badly replaced the original ones to maintain the door functionality.

The poor conservation state of the inner side required intervention aimed at restoring the door functionality. The reconstruction of the lower part has been made by jointing the vertical boards of the original part with the new ones in elm wood (Figure 2a). The outer layer showed a very critical situation due to chemical and physical degradation processes but also to the lack of correct ordinary and planned maintenance. The deterioration of the surface was caused above all by light sun exposure without any wood protection. The original colour of wood was turned to a silver-grey one, due to the surface photo-degradation [7-10]. The external layer of horizontal boards has been restored, with the care to preserve the original materials and to maintain the aesthetic appearance. Subsequently, the two door wings were aligned and consolidated by applying, in the upper part, two iron bars secured by screws. Finally, where necessary, plugs were inserted made of elm wood, vinyl glue and wood powder. The puttying was carried out with Balsite, un-shrinking resin-based filler. It can be coloured with earths and oxides and easily sanded. The final stage was to restore colour and make uniform the new parts with the originals. This goal was reached by three applications of boiled linseed oil diluted with petroleum in the volume ratio 3:1.
