Corrosion of Building Assets – Problems and Prevention

L. H. Boulton

Les Boulton & Associates Ltd. Auckland, New Zealand

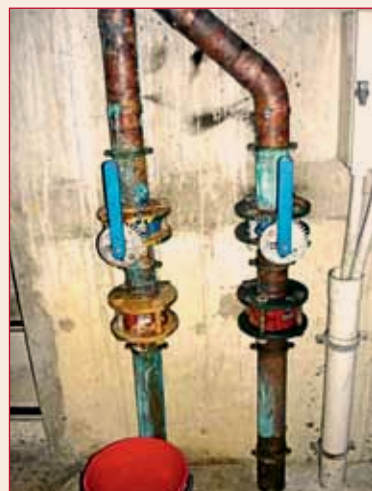
Figure 3. Corrosion at badly designed valve-pipe joint in water piping of high-rise building.

The design and construction of the building services piping system for draining waste water into the sumps had contributed to *erosion-corrosion* damage inside the copper piping. Additional problems included copper pipe encapsulated into concrete, dissimilar metal contact between copper pipe and steel valves (Figures 3,4), bifurcated joints showing erosion-corrosion due to turbulent flow, and poorly brazed copper elbows. The repair of leaking copper pipes by brazing had produced a harmful microstructure in localised areas of the copper piping which contributed to localised internal corrosion on the copper piping.

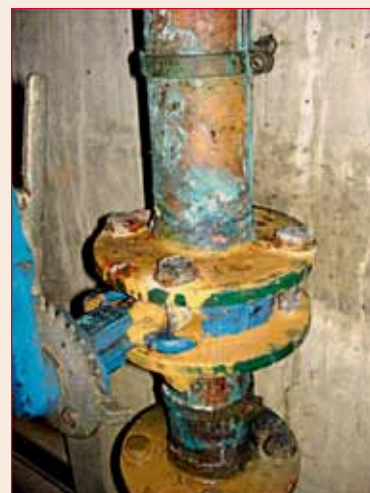
Figure 4. Severe galvanic corrosion of the steel at valve-copper piping joint.

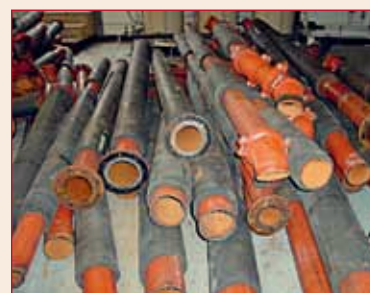
Examination showed that the pipework leaks were due to internal pitting corrosion which caused perforations in the black steel piping. The pitting corrosion was determined to be due to MIC on the internal walls of the steel water pipes. Microbiological examination showed that a sulphate-reducing bacteria (SRB) strain had colonised the inside of the steel water pipes. SRB were introduced into the cooling pipework circuit via the ground source water supply which was not treated with a biocide. Hundreds of metres

Figure 5. Steel piping failed in once-through AC water circuit at airport complex due to MIC.

of corrosion-damaged steel piping was replaced with ABS plastic piping at a very high cost (Figure 5), and legal action ensued. Similar MIC issues have arisen in building fire water piping and in galvanised steel potable water piping in commercial buildings [8-10]. Conventional copper tubing used for potable water supply in plumbing systems within institutional buildings is also known to be susceptible to MIC attack under certain circumstances [11].

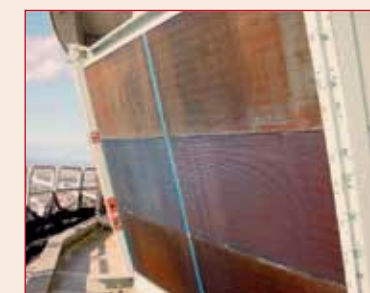
The corrosion damage due to windborne sea salt on bare copper fin-fan coils of a large AC condenser unit exposed to the atmosphere 56 levels up on a tower structure located in a marine environment is illustrated in Figure 9. The copper fins had undergone surface corrosion damage to an extent that the copper fins had become useless for heat transfer. The copper fins on the coils had not been given adequate protective coating during manufacture. A high quality protective coating on the copper fins is essential to mitigate the effect of a severely corrosive environment.

Figure 9. Corrosion of copper air-cooled fin-fan units of large condenser units on high-rise tower situated in a severe marine environment.

- Externally located AC condenser units with copper or aluminium fins should be washed frequently with fresh water to ensure that deposited salts and grime are removed from metal surfaces which are susceptible to atmospheric corrosion.

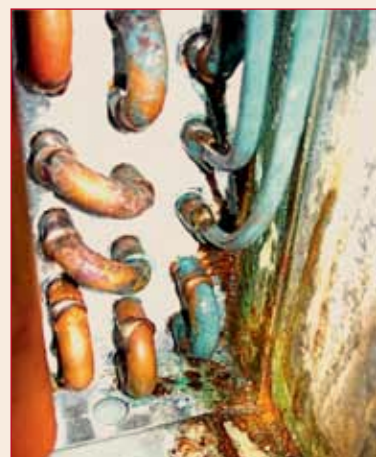
There was some galvanic corrosion occurring on the condenser end plates due to dissimilar metal contact between the copper tubes and galvanised steel in the bulkhead environment. The dissimilar metal corrosion was exacerbated by the presence of moisture and grime in the vicinity. The lack of adequate corrosion protection, namely a good organic coating on the end plate metal components, exacerbated the rate of the corrosion. There was also turbulent air flow occurring in the condenser area which contributed to the presence of *wet* and *dry* areas adjacent to each other on the end plate. Where *wetness* was present on the copper and galvanised steel components at the condenser end plate corrosion on the copper coils and on the galvanised steel was higher.

The probable cause of the corrosion on the copper condenser coils was *thermogalvanic corrosion*. It is not possible to design AC condenser coils with completely isothermal surfaces. Condensers can have temperature differentials along the same metal surface in the presence of an electrolyte. Temperature differences give rise to electrode potential differences that generate small DC current on metal components and corrosion occurs in the *hotter* zone. Depending upon the environment localised corrosion on metals may accelerate or decelerate. The driving force for *thermogalvanic corrosion* is small and if the resistance of an electrolyte is low the corrosion is confined to small areas causing pitting corrosion at the edge of the hotter zone. Thermogalvanic corrosion is usually a dormant condition that can accelerate localised corrosion on a passive metal such as copper if the environment alters.

Figure 10. Thermogalvanic corrosion on copper tubes at end plate of condenser unit. Galvanic corrosion on galvanised steel.

- Corrosion occurs preferentially at *hot spots* in heating plant and in heat exchangers. As much as it is possible there should be few *hot spots* on the end-plates of the AC condenser units in order to avoid thermogalvanic corrosion.

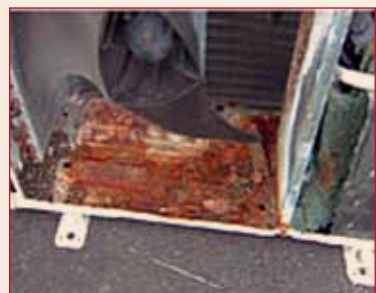
Water that forms from air passing over a cold condenser surface inside a heat pump cabinet must be drained to an external sump. However, if the water does not drain freely and moisture condenses on the bottom of the heat pump cabinet, hidden internal corrosion of the casing can ensue and failure of the heat pump may result (Figure 10).

Manufacturers, installers and owners need to be more aware that heat pump are usually contained in steel cabinets with a basic coating (paint or powder coating) for corrosion protection. The internal steel surface of a the cabinet is often susceptible to surface corrosion. The corrosion problem can occur inside small units installed externally on walls and roofs of buildings located in corrosive environments. Heat pumps used to heat swimming pools employing salt water chlorinators may also be susceptible to internal corrosion damage.

Figure 11. Corrosion inside poorly protected steel cabinet of a heat pump. Condensed water inside cabinet supports corrosion.

- Consideration should be given to coating fin-fan condensers with a good quality coating to insulate any dissimilar metal contacts, particularly if a damp environment prevails. A good coating requirement also applies to the internal cabinet surfaces of heat pumps and air conditioners.

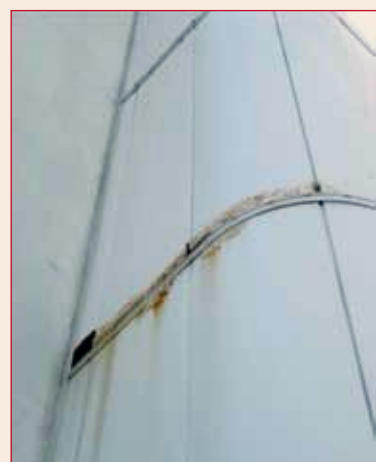
Figure 12 shows the condition of a proprietary coated steel cladding material on a building after only 15 years in service. The external corrosion is due to poor cladding design resulting in crevice corrosion and ingress of rain water. The steel cladding panels had undergone crevice corrosion in areas where rain water containing aggressive marine salts had been trapped in joint locations causing serious degradation of the cladding. The corrosion damage observed was superficial in some areas but extensive in others, including locations where cladding perforations had occurred. The entire building had to be reclad after 15 years. Similar cladding failures have been reported involving corrosion of proprietary aluminium composite panel claddings on high-rise buildings that suffered leakages. In most cases the cause of water ingress into the internal wall cavities was poor cladding detail and poor installation of the cladding material on the building façade.

Figure 12. Failure of proprietary cladding showing corrosion distress at seams resulting in water leakage.
