19 PRESERVATION BRIEFS

The Repair and Replacement of Historic Wooden Shingle Roofs

Sharon C. Park, AIA

U.S. Department of the Interior, National Park Service
Preservation Assistance Division, Technical Preservation Services

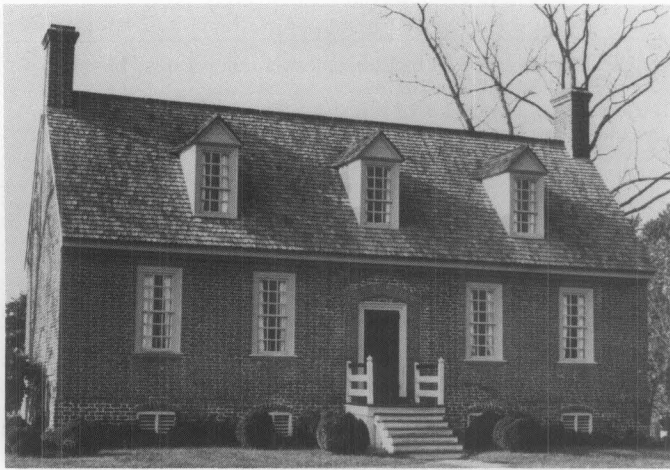
1. The Rolfe-Warren House, a tidewater Virginia property, was restored to its 18th-century appearance in 1933. The handsplit and dressed wooden shingles are typical of the tidewater area with special features such as curved butts, projecting ridge comb and closed swept valleys at the dormer roof connections. Circa 1970 Photo: Association for the Preservation of Virginia Antiquities.

Wooden shingle roofs are important elements of many historic buildings. The special visual qualities imparted by both the *historic shingles* and the *installation patterns* should be preserved when a wooden shingle roof is replaced. This requires an understanding of the size, shape, and detailing of the historic shingle and the method of fabrication and installation. These combined to create roofs expressive of particular architectural styles, which were often influenced by regional craft practices. The use of wooden shingles from the early settlement days to the present illustrates an extraordinary range of styles (see illus. 1, 2, 3, 4).

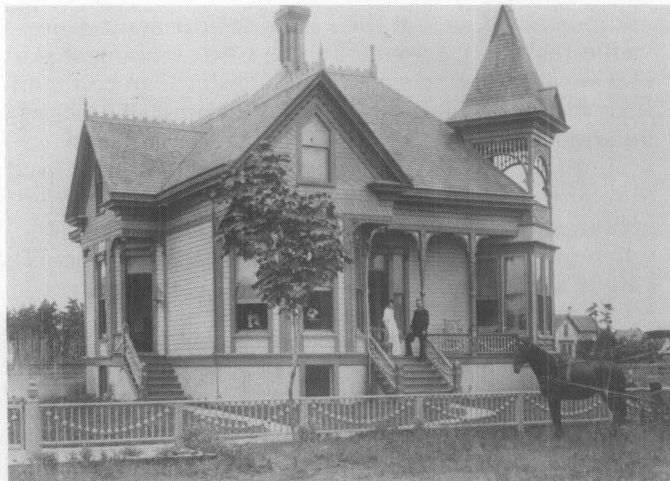
3. Readily available and inexpensive sawn shingles were used not only for roofs, but also for gables and wall surfaces. The circa 1891 Chambers House, Eugene, Oregon used straight sawn butts for the majority of the roof and hexagonal butts for the lower portion of the corner tower. Decorative shingles in the gable ends and an attractive wooden roof cresting feature were also used. Photo: Lane County Historical Society.

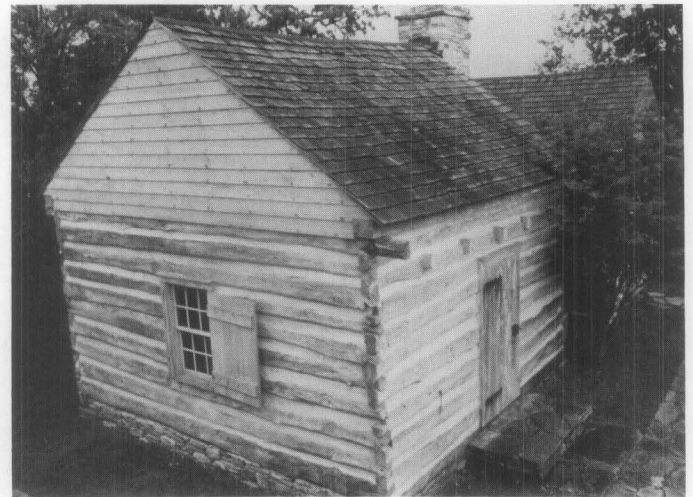
2. Handsplit and dressed shingles were also used on less elaborate buildings as seen in the restoration of the circa 1840 kitchen at the Winedale Inn, Texas. The uneven surfaces of the handsplit shingles were generally dressed or smoothed with a draw-knife to keep the rainwater from collecting in the wood grain and to ensure that the shingles lay flat on the sub-roof. Photo: Thomas Taylor.

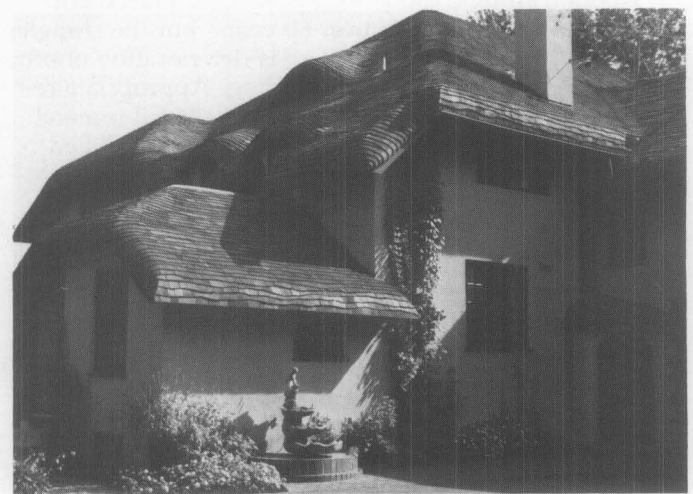
4. With the popularity of the revival of historic styles in the late 19th and early 20th centuries, a new technique was developed to imitate English thatch roofs. For the Tudor Revival thatch cottages, steaming and curving of sawn shingles provided an undulating pattern to this picturesque roof shape. Photo: Courtesy of C.H. Roofing.

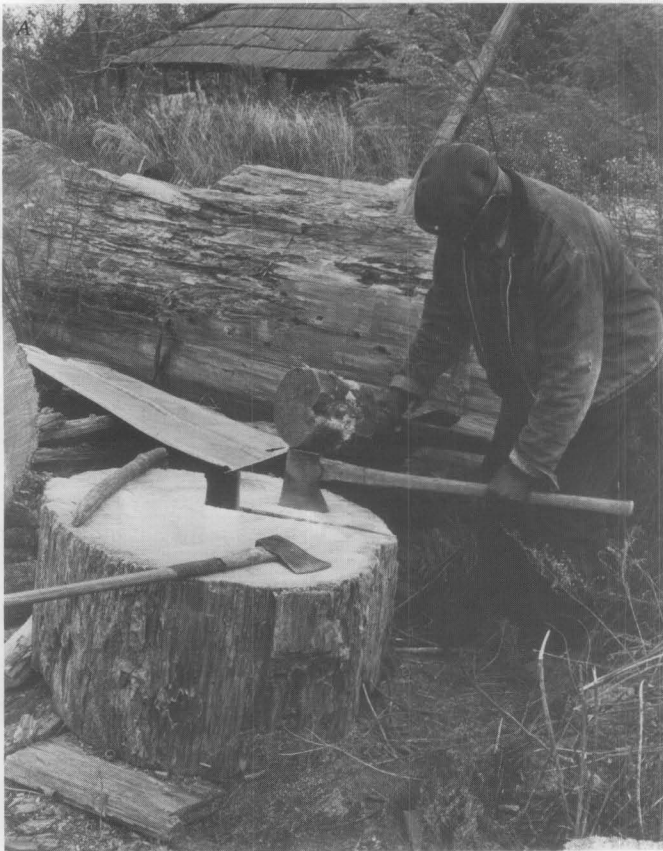
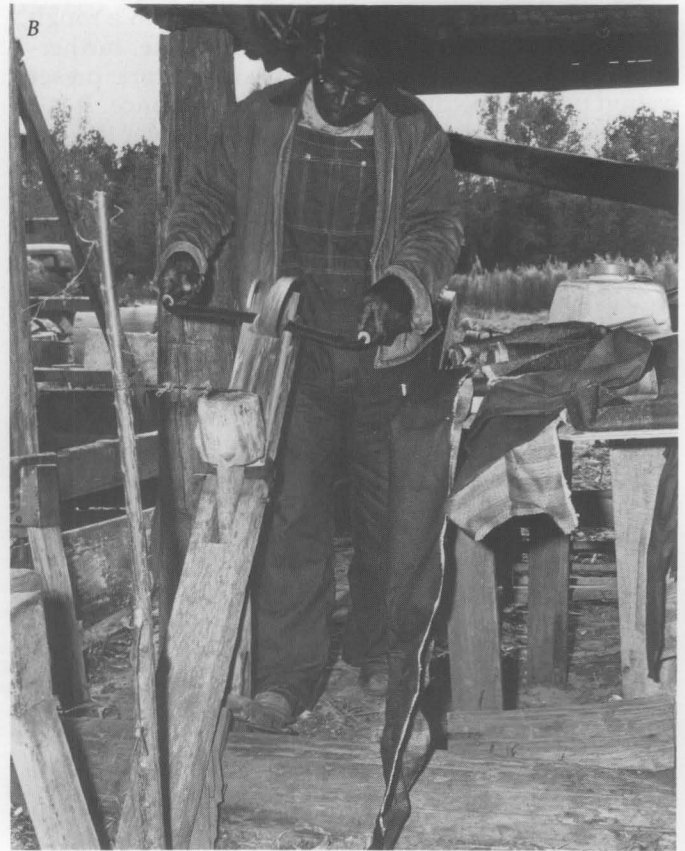
5. Custom Handsplit shingles are still made the traditional way with a mallet and froe or ax. For these cypress shingles, a "bolt" section of log (photo A) the length of the shingle has been sawn and is ready to be split into wedge-shaped segments. Handsplit shingles are fabricated with the ax or froe cutting the wood along the grain and separating, or riving, the shingle away from the remaining wedge. The rough surfaces are dressed on a shavinghorse using a draw-knife as shown above (photo B). Note the long wooden shingles covering the work shed in photo A. Photos: Al Honeycutt, North Carolina Division of Archives and History.

to dress or plane the shingles on a shavinghorse with a draw-knife or draw-shave (see illus. 5B) to make them fit evenly on the roof. This reworking was necessary to provide a tight-fitting roof over typically open shingle lath or sheathing boards. Dressing, or smoothing of shingles, was almost universal, no matter what wood was used or in what part of the country the building was located, except in those cases where a temporary or very utilitarian roof was needed.

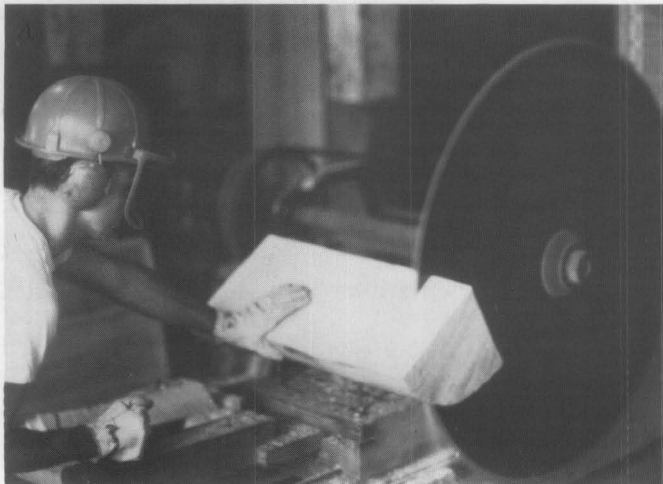
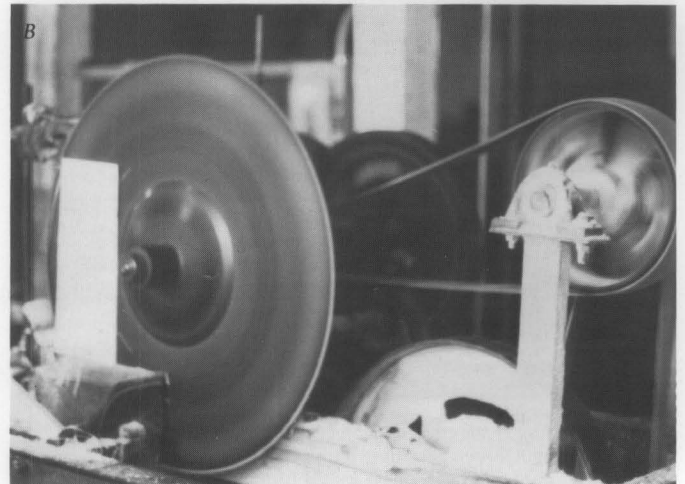
6. Modern machine-made shingles are sawn. Shown are: (photo A) Eastern White Pine quarter split shingle block on equalizer saw being trimmed to parallel the ends; and (photo B) the restored 19th-century shingle mill saw cutting tapered flitches or shingles. The thickness and taper can be precisely controlled. Photo: Steve Ruscio, The Shingle Mill.

Shingle fabrication was revolutionized in the early 19th century by steam-powered saw mills (see illus. 6). Shingle mills made possible the production of uniform

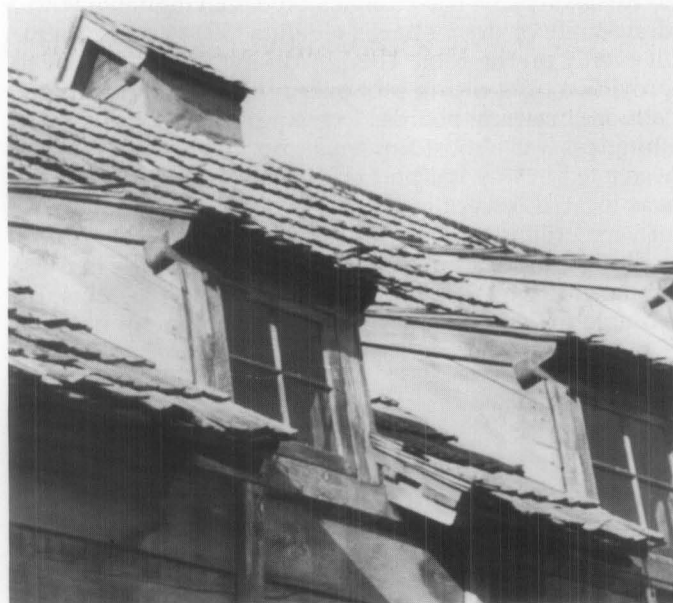
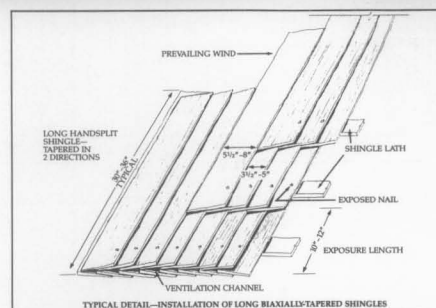
8. The long biaxially tapered handsplit shingles on the Ephrata Cloisters in Pennsylvania were overlapped both vertically and horizontally. The insert sketch shows channels under the shingles that provided ventilation and drainage of any trapped moisture. The aged appearance of these handsplit and dressed shingles belies their original smoothness. Replacement shingles should match the original, not the aged appearance. Photo: National Park Service; Sketch: Reed Engle.

Not all shingles were laid in evenly spaced, overlapping, horizontal rows. In various regions of the country, there were distinct installation patterns; for example, the biaxially-tapered long shingles occasionally found in areas settled by the Germans (see illus. 8). These long shingles were overlapped on the side as well as on top. This formed a ventilation channel under the shingles that aided drying. Because ventilation of the shingles can prolong their life, roofers paid attention to these details (see illus. 9).

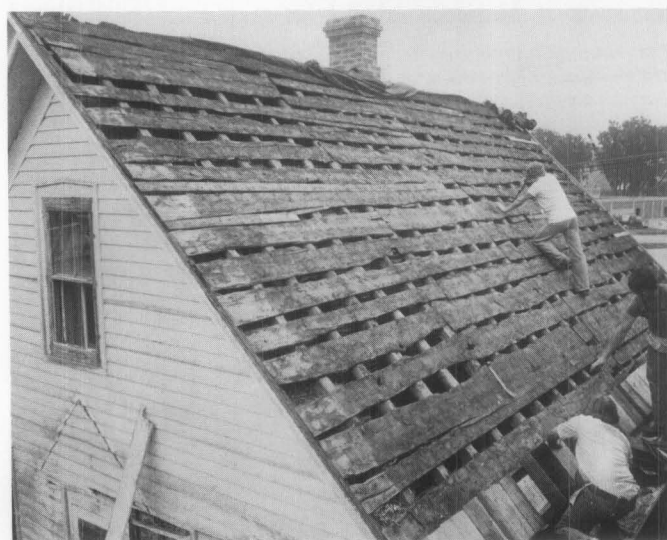
7. The reshingling of the circa 1856 Stovewood House in Decorah, Iowa, revealed the original open sheathing boards and pole rafters. Sawn cedar shingles were used as a replacement for the historic cedar shingles seen still in place at the ridge. A new starter course is being laid at the eaves. Photo: Norwegian-American Museum, Decorah, Iowa.

In order to have a weathertight roof, it was important to have adequate coverage, proper spacing of shingles, and straight grain shingles. Many roofs were laid on open shingle lath or open sheathing boards (see illus. 7). Roofers typically laid three layers of shingles with approximately 1/3 of each shingle exposed to the weather. Spaces between shingles (1/8"–1/2" depending on wood type) allowed the shingles to expand when wet. It was important to stagger each overlapping shingle by a minimum of 1-1/2" to avoid a direct path for moisture to penetrate a joint. Doubling or tripling the starter course at the eave gave added protection to this exposed surface. In order for the roof to lay as flat as possible, the thickness, taper and surface of the shingles was relatively uniform; any unevenness on handsplit shingles had already been smoothed away with a drawknife. To keep shingles from curling or cupping, the shingle width was generally limited to less than 10".

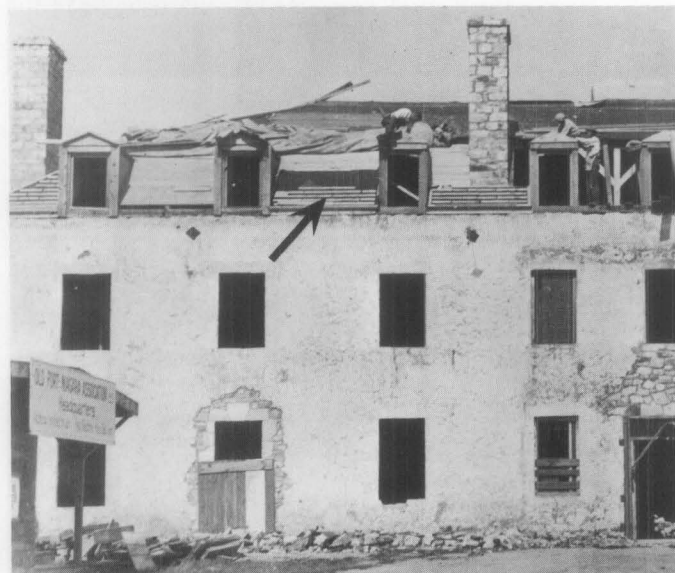
9. This 1927 view of the reshingling of the French Castle at Old Fort Niagara, N.Y., shows the wooden sleepers being laid (see arrow) over solid sheathing in order to raise the shingles up slightly to allow under-shingle ventilation. Note that the horizontal strips are not continuous to allow airflow and trapped moisture to drain away. This cedar roof has lasted for over 60 years in a harsh moist environment. Photo: Old Fort Niagara, Assoc. Inc.

Beware of heavily insulated attic rafters. Historically, the longest lasting shingle roofs were generally the ones with the best roof ventilation. Roofs with shingling set directly on solid sheathing and where there is insulation packed tightly between the wooden rafters without adequate ventilation run the risk of condensation-related moisture damage to wooden roofing components. This is particularly true for air-conditioned structures. For that reason, if insulation must be used, it is best to provide ventilation channels between the rafters and the roof decking, to avoid heavy felt building papers, to consider the use of vapor barriers, and perhaps to raise the shingles slightly by using "sleepers" over the roof deck. This practice was popular in the 1920s in what the industry called a "Hollywood" installation, and examples of roofs lasting 60 years are partly due to this under-shingle ventilation (refer to illus. 9).

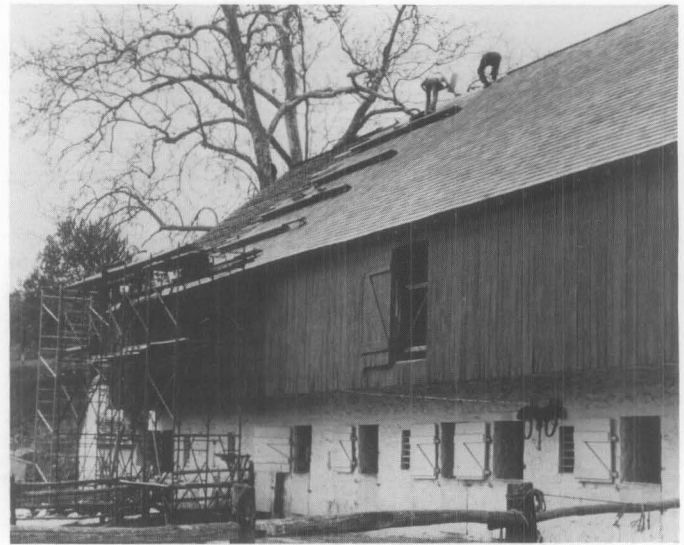
11. The replacement sawn red cedar shingles matched the deteriorated shingles exactly for this barn re-roofing. The old shingles, seen to the far left, were removed as the new shingles were installed. Even the horizontal coursing matched because the exposure length for both old and new shingles was the same. Photo: Williamsport Preservation Training Center.

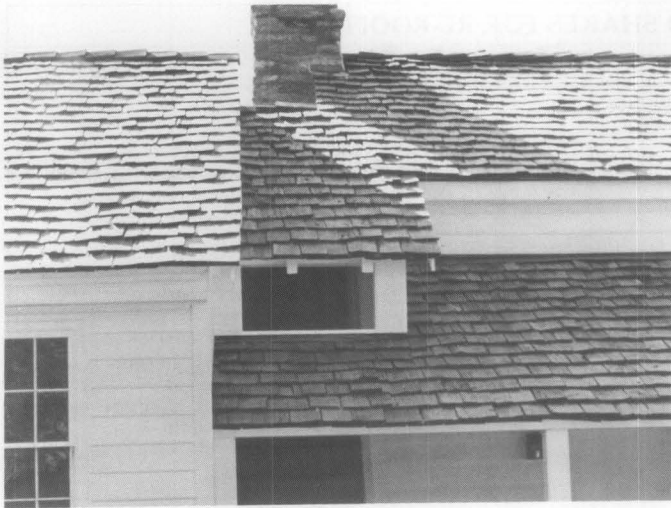
12. Inappropriately selected and installed wooden shingles can drastically alter the historic character of a building. This tavern historically was roofed with handsplit and dressed shingles of a relatively smooth appearance. In this case, a commercially available shake was used to effect a "rustic" appearance. Photo: National Park Service.

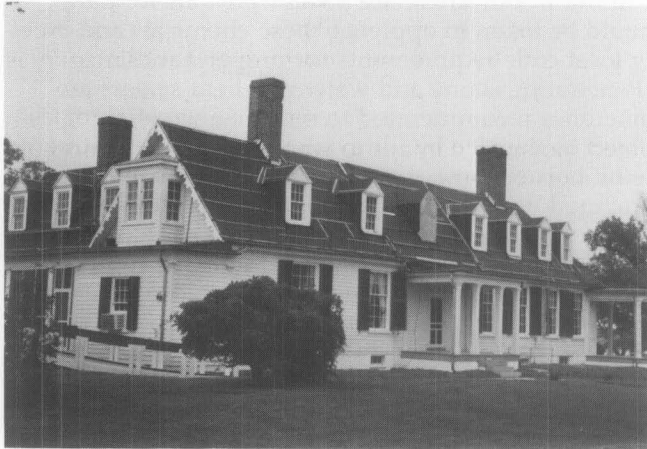
A. The later non-historic shingles were removed from Appomattox Manor (circa 1840 with later additions) and roofing paper was installed for temporary protection during the re-shingling.

14. Original 19th-century handsplit and dressed wooden shingles 18" long, 3"-4" wide, and 5/8" thick were found in place on the Appomattox Manor at Hopewell, Virginia. The butts were curved and evidence of a red stain remained. The specifications and details were researched so that the appearance of the historic shingles and installation patterns could be matched in the re-shingling project. Photos: John Ingle.

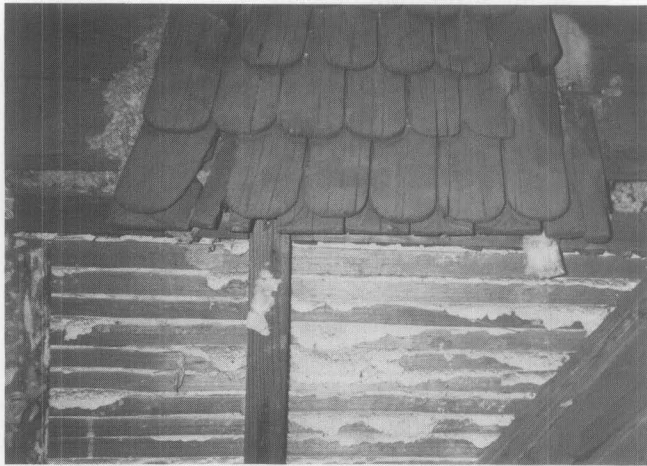
B. These weathered historic 19th-century handsplit and dressed shingles were found in place under a later altered roof. Note the straight butt eave shingles under the curved butts of the historic dormer shingles.

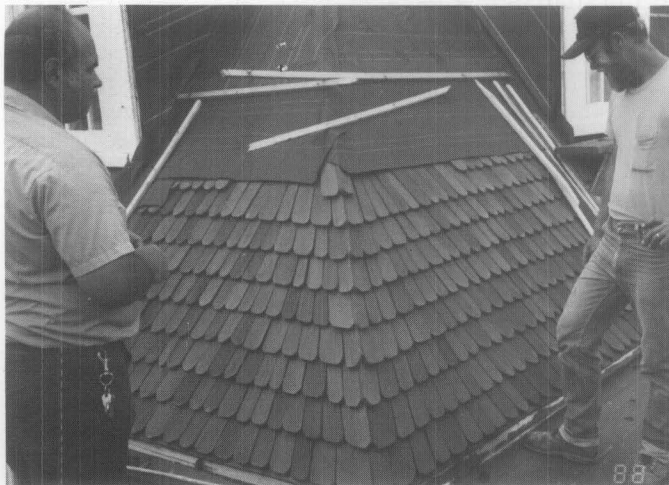
D. The fanned hips (seen here), swept valleys, and projecting ridge combs were installed as part of the re-roofing project. Special features, when documented, should be reproduced when re-shingling historic roofs.

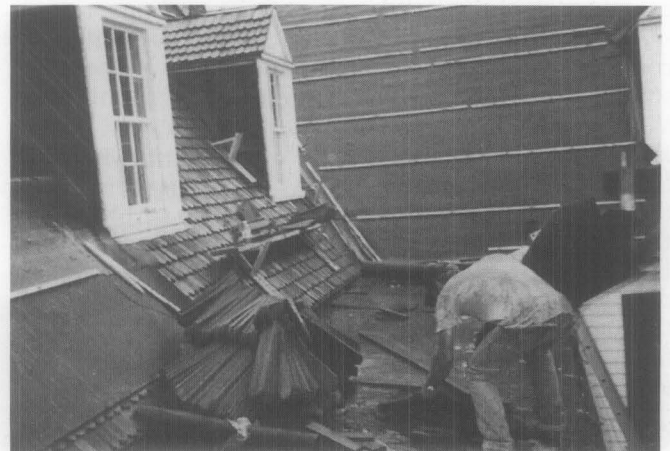
C. The replacement shingles (see specifications above), matched the historic shingles and were of such high quality that little hand dressing was needed at the site. The building paper, a temporary protection, was removed as the shingles were installed on the sheathing boards.

Type of wood to be used: Western Red Cedar.
Grade of wood and manufacturing process: Number One, Tapersplit Shakes, 100% clear, 100% edgegrain, 100% heartwood, no excessive grain sweeps, curvatures not to exceed 1/2" from level plain in length of shake; off grade (7% tolerance) material must *not* be used.
Size of the shingle: 18" long, 5/8" butt tapered to 1/4" head, 3"-4" wide, sawn curved butts, 5-1/2" exposure
Surface finish and any applied coatings: relatively smooth natural grain, no more than 1/8" variation in surface texture, butt thickness to be uniform throughout bundles. Site dipped with fire-rated chemicals tinted with red iron oxide for opaque color.
Type of nails and flashing: double hot dipped galvanized nails sized to penetrate sheathing totally; metal flashing to be 20 oz. lead-coated copper, or terne-coated stainless steel; additional flashing reinforcement to be aluminum foil type with fiber backing to use at hips, ridges, eaves, and valleys.

Type of sheathing: uninsulated attic, any deteriorated 3/4" sheathing boards, spaced 1/2"-3/4", to be replaced in kind.

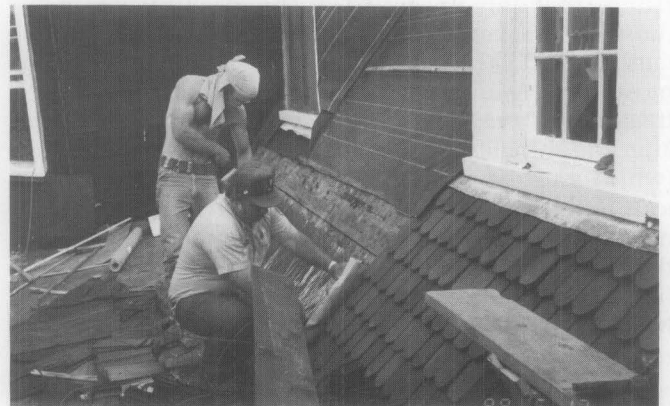
E. In order to achieve a "Class B" fire-rating, the shingles were dipped in fire-retardant chemicals and allowed to dry prior to installation. Iron oxide was added to this chemical dip to stain the shingles to match the historic red color. These coatings will need periodic reapplication.

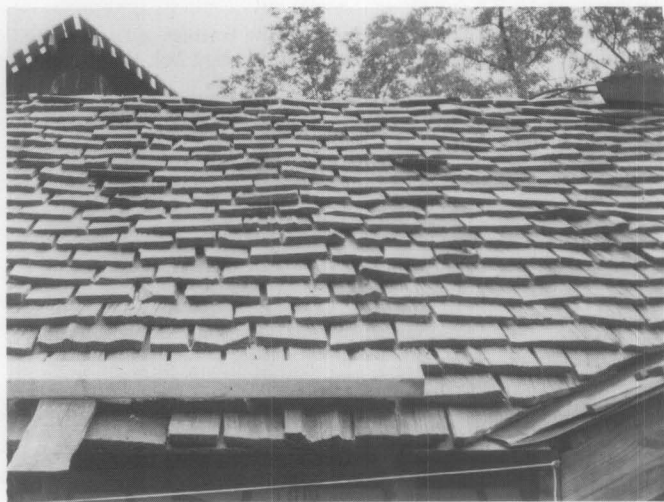
15. These commercially available roofing products with rustic split faces are not appropriate for historic preservation projects. In addition to the inaccurate appearance, the irregular surfaces and often wide spaces between shingles will allow wind-driven moisture to penetrate up and under them. The excessively wide boards will tend to cup, curl and crack. Moss, lichens and debris will have a tendency to collect on these irregular surfaces, further deteriorating the roofing. Photo: Sharon C. Park.

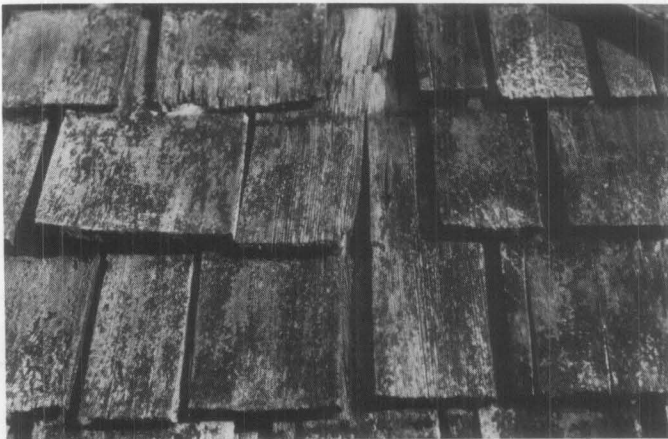
16. Routine maintenance is necessary to extend the life of the roof. On this roof, the shingles have not seriously eroded, but the presence of lichens and moss is becoming evident and there are a few cracked and missing shingles. The moss spores should be removed, missing shingles replaced, and small pieces of metal flashing slipped under cracked shingles to keep moisture from penetrating. Photo: Williamsport Preservation Training Center.

Periodic maintenance inspections of the roof may reveal loose or damaged shingles that can be selectively replaced before serious moisture damage occurs (see illus. 16). Keeping the wooden shingles in good condition and repairing the roof, flashing and guttering, as needed, can add years of life to the roof.
