Mulch Filter and Resorption Trench for Onsite Greywater Managment

Report from a demo-facility built in
Kimberly, South Africa.

Peter Ridderstolpe
2007-02-12

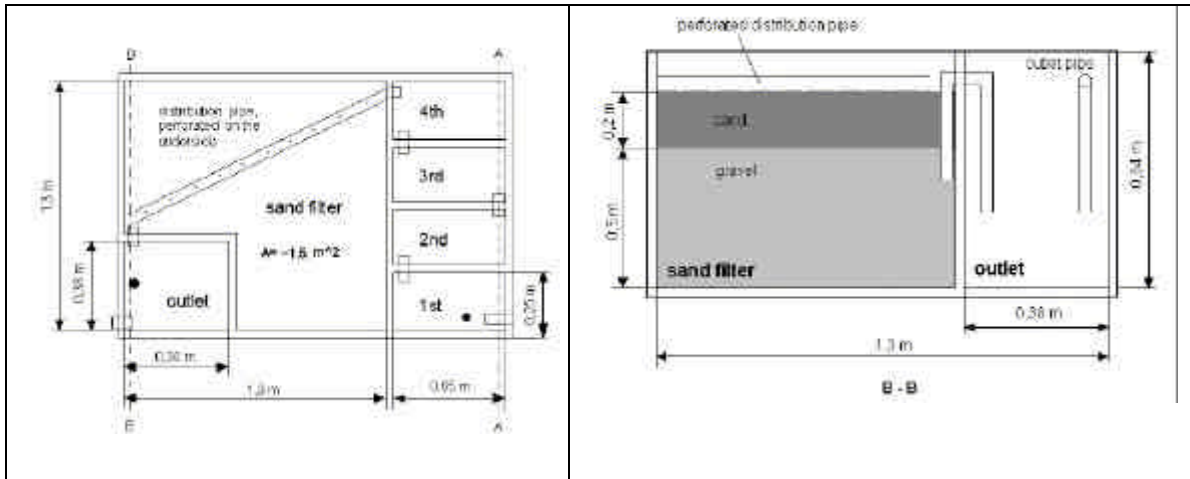
Figure 2 and 3. Plan and section of treatment unit. Water is flowing by a serial of small chambers the last one filled with sand and gravel. As seen from the section water outlet is near ground making all the volumes to be saturated with water (drawing from Källarfelt&Nordberg 2004)

The arrangement of the outlet pipe resulted in the whole system being saturated with water. The sand filter became anaerobic, instead of aerobic as planned. The size of the whole treatment unit is 1,95 m x 1,3 m x 0,84 m corresponding a volume of about 2,2 m³ (figure 2 and 3).

A submerged sand/gravel filter, as the one constructed in Eco-village function as an anaerobic biological reactor. As such, both straining and capacity for biological treatment is expected to be low. Design of a limited volume, where the large part was filled with grease, oil, sand and gravel make volume for treatment and the retention time minimal. Under these circumstances, smelling water and very little removal of BOD removal is to be expected. Lack of maintenance (removal of sludge) and a load of BOD far exceeding capacity for mineralisation made clogging unavoidable.

The intention it seems is that the sand filter was meant to work as a vertical filter (i.e. with unsaturated flow), but the arrangement of the outlet pipe resulted in a drowned system. Another obvious technical weakness was the use of steel sheets, sensitive to rust, as lid.

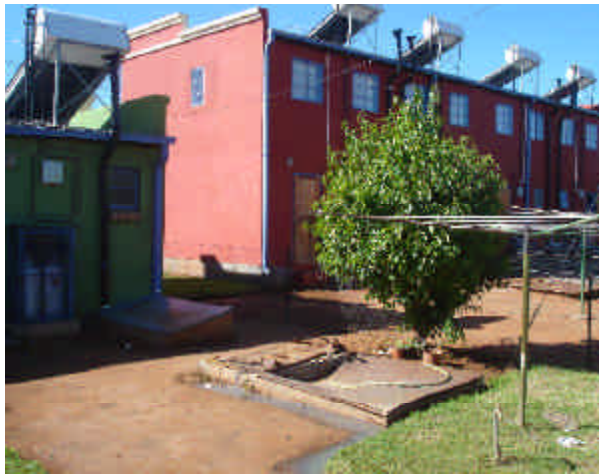
Figure 4. Treatment unit with rusty lid and pounded, May 2006

During visit in May 2006 it was obvious that system had further failed. Blockage in pipes and in filters stopped any grey water being treated or collected in the pond. Instead greywater had to be removed from treatment units by pumping and trucking to the municipal treatment plant. This routine took place once a week. Picture below (figure cc) shows a pounded unit before emptying. As seen from the picture the lid

covering the treatment units is weathered and partly cracked. (Also the lid of the big urine tank was rusty and had turned to deadly trap for children and animals. The pond was also found to be very dangerous for drowning since it was deep and constructed with very steep sides. In the picture below the nutrient enriched grey- and storm water in the pond is seen.

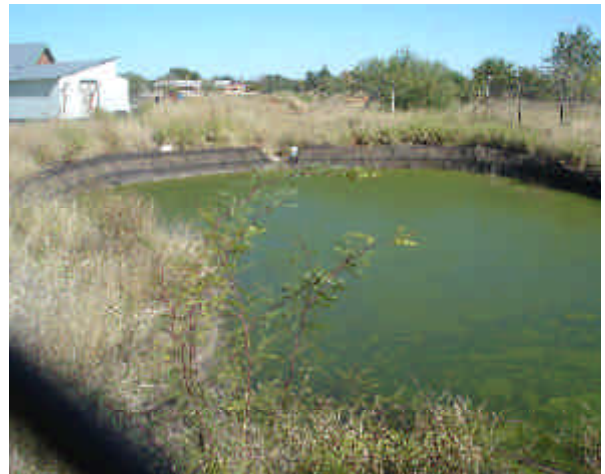
Figure 5. Pond enriched with nutrient from earlier collected greywater, May 2006

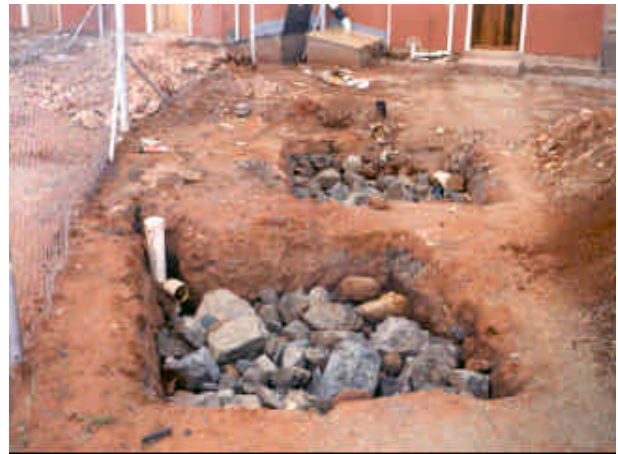
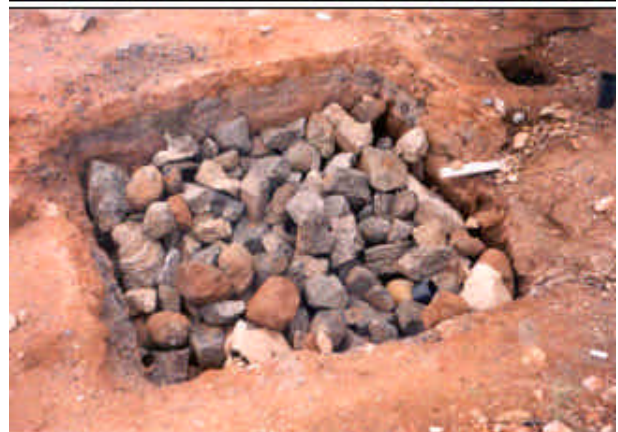
Figure 7. Greywater (and the urine) discharged in soakaway pits outside houses (Källarfelt& Nordberg 2004)

In Hull Street a very simple solution for greywater (and urine) management was chosen. As seen in pictures below, the greywater (and the urine) was simply led to soakaway , about 1 m³ in size outside houses (figure cc). This solution was said to be temporary until better options had been found (Källarfelt & Nordberg 2004).

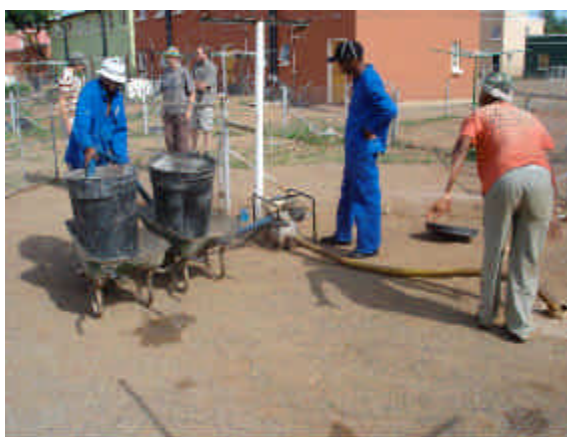
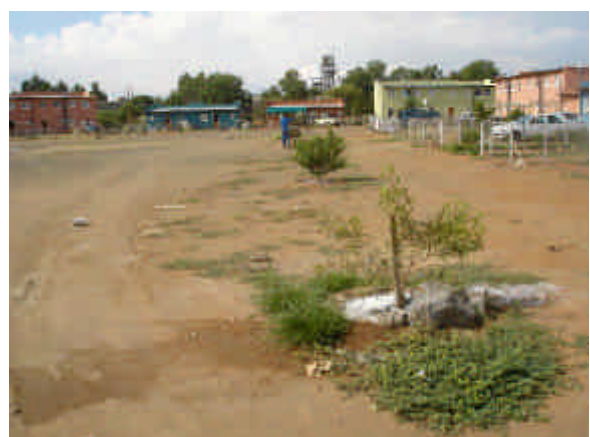
Figure 8 and 9. Greywater sucked from soakaway pits and

.... used for irrigation to trees planted in the yard (Jan 2006) .

Soon after taking the systems into operation, the soakaway pits started to fill with water. In April 2004, it was concluded that some pits where filled with water and the infiltration capacity seemed to be reduced by a biomat (Källarfelt & Nordberg, 2004). In January 2006, infiltration capacity had been reduced to the extent that no or very little water was infiltrated. Instead one had been forced to empty greywater by a pump. The water was carried in container by wheel barrel and used for irrigating young trees that were planted in the yard (Figures 8 and 9).

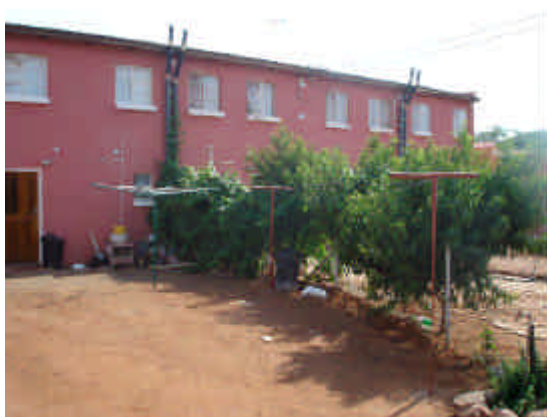
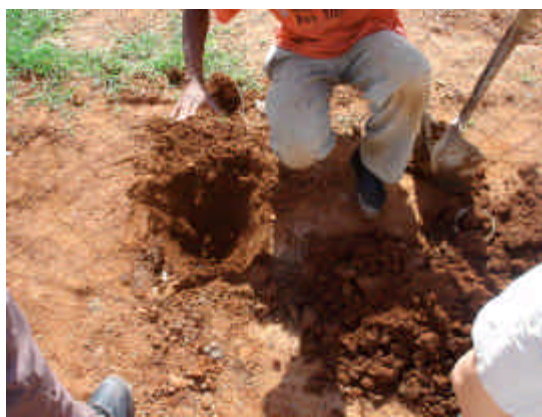
Figure 10 and 11. Infiltration trenches for greywater disposal and reuse was also tested but after some month soil start to clog.

Further temporary solutions were implemented and included, infiltration trenches for greywater disposal and reuse. Shallow trenches were dug along the fence between houses and filled with gravel and small stones. A plastic liner was used to protect gravel from refilled soil. Greywater from kitchen and bathroom was led to the trench by a pipe ended up in gravel in the beginning of the trench, Figures 10 and 11.

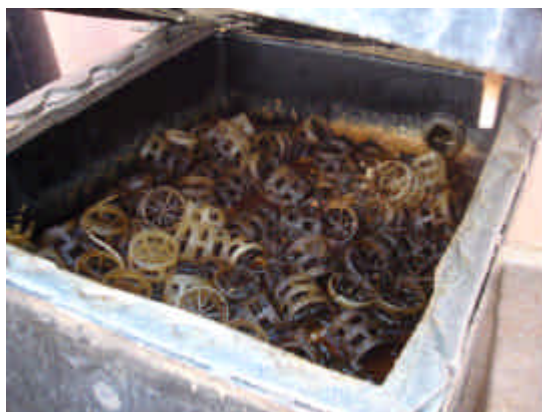
Figure 12. In some houses grease traps was installed for kitchen water. The grease traps was filled with plastic materials for carrying bio film and several so-called bio cultures was tested to improve degradation of trapped sludge.

In some houses with pounded soakaway pits, grease traps were installed for kitchen water, figure 12. The idea was that these traps should protect soil from clogging. The grease traps were filled with plastic materials for carrying bio film and several so-called biocultures were tested to improve degradation of the trapped sludge.

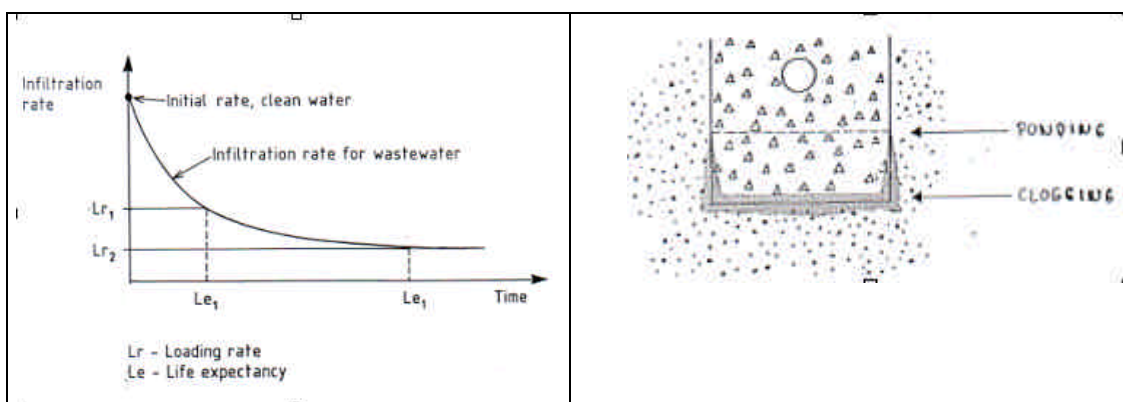
Figur 13. Diagrams showing that bacteria's grow in the upper layer of soil when soil is loaded with wastewater. Due to the clogging effect infiltration capacity decrease by time. In fine texture soils (like loam and clay) infiltration rate for wastewater are near zero (after Jenssen & Siegrist 1990)

It is well documented that the natural infiltration rate in an infiltration system decreases when loaded with wastewater. This is a consequence of the development of

a biofilm at the infiltration surface. This partly fills up and clogs the pores of the surface. Figures 13 and 14 illustrate the change in infiltration rate when a soakaway start to be loaded with wastewater. Sandy or sandy loamy soil fed by normal waste water septic tank effluent usually reaches a long term infiltration rate of about 15 to 20 mm per day. A clayish soil, like the ones in Hull Street, reaches no steady state. A slimy anaerobic biofilm develops and soon or later the infiltration surface is totally blocked and infiltration capacity is for practical purposes zero. Therefore it was logical that the trials with soakaway pits and infiltration trenches has not been successful.

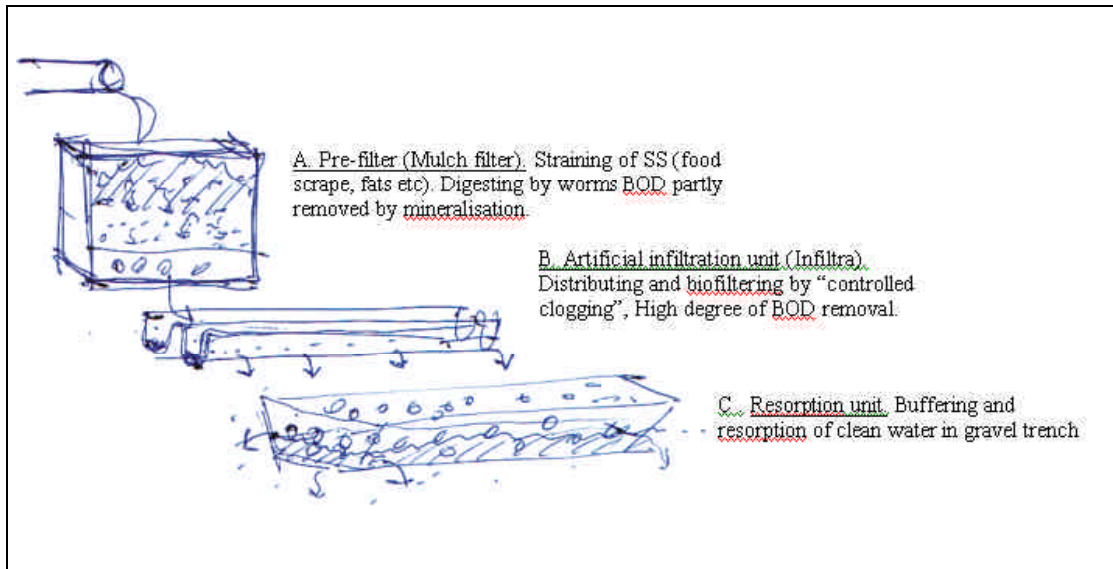
Figure 15. The three treatment units suggested for on site greywater handling in Hull Street.

The solution suggested was to build the mulch filter unit with the main objective to perform only the pre-treatment processes (mechanical straining of solids in mulch media and digestion of the organic by invertebrates (e.g. earth worms). The main part of the biological treatment (mineralisation) was suggested to be carried out in a biofilm in an artificial media after the mulch filter. The artificial media was suggested to be constructed according the Infiltra concept (Ridderstolpe 2004). Below the principle for handling system is outlined, Figure 15

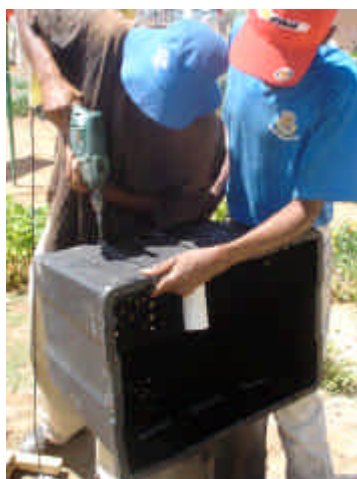
Drilling holes in containers for drainage and aerating filter

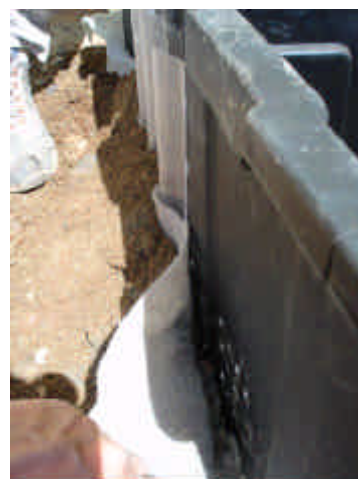
Holes in container wall to let filter communicate with soil

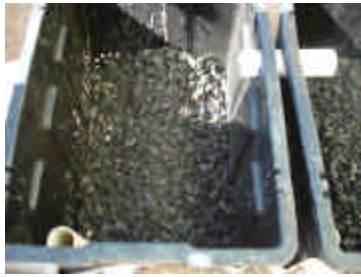
Drainage layer in filter

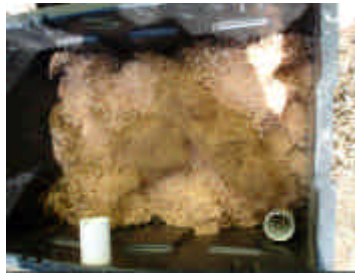
Inspection pipes in mulch

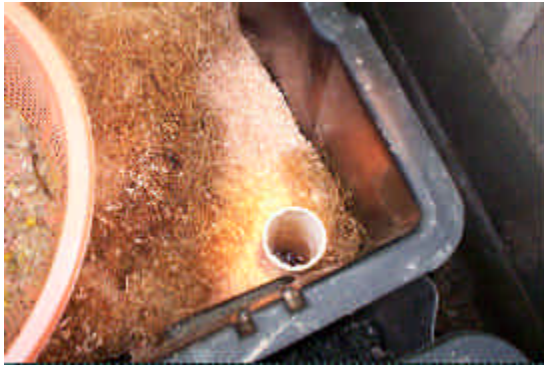
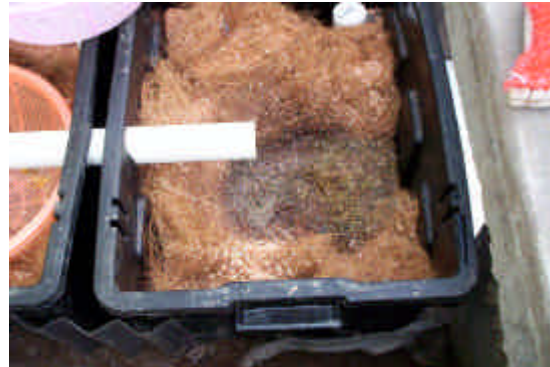
Rain start in January. No signs of anaerobic conditions in prefilter. Increased water level observed in monitoring pipe in resorption. Also some smell was observed from inspection box and monitoring pipe in resorption filters (Photo 02-25 M v d Molen).

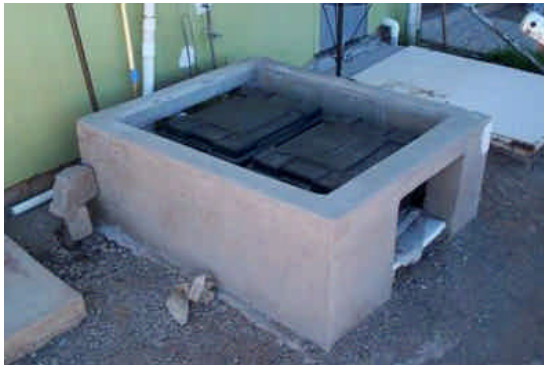
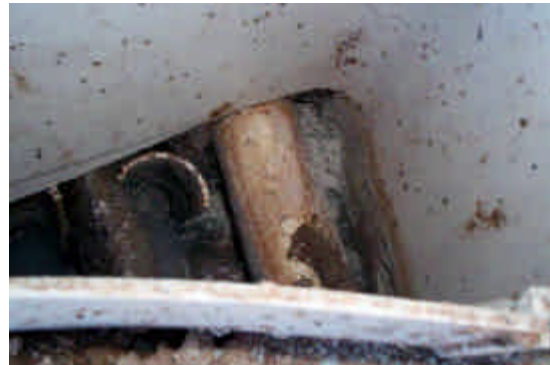
Superstructure and the contours made on facility protected it from storm water At right shower pipe entering inspection box (Photos 0302 from M v d Molen).

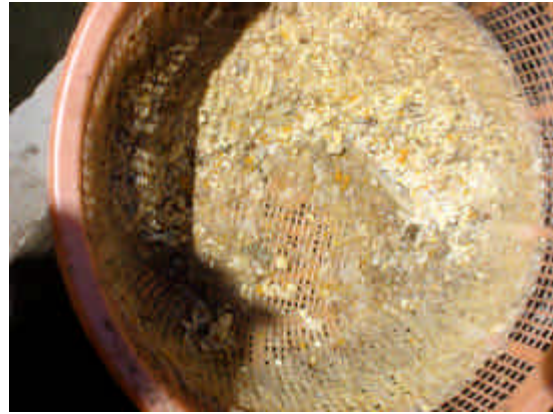
Basket one month without emptying

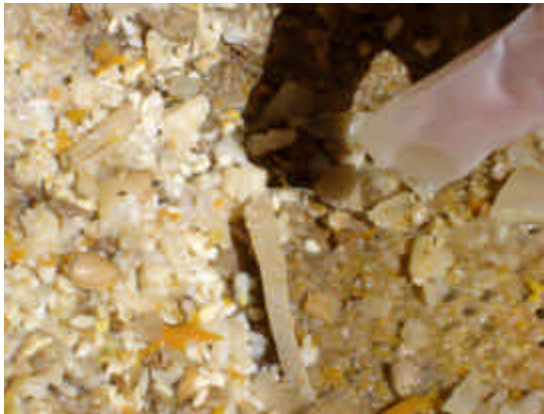
Debris in different degrees of degradation

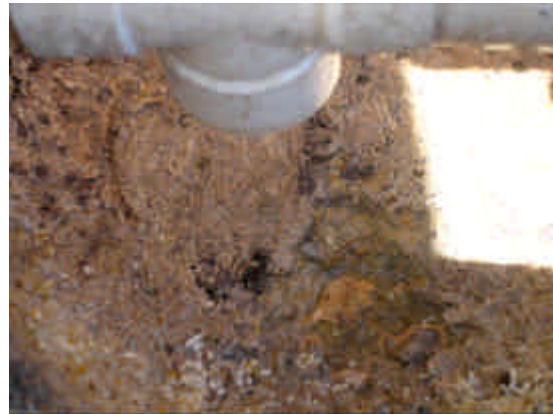
Under basket: strained particles and light coloured slime, no smell

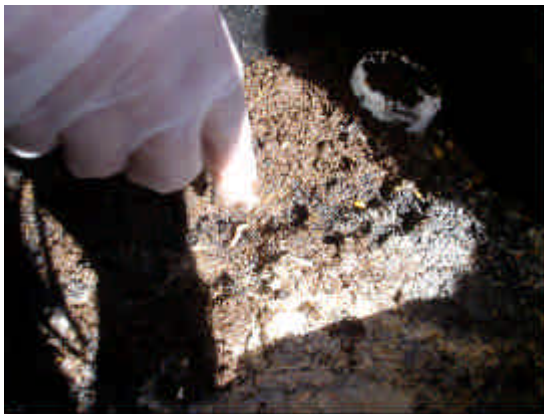
10 cm down in mulch: Brownish slime on mulch. First worm found

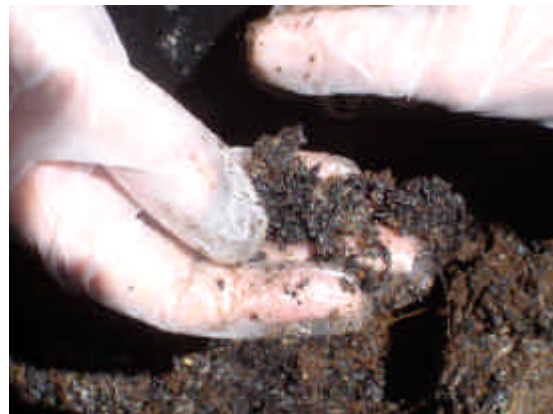
20 cm down: Still brownish well structured mulch. Eggs from worms found

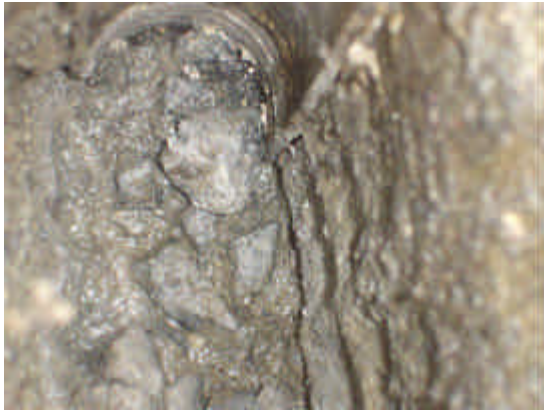
Bottom of Infiltra seen by inspection box: Grey and healthy biofilm. Some maggots, no sign of anaerobic

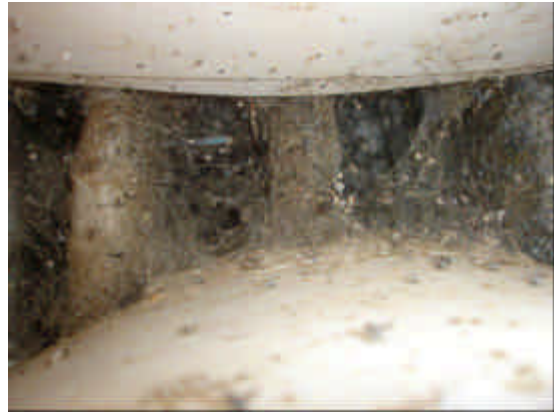
Infiltra layer seen in inspection box. No pounding of water, some slime and residuals in bottom of valleys. Small spiders

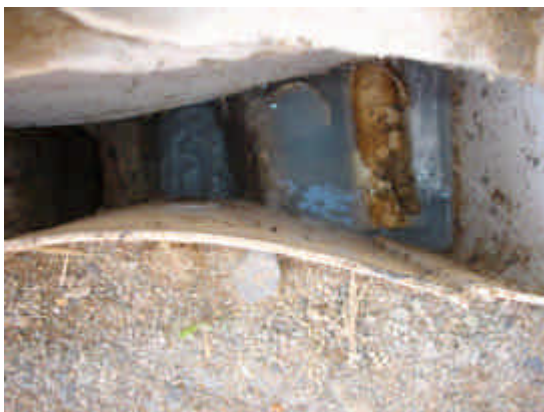
Water from shower entering from pipe in the right valley of Infiltra, flooding from valley to valley. Red colour from flocculated iron salts

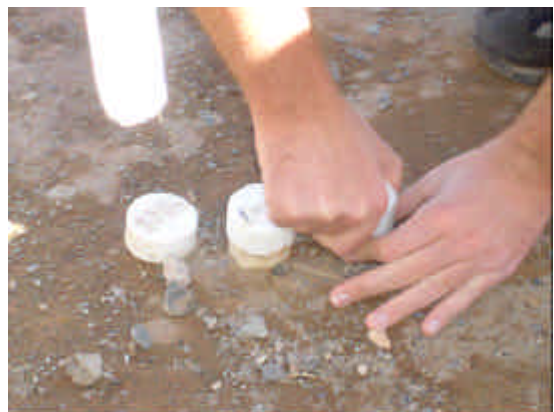
Checking the end of the valleys in Infiltra. No water found in valleys. No bacteria film nor flocks on textile.

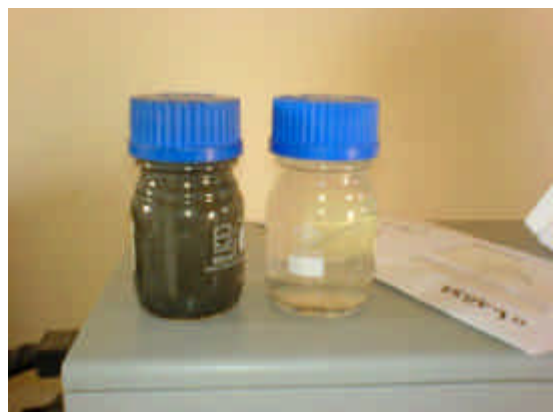
Water after prefilter (left) and after Infiltra (right)

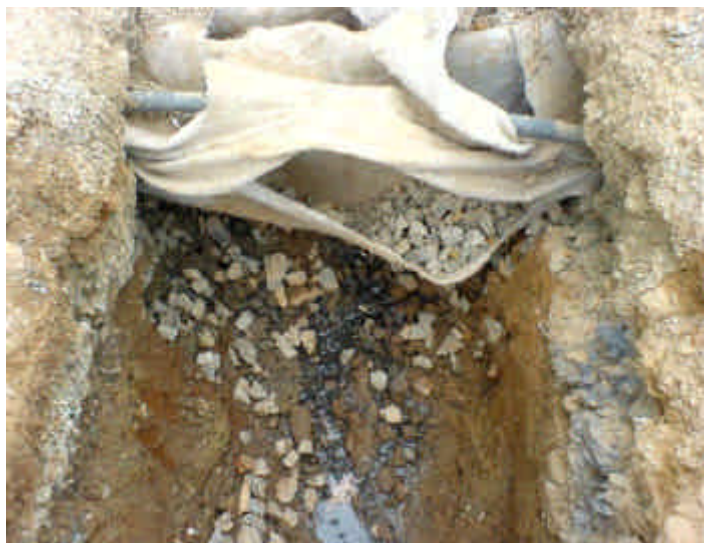
Gravel and textile looked unused

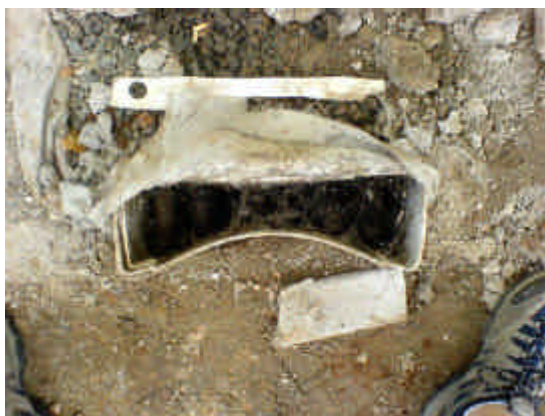
No signs of clogging beneath containers
