THE SECRETARY OF THE INTERIOR'S STANDARDS FOR THE TREATMENT OF HISTORIC PROPERTIES

WITH
**GUIDELINES FOR
PRESERVING,
REHABILITATING,
RESTORING &
RECONSTRUCTING
HISTORIC
BUILDINGS**

U.S. Department of the Interior
National Park Service
Technical Preservation Services

2017

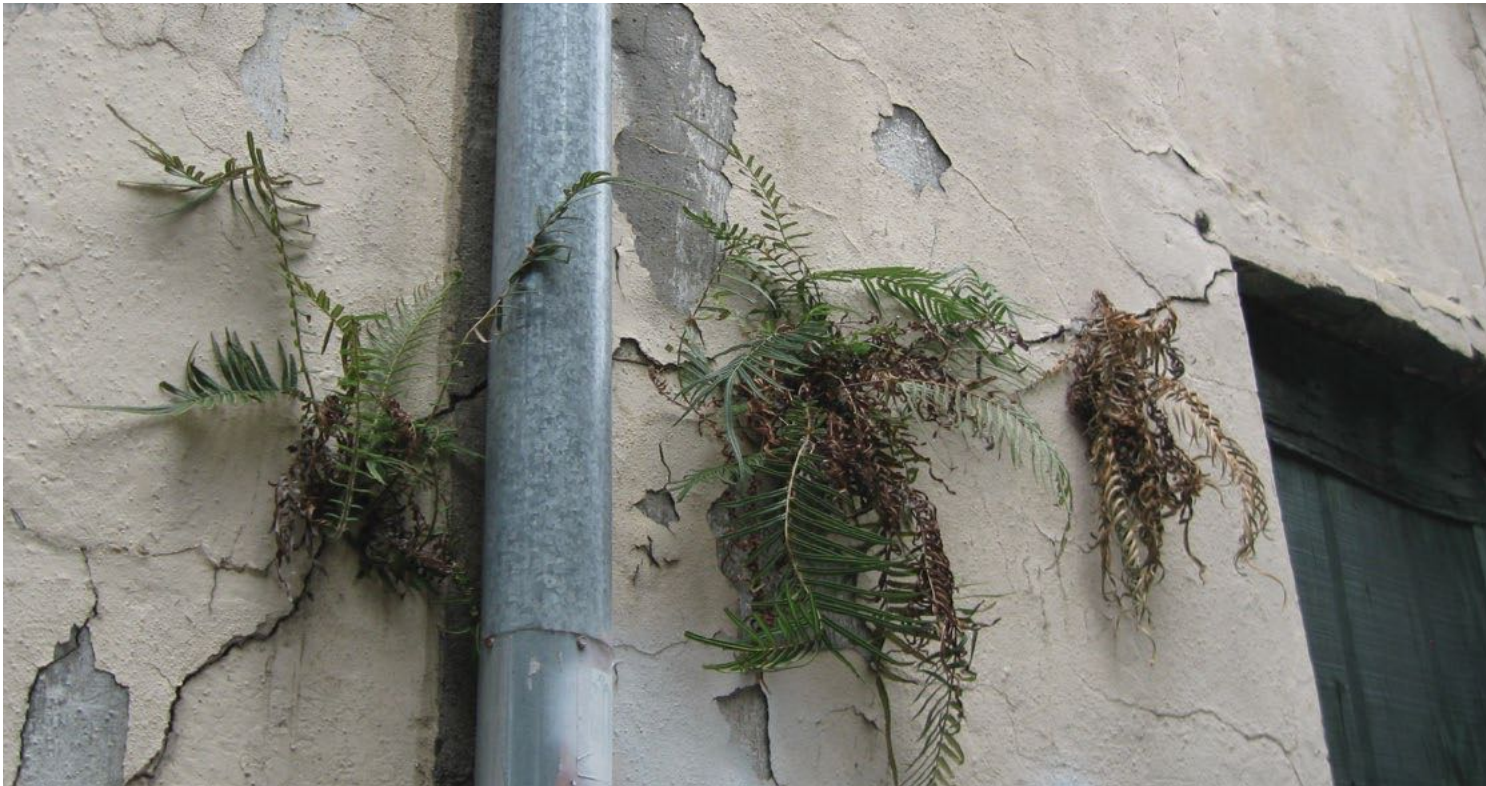
[3] **Not Recommended:** Cracks in the stucco have not been repaired, thereby allowing ferns to grow in the moist substrate which will cause further damage to the masonry.

Repairing stucco by removing the damaged material and patching with new stucco that duplicates the old in strength, composition, color, and texture.	Removing sound stucco or repairing with new stucco that is different in composition from the historic stucco. Patching stucco or concrete without removing the source of deterioration. Replacing deteriorated stucco with synthetic stucco, an exterior insulation and finish system (EIFS), or other non-traditional materials.
Using mud plaster or a compatible lime-plaster adobe render, when appropriate, to repair adobe.	Applying cement stucco, unless it already exists, to adobe.
Sealing joints in concrete with appropriate flexible sealants and backer rods, when necessary.	Repointing masonry units (other than concrete) with a synthetic caulking compound instead of mortar.

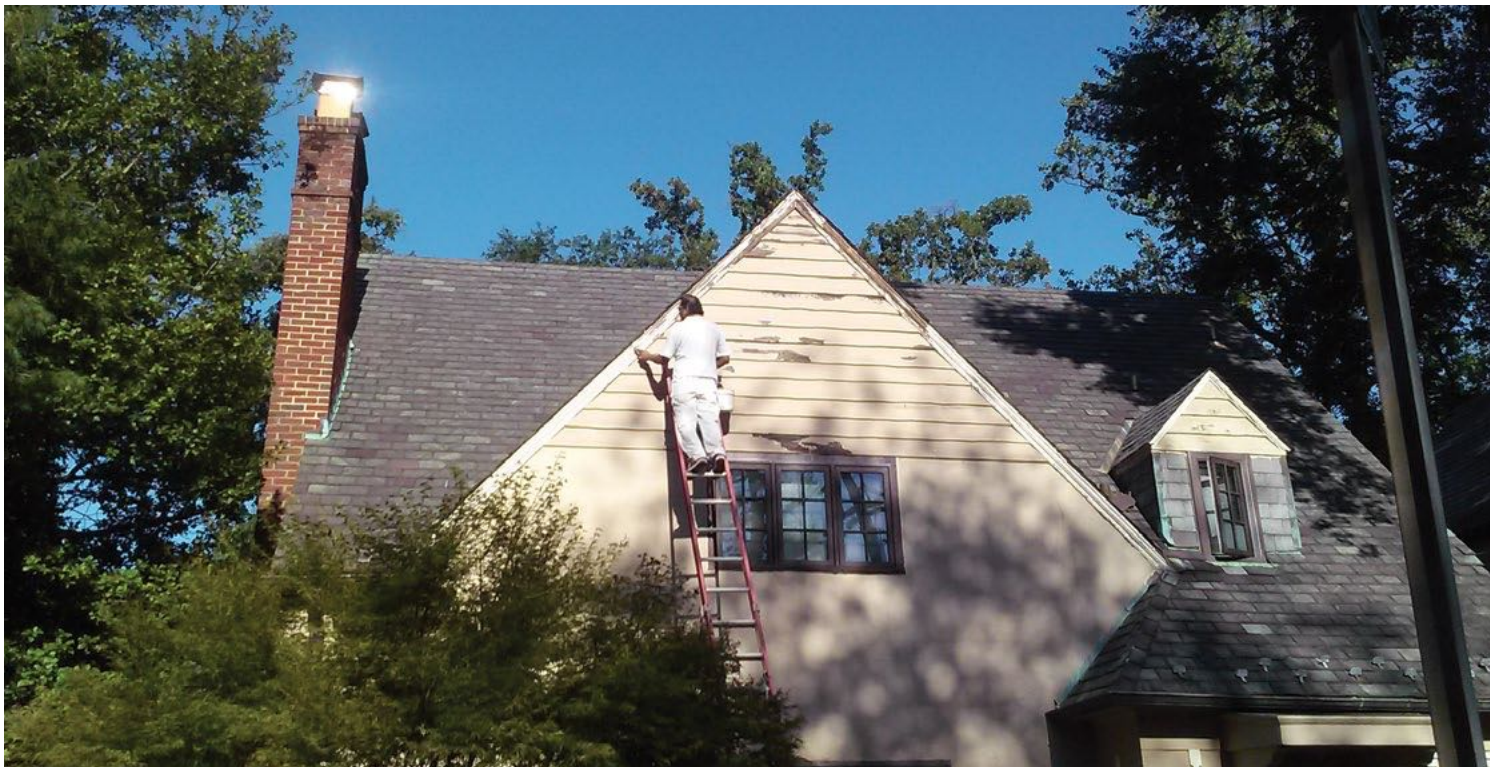
[4] Hand scraping to remove peeling paint from wood siding in preparation for repainting is an important part of regularly-scheduled maintenance.

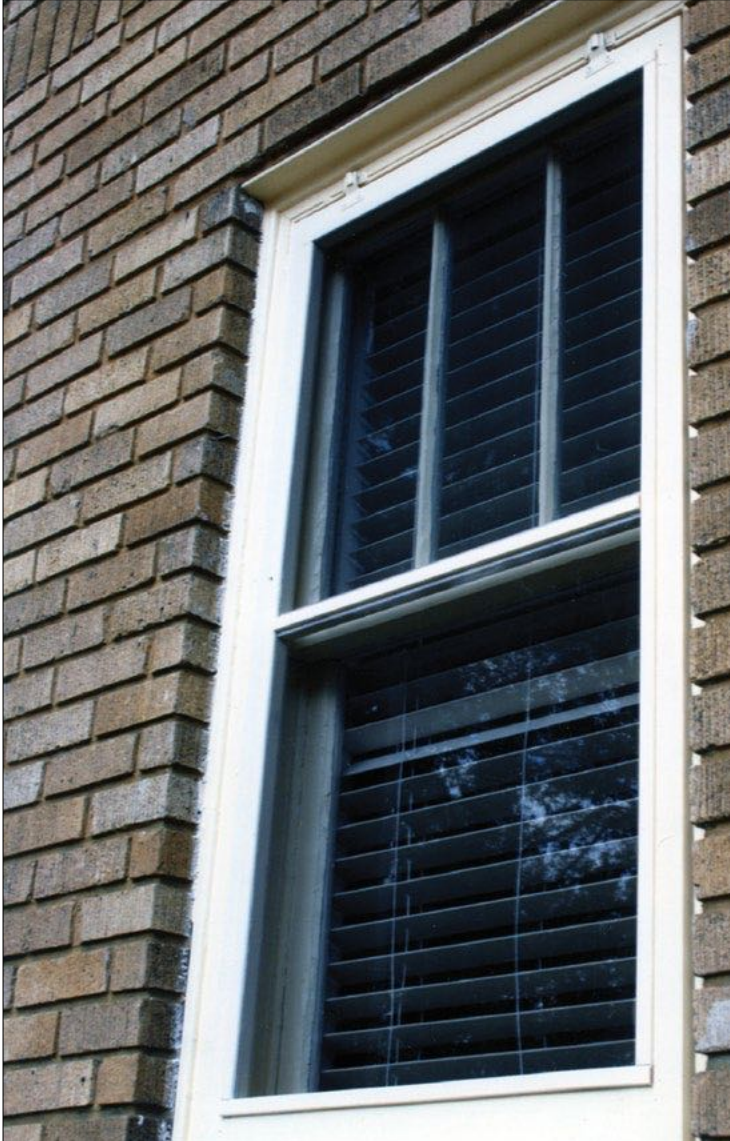
[10] Historic exterior storm windows preserve and help to insulate wood windows.

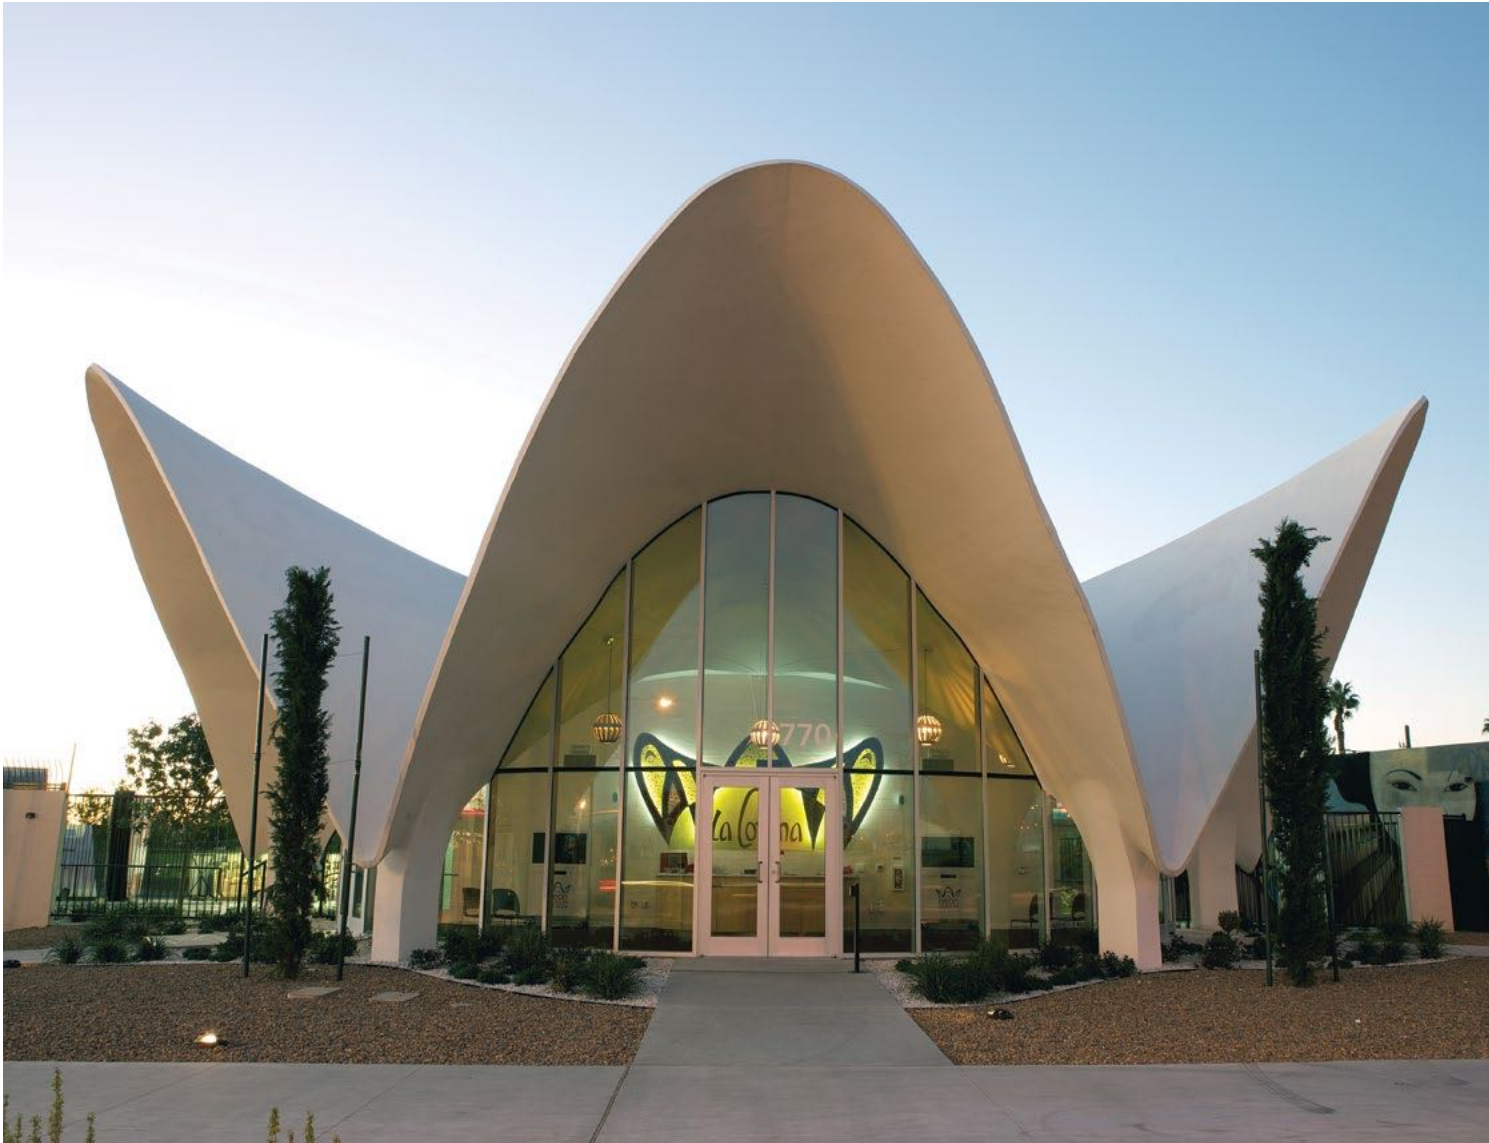
[2] Mid-century modern building technology made possible the form of this parabolic-shaped structure and its thin concrete shell construction. Built in 1961 as the lobby of the La Concha Motel in Las Vegas, it was designed by Paul Revere Williams, one of the first prominent African-American architects. It was moved to a new location and rehabilitated to serve as the Neon Museum, and is often cited as an example of Googie architecture. *Credit: Photographed with permission at The Neon Museum, Las Vegas, Nevada.*

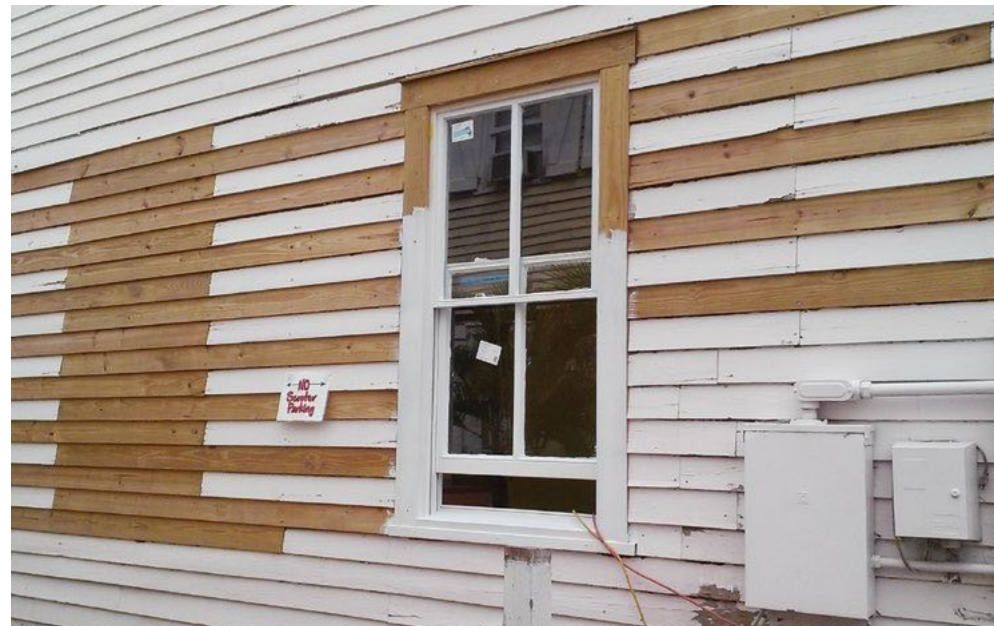
[8] Rotted clapboards have been replaced selectively with new wood siding to match the originals.

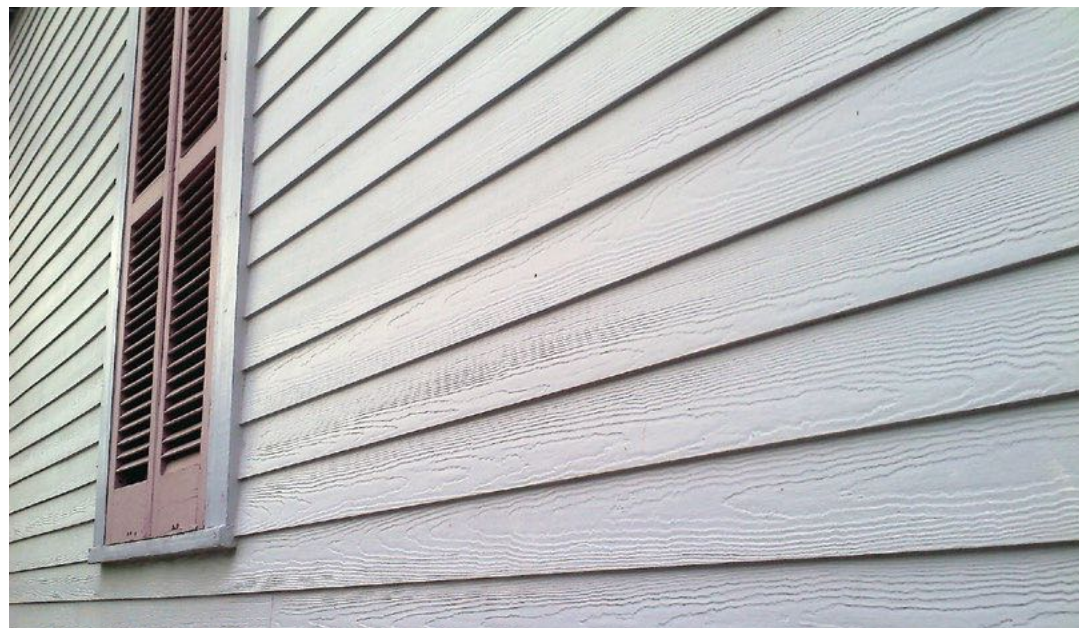
[10] **Not Recommended:** Cementitious siding with a raised wood-grain texture is not an appropriate material to replace historic wood siding, which has a smooth surface when painted.

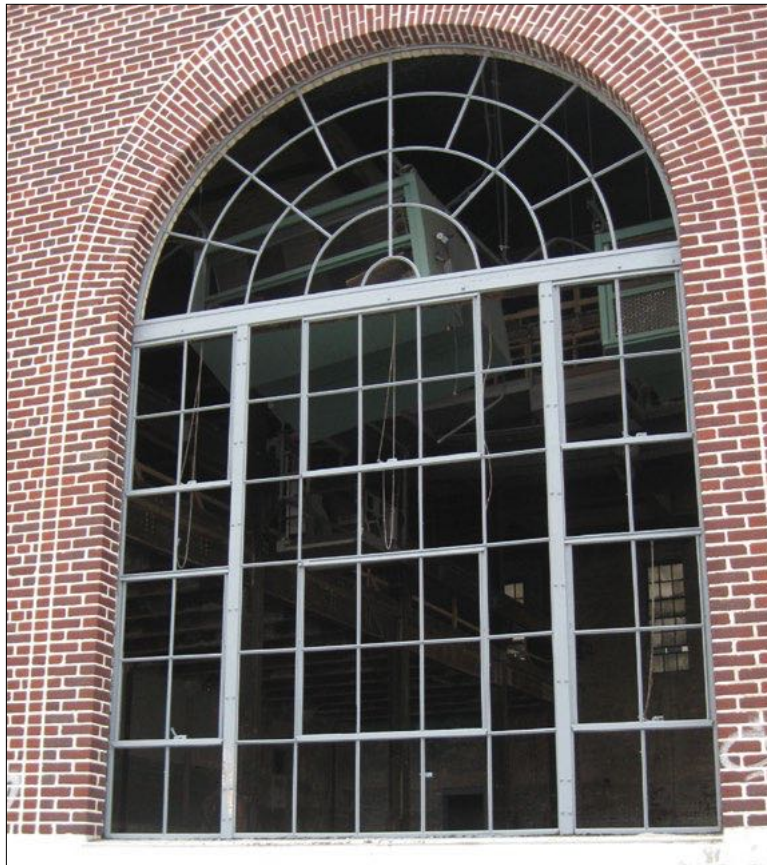
[12] This historic steel window has been cleaned, repaired, and primed in preparation for painting and reglazing.

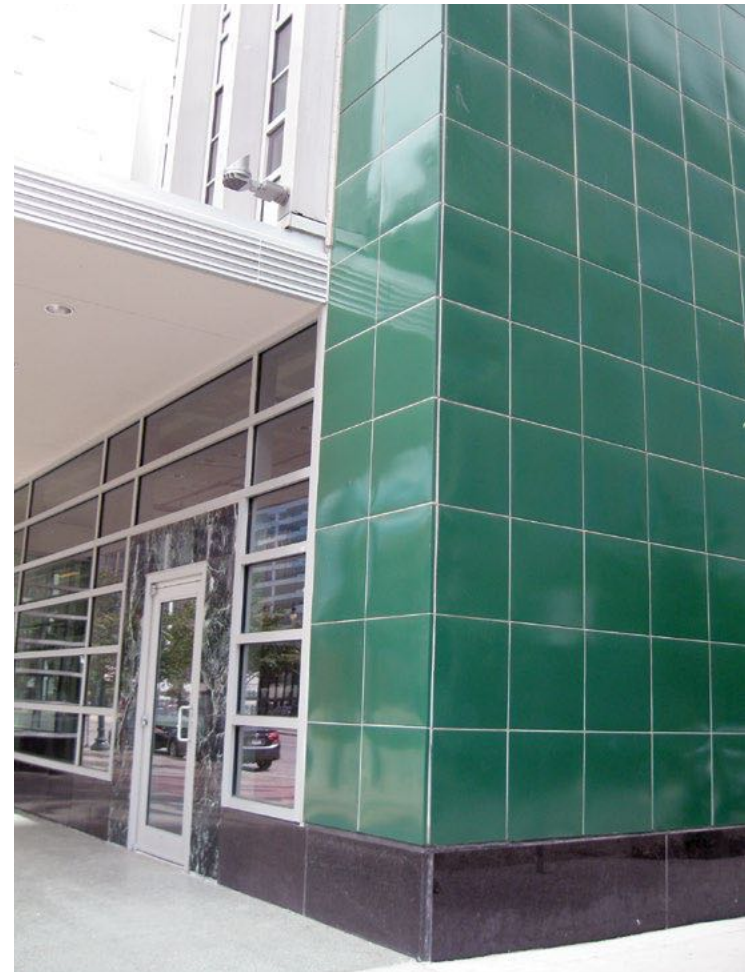
[15] New enameled-metal panels were replicated to replace the original panels, which were too deteriorated to repair, when the storefront of this early 1950s building was recreated.

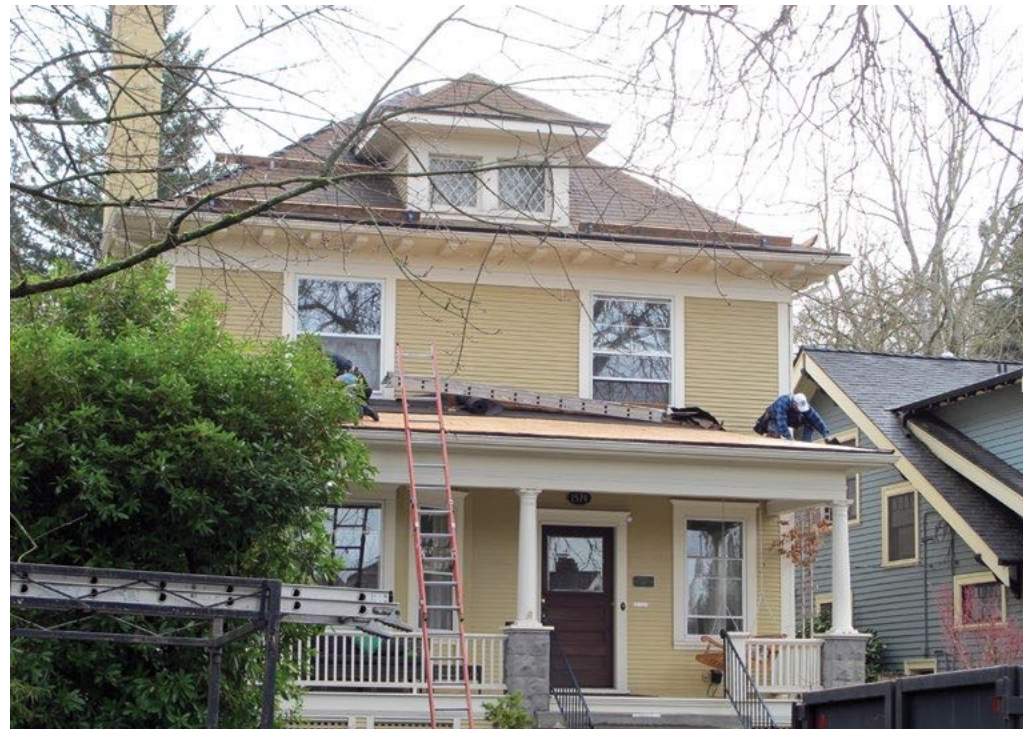
[16] The deteriorated asphalt shingles of this porch roof are being replaced in kind with matching shingles.

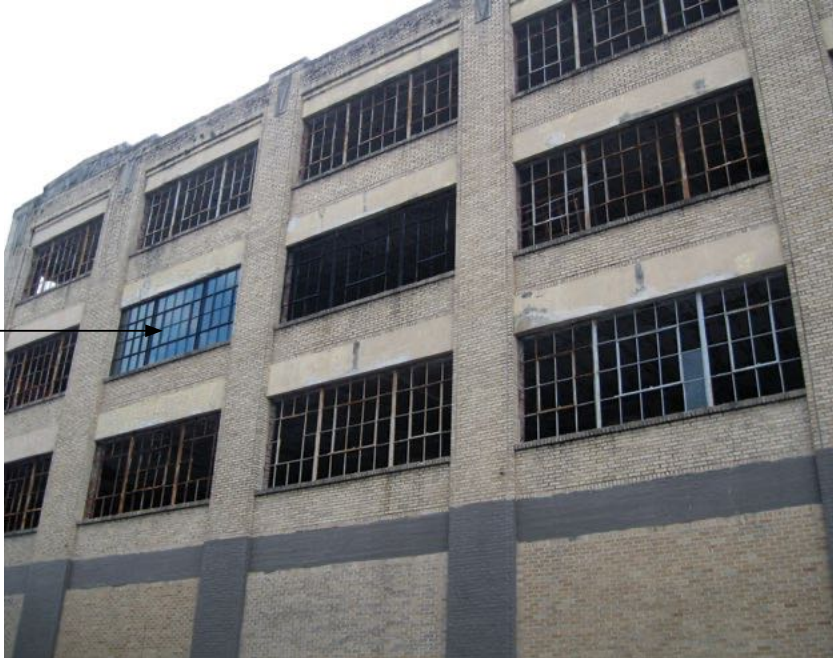
[19] Installing a mockup of a proposed replacement window can be helpful to evaluate how well the new windows will match the historic windows that are missing or too deteriorated to repair.

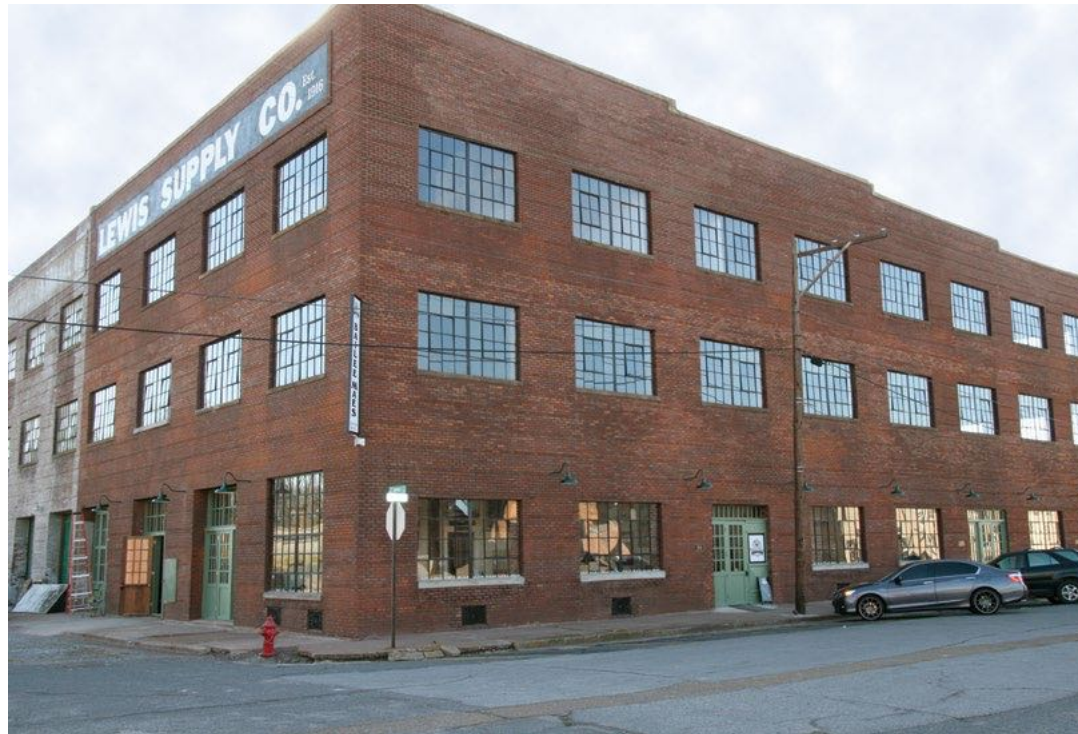
[20 a-d] The original steel windows in this industrial building were successfully repaired as part of the rehabilitation project (left).

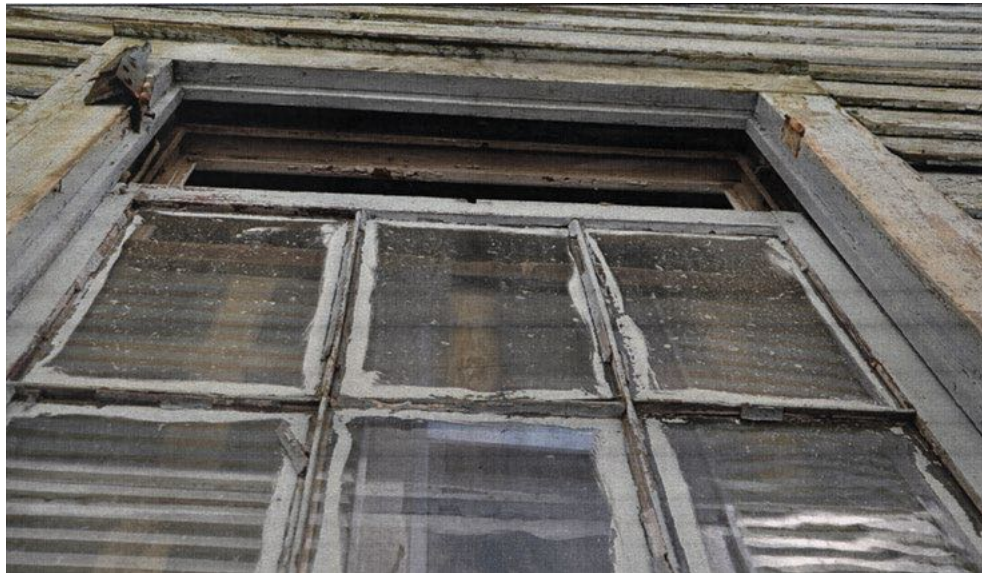
[23] (a) This deteriorated historic wood window was repaired and retained (b) in this rehabilitation project.

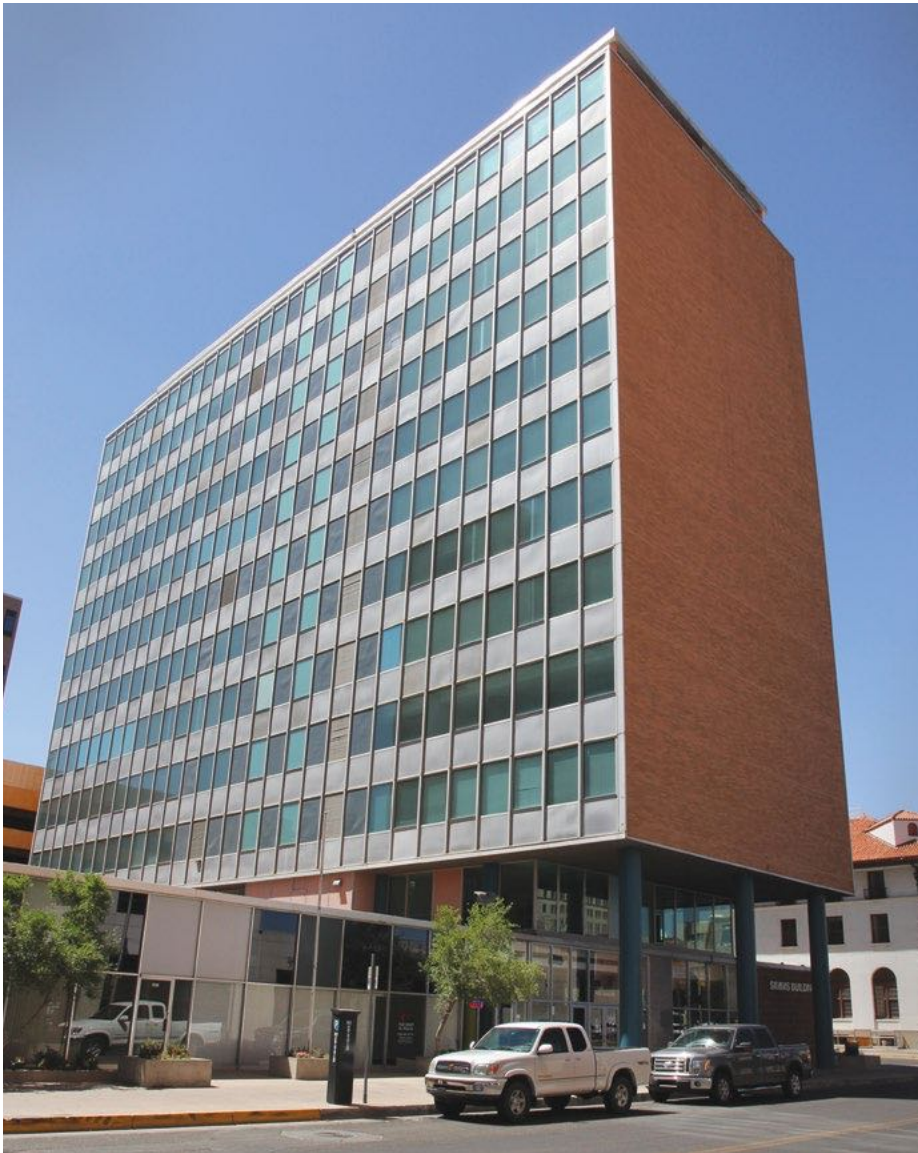
[30] Rather than replace the original curtain wall system of the 1954 Simms Building in Albuquerque, NM, with a different color tinted glass or coat it with a non-historic reflective film, the HVAC system was updated to improve energy efficiency. Photo: Harvey M. Kaplan.

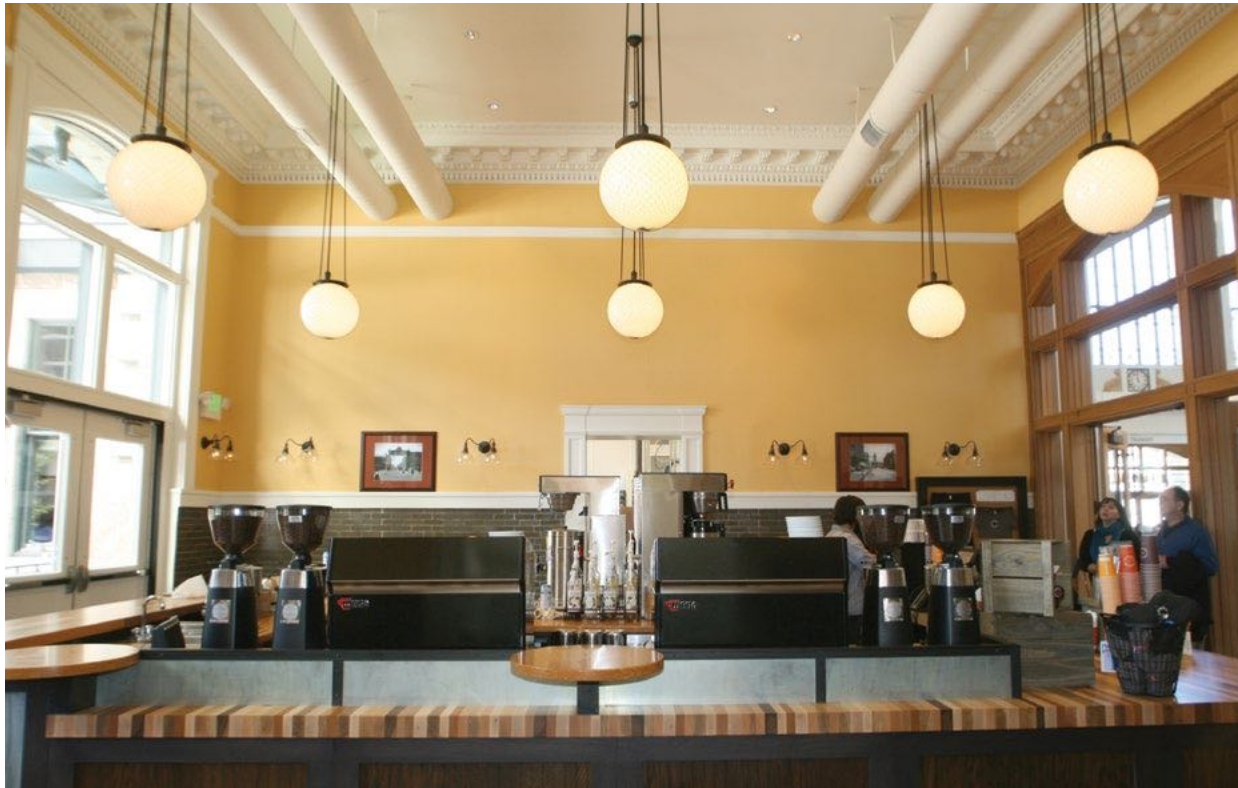
[37] Exposed and painted ducts were appropriately installed here in a retail space in Denver's historic Union Station after considering other options that would have impacted the ceiling height, or damaged or obscured the ornamental plaster crown molding. *Photo: Heritage Consulting Group.*

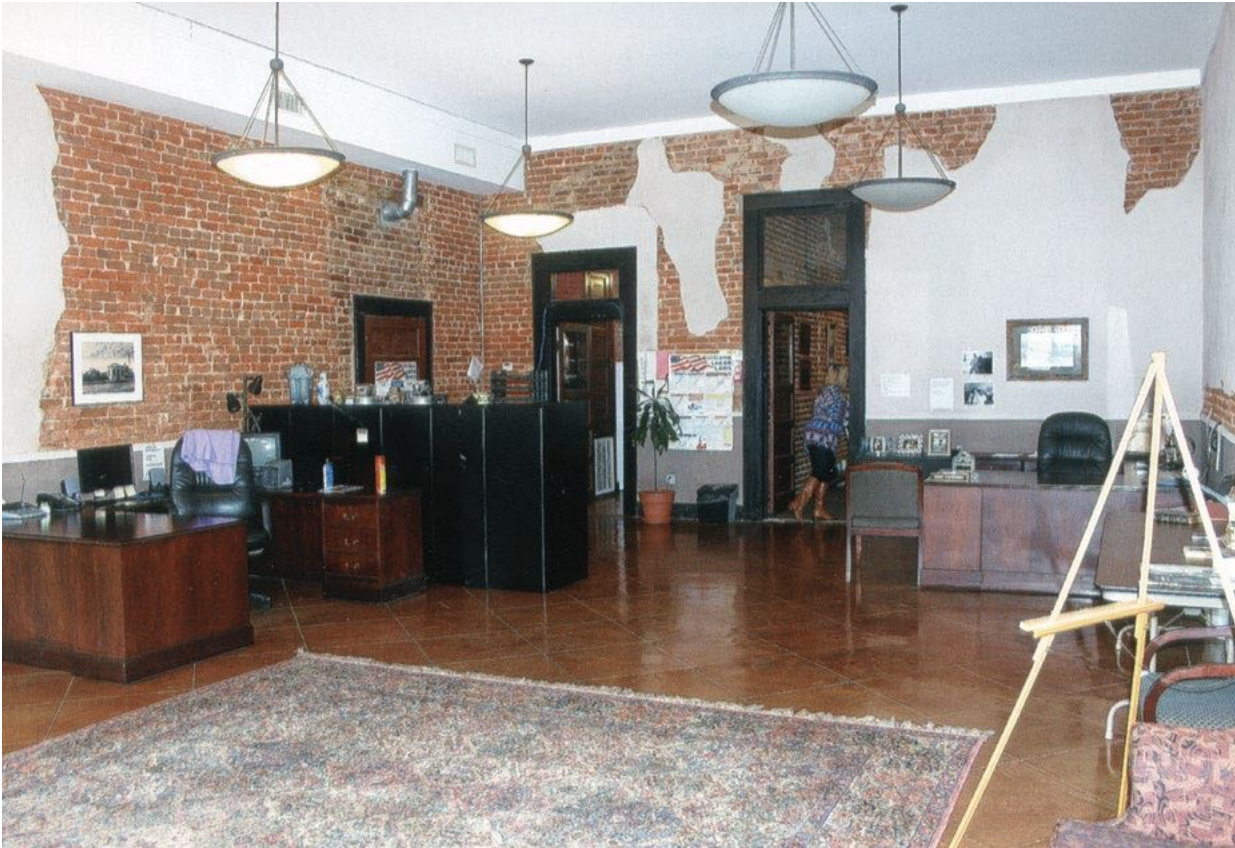
[41] Not Recommended: Leaving fragments of deteriorated or “sculpted” plaster is not a compatible treatment for either finished or unfinished interior spaces.

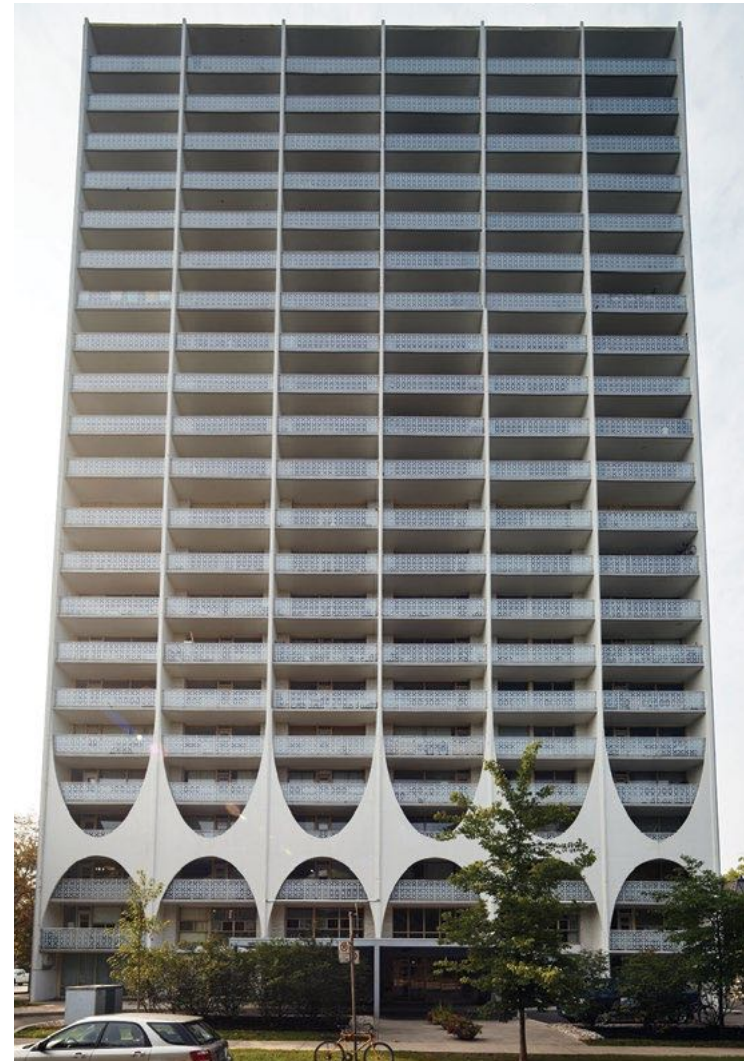
[59] (a-b) The decorative concrete balcony railings on this 1960s building did not meet life-safety code requirements. They were replaced with new glass railings with a fritted glass pattern matching the original design—a creative solution that satisfies codes, while preserving the historic appearance of the building when viewed from the street (c-d). Photos: (a, b, d) ERA Architects, Inc.; (c) Nathan Cyprys, photographer.

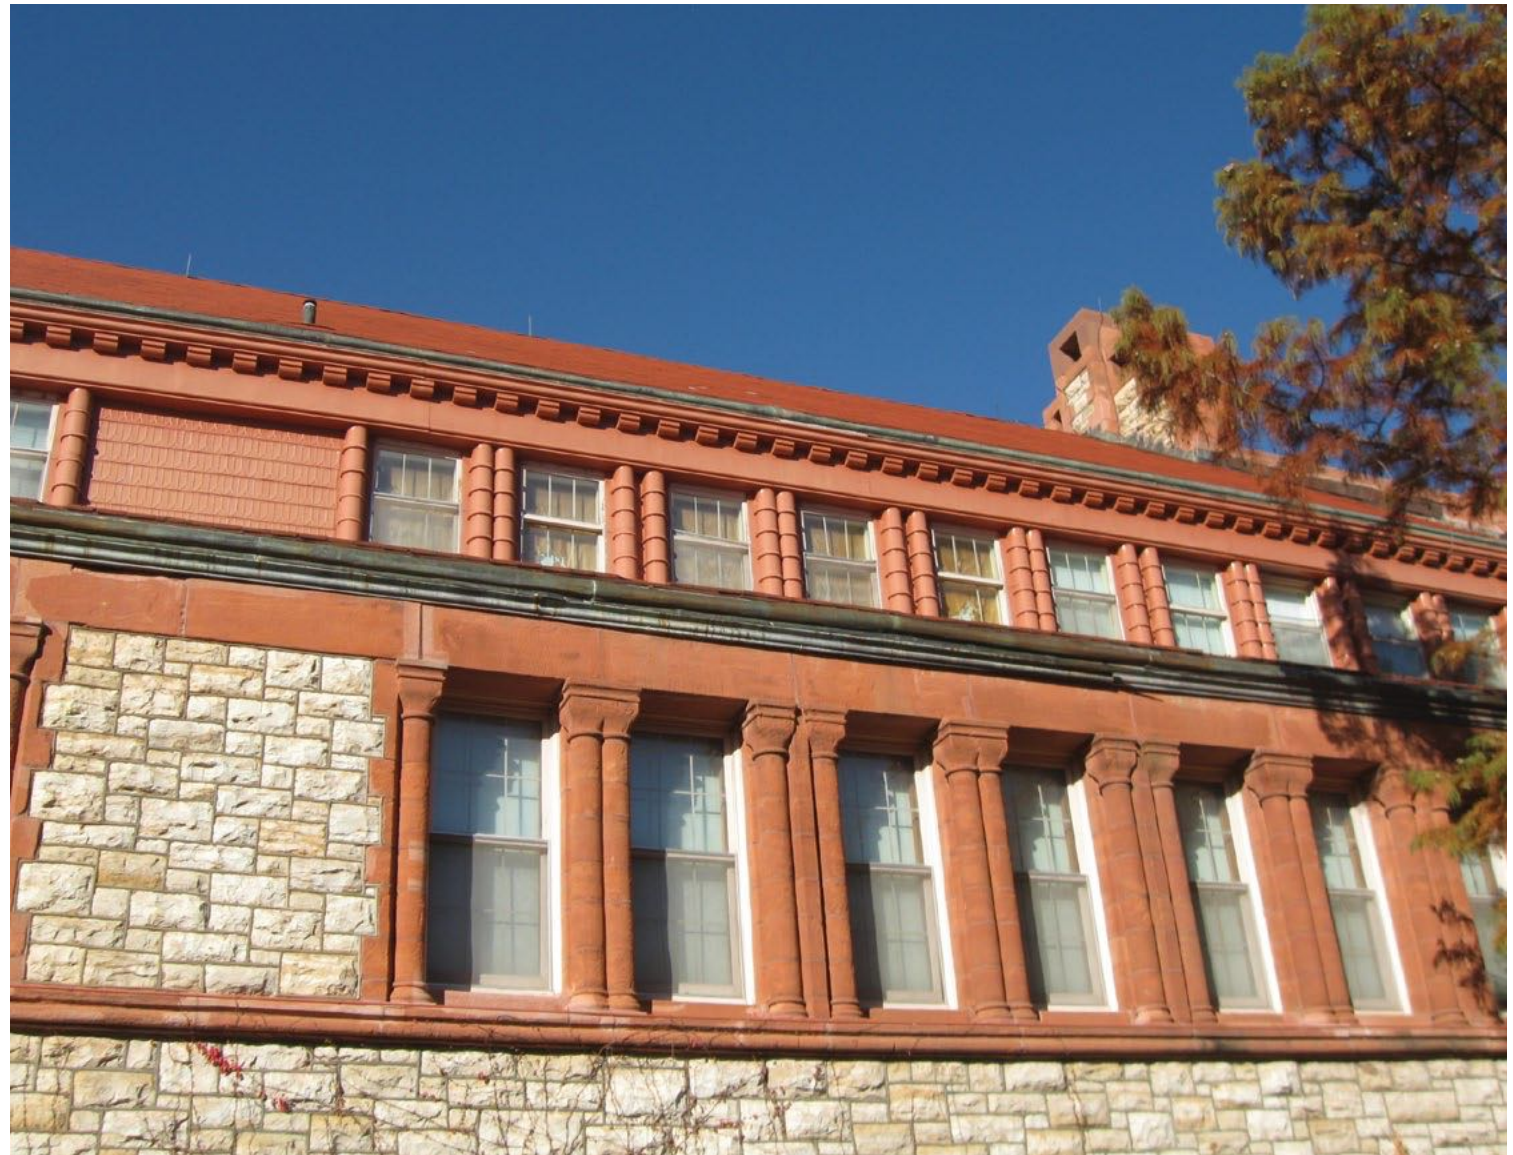
[6] Preliminary work before starting restoration revealed that the columns and the decorative shingles ornamenting the top floor of this historic building were fabricated of metal to imitate the red sandstone used elsewhere on the building.

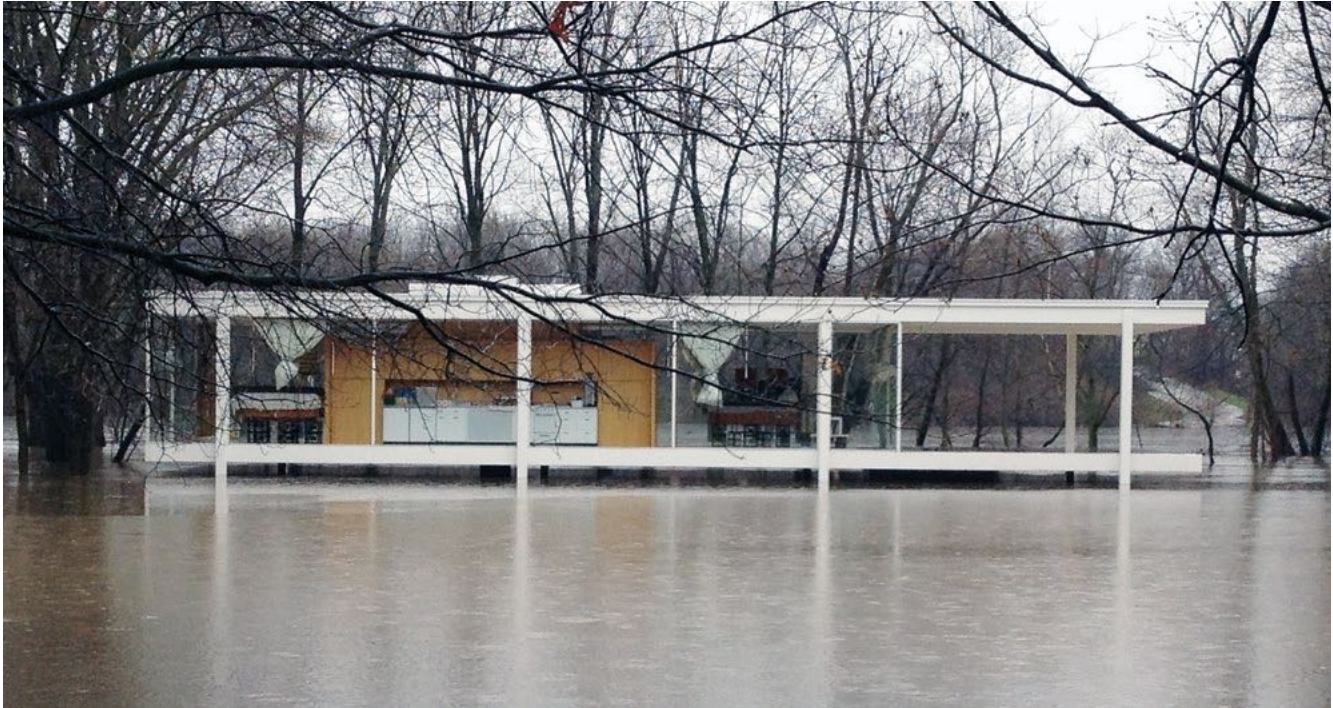
[19] The 1951 Mies van der Rohe-designed Farnsworth House, Plano, IL, was built close to the Fox River, which is increasingly prone to floods. To preserve the house in its original location, historic preservation architects and engineers continue to explore ways to protect it from the flooding, including a possible system that would lift the house above the flood waters and lower it back to the ground. *Photo: Courtesy Farnsworth, A Site of the National Trust for Historic Preservation.*
