Tech Notes

MUSEUM COLLECTIONS

NUMBER 2

Reducing Visible and Ultraviolet Light Damage to Interior Wood Finishes

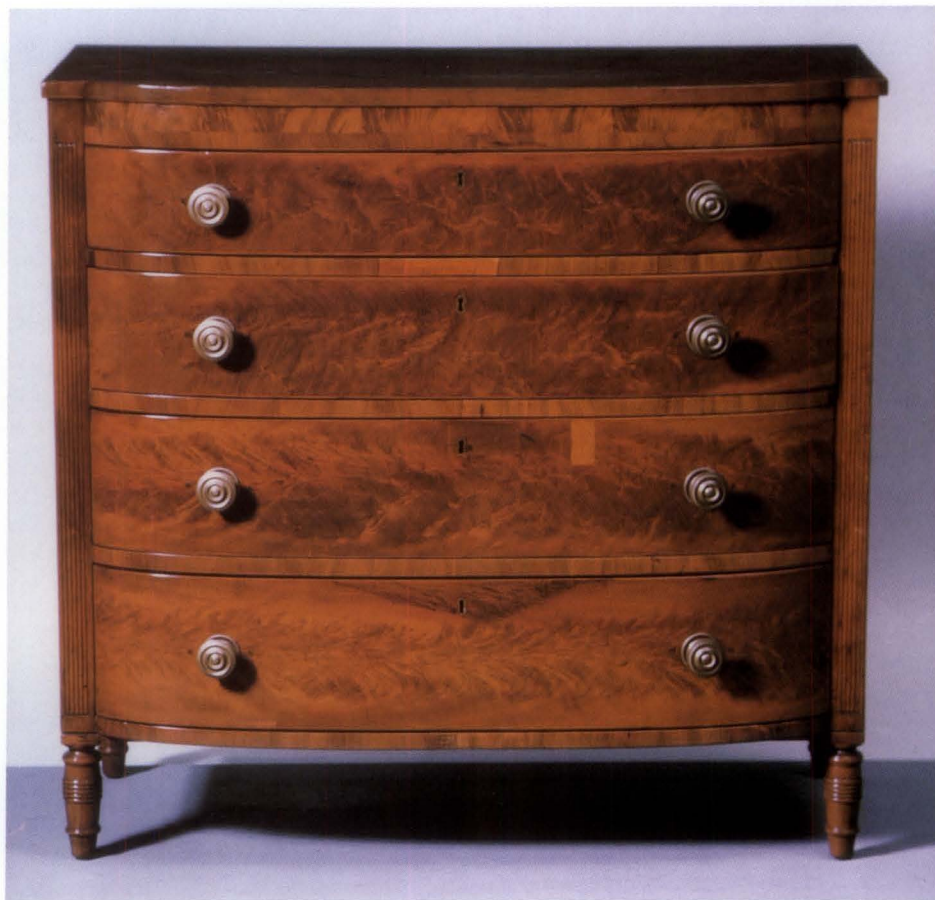
Figure 2. A veneer repair patch, located on the front of the third drawer, has faded from light. This extreme fading is typical of areas where aniline stains have been applied. Photo: Mike Wiltshire, National Park Service.

1. Natural light is damaging to certain types of wood finishes, even in cases of only indirect light exposure.
2. Although only a few aniline dyes were tested, the results strongly indicate that they are extremely light sensitive (see figure 2).
3. Certain oil colors (earthen pigments ground in oil) appear to produce a stable stain that resists fading.
4. UF-3 Plexiglas may shield out most of the ultraviolet light, yet visible light is left largely unfiltered and can be extremely

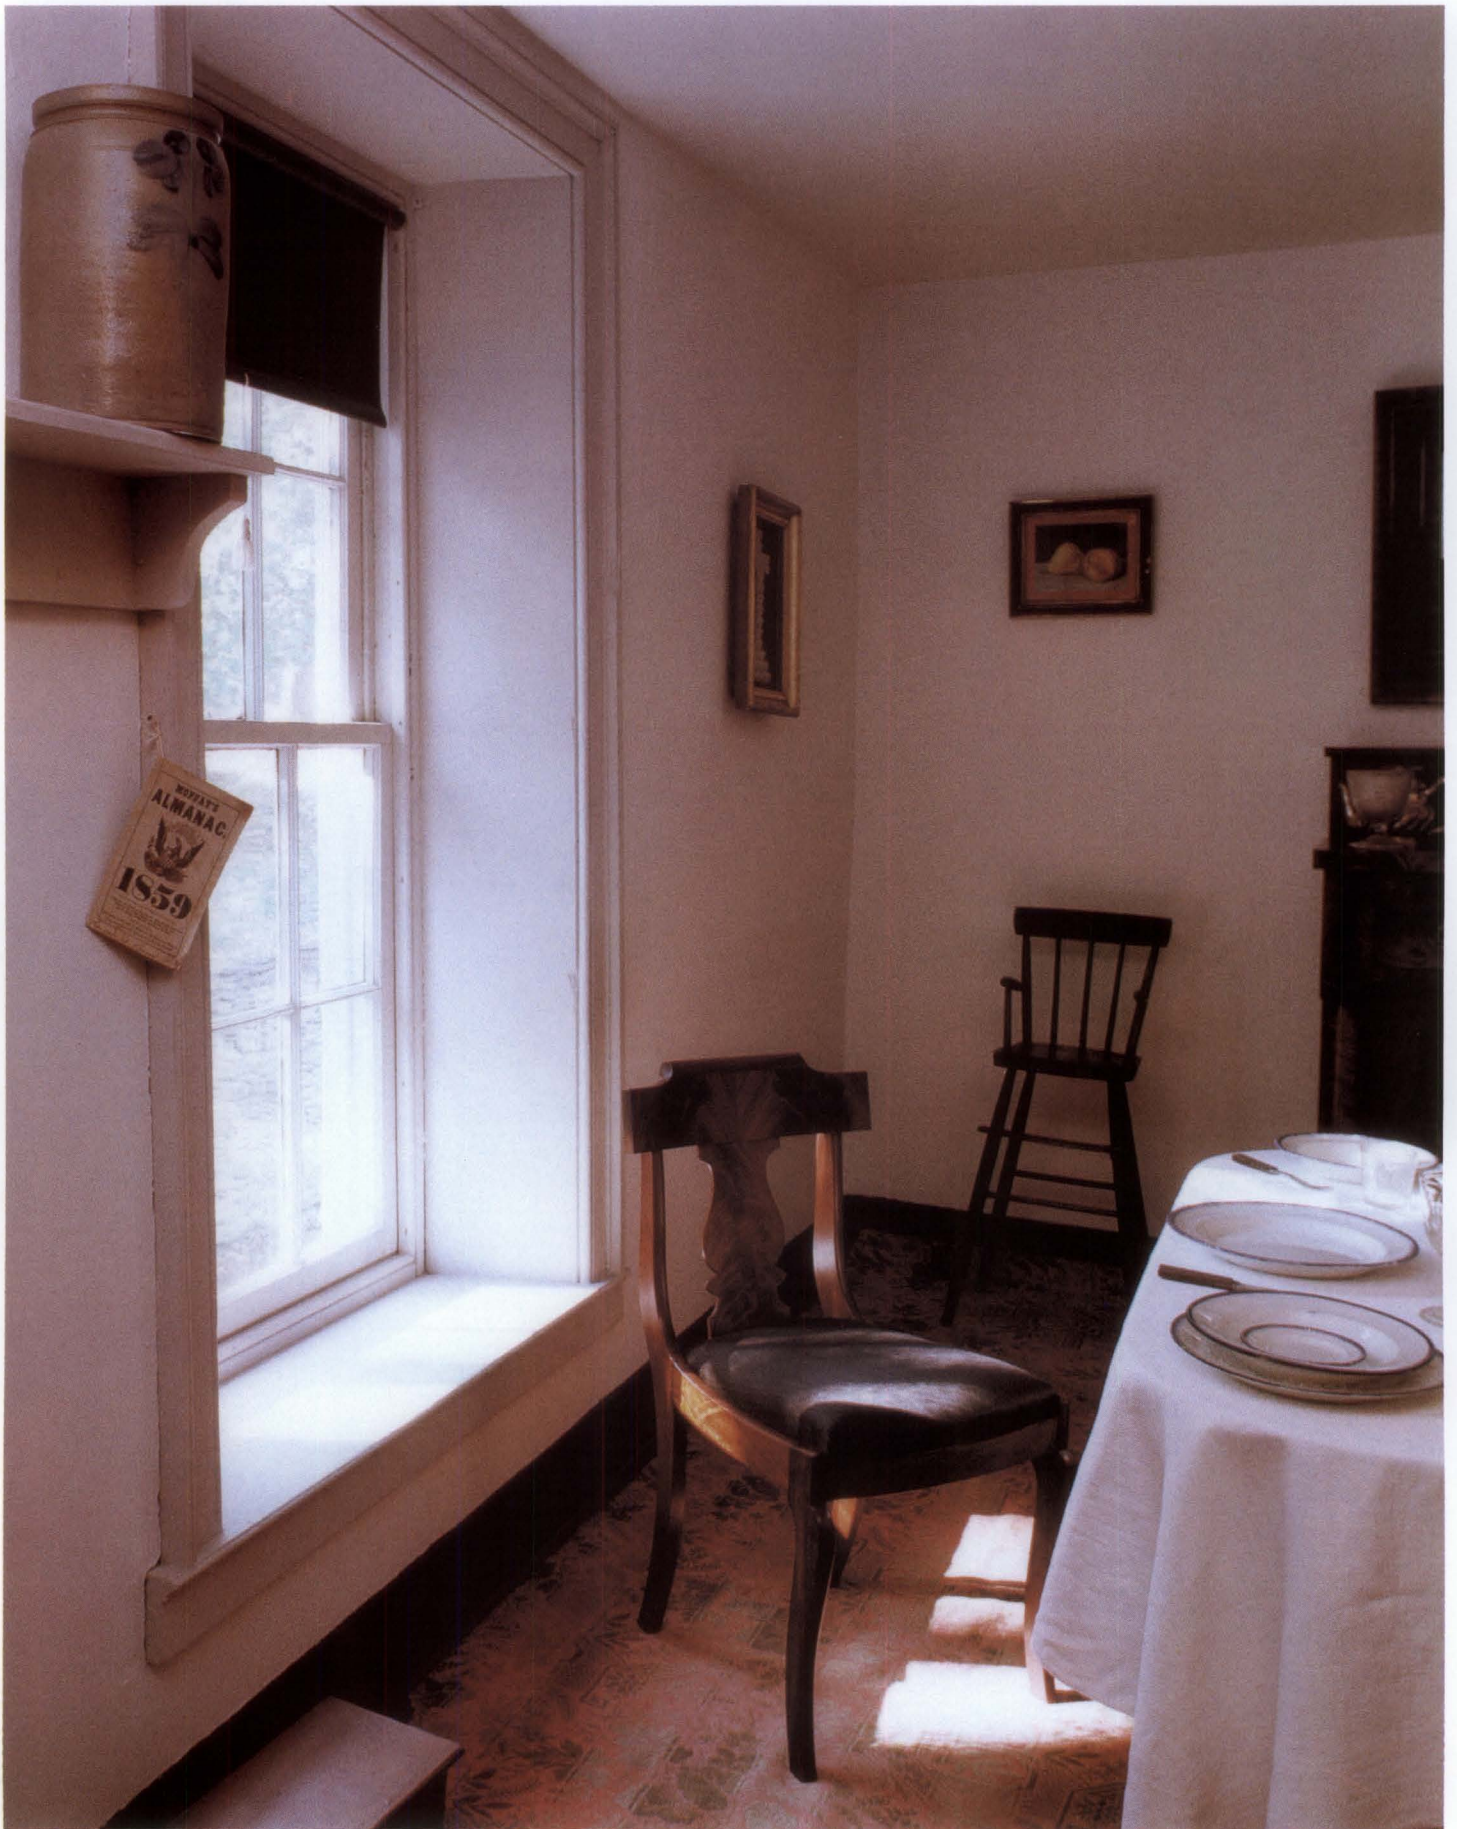
Figure 4. A number of steps can be taken to control or reduce the damage to historic furnishings caused by light entering through windows. In this house museum, a reproduction table cloth is appropriate for use in protecting the mid-nineteenth century dining room table. The chair would be better protected by moving it away from the window. The dark window roller shade should be drawn in this house museum during periods of direct sunlight and when the building is closed to the public. Photo: Mike Wiltshire, National Park Service.

A number of other steps can be taken with both historic and non-historic buildings and furnishings to control visible and ultraviolet light (*see figures 4 and 5*). Where the application of filtering films or specially treated glass is determined not in keeping with the historic character of a building, the following treatments are particularly important to consider:

1. Install window roller shades and use them at times of direct sunlight penetration and whenever a room is not in use, including at closing time.
2. Utilize existing shutters and Venetian blinds to control light into a room throughout the day.
3. Close draperies and curtains during times of direct sunlight and whenever a room is not in use. Where historic draperies exist, have reproductions made and use them in place of the historic draperies or curtains.
4. Locate particularly light-sensitive furnishings away from direct window light. With some historic museum settings, this may mean that a particular furnishing cannot be placed in its exact

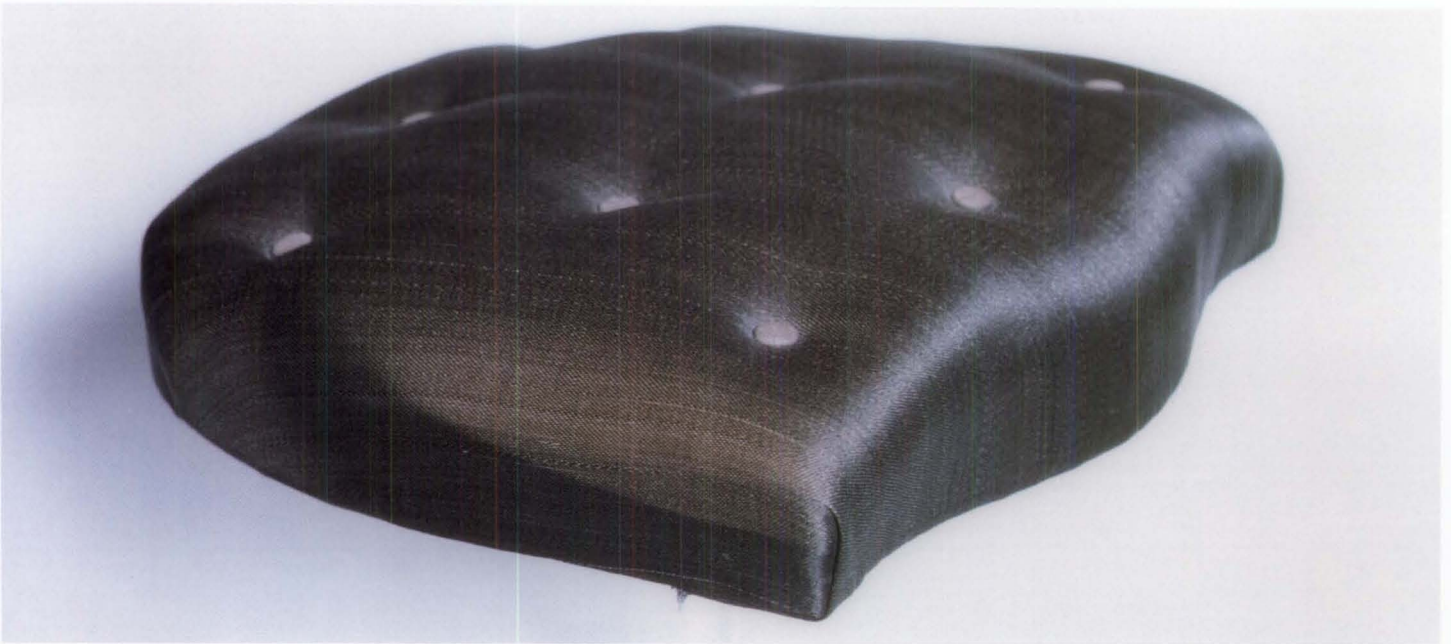
Figure 5. The chair seat, covered with reproduction black haircloth, similar to the one in figure 4, has faded in just eleven years due to exposure to unfiltered natural light. The unfaded (dark) area on the side of the seat was protected from the light by the seat rail of the chair. Photo: Mike Wiltshire, National Park Service.

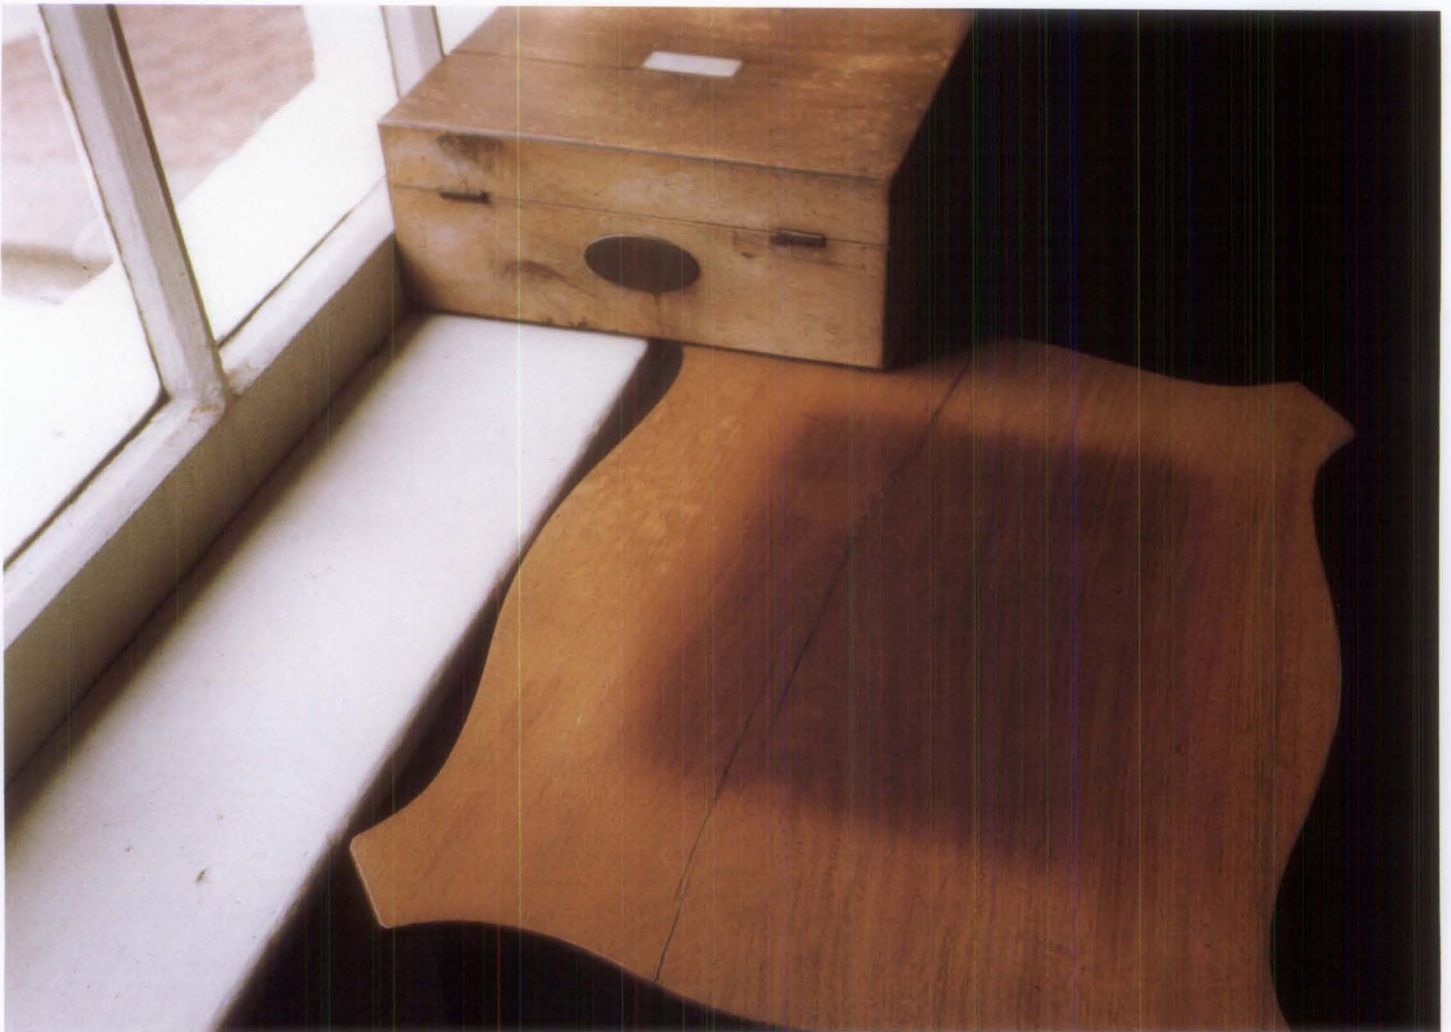
Figure 6. This small table and wooden box should not have been located beneath the window. Light has faded the finish of the table top except in the center, where the box rested and shielded the finish. The finish on the top and back of the box is nearly completely lost. Photo: Mike Wiltshire, National Park Service.

historic location (see figure 6).
