The Maintenance, Repair and Replacement of Historic Cast Stone

Preservation Briefs

42

Richard Pieper

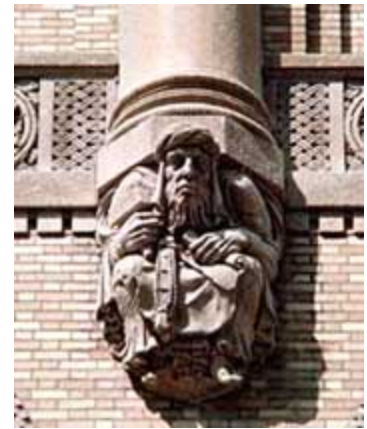
Detail of sculptural cast stone ornament on the Level Club, New York City (1926). Photo: Richard Pieper.

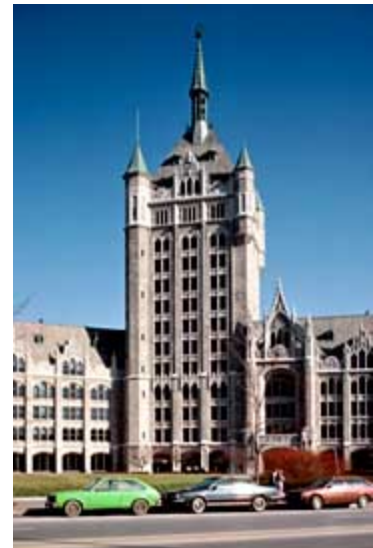
The prominent Delaware and Hudson Building, Albany, New York, (1916) made extensive use of cast stone as trim combined with a random ashlar facing of natural granite. Photo: Richard Pieper.

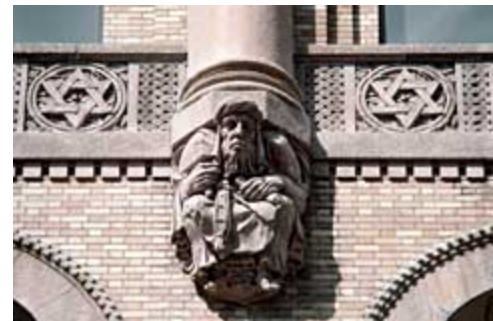
Sculptural ornament was frequently produced in cast stone. Repetitive detail, such as these banding course panels on the Level Club in New York City (1926), were produced much more economically than they could be in natural stone. Photo: Richard Pieper.

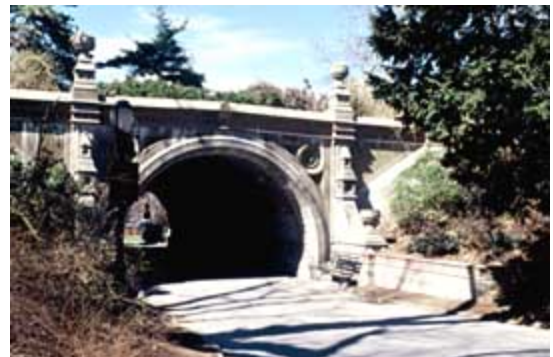
Constructed in 1868 of Beton Coignet, the Cleft Ridge Span in New York City's Prospect Park is one of the earliest extant cast stone structures in the United States.
Photo: Richard Pieper.

Another product which utilized natural cement as its cementing agent was Beton Coignet (literally, "Coignet concrete," also known as "Coignet Stone"). Francois Coignet was a pioneer of concrete construction in France. He received United States patents in 1869 and 1870 for his system of pre-cast concrete construction, which consisted of portland cement, hydraulic lime, and sand. In the United States the formula was modified to a mix of sand with Rosendale Cement (a high quality natural cement manufactured in Rosendale, Ulster County, New York). In 1870 Coignet's U.S. patent rights were sold to an American, John C. Goodrich, Jr., who formed the New York and Long Island Coignet Stone Company. This company fabricated the cast stone for one of the earliest extant cast stone structures in the United States, the Cleft Ridge Span in Prospect Park, Brooklyn, New York.

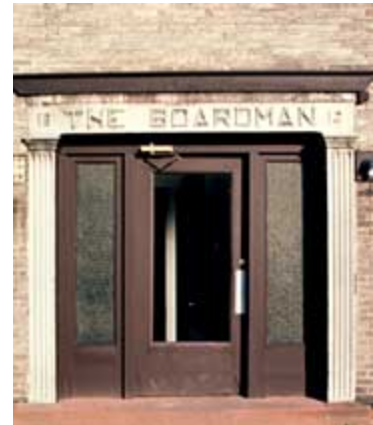
Cast stone was commonly used for molded trim in conjunction with brick or natural stone. This brick building in Rochester, New York, uses cast stone for the entry surround, and natural stone for unornamented windows sills, thresholds, and water table units. Photo: Richard Pieper.

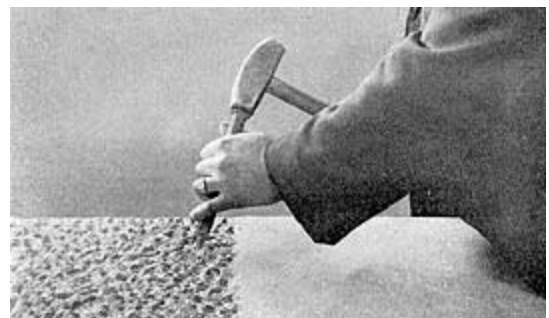
Historically, a point finish was put on with a single pointed chisel. Photo: From Onondaga Litholite Company Catalog. Courtesy, Collection of Michael F. Lynch.

High quality cast stone was frequently "cut" or tooled with pneumatic chisels and hammers similar to those used to cut natural stone. In some cases, rows of small masonry blades were used to create shallow parallel grooves similar to lineal chisel marks. The results were often strikingly similar in appearance to natural stone. Machine and hand tooling was expensive, however, and simple molded cut cast stone was sometimes only slightly less costly than similar work in limestone. Significant savings could be achieved over the cost of natural stone when repetitive units of ornate carved trim were required.

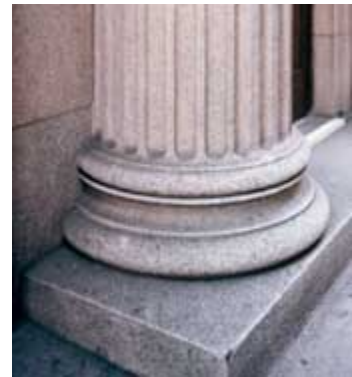
For this column, the appearance of a "pink granite" was simulated by using a pinkish matrix with white and black aggregate. Erosion of a tinted matrix results in a significant lightening of the cast stone surface. Photo: Richard Pieper.

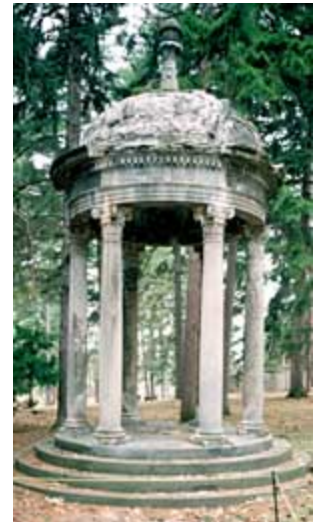
Scaling of cast stone units signals problems with the cementing mix and method of manufacture. Serious deterioration of cast stone, such as this, warrants replacement. Photos: Richard Pieper.

While it is relatively uncommon in twentieth century cast stone, serious deterioration of the cementing matrix can cause extensive damage to cast stone units. A properly prepared cementing mix will be durable in most exterior applications, and any flaking of exterior surfaces signals problems in the cementing mix and in the method of manufacture. The use of poor quality or improperly stored cement, impure water, or set accelerators can cause cement problems to occur years after a structure is completed. Improper mixing and compaction can also result in a porous concrete that is susceptible to frost damage and scaling. Severe cement matrix problems may be impossible to repair properly and often necessitate replacement of the deteriorating cast stone units.

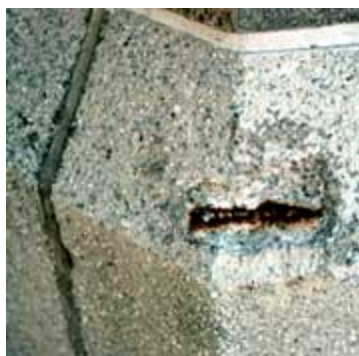
Rusting of reinforcement near the surface of the stone may result in spalling. Sections of reinforcement, such as this, may be cut out and the spall repaired with a matching composite mortar.

where repeated heavy wetting leads to loss of alkalinity in the concrete, allowing the reinforcement to rust. If damage from the deteriorating reinforcement is extensive, as for instance, the splitting of a baluster from the rusting of a central reinforcing rod, the cast stone unit may require replacement.

To repair a spall caused by deterioration of a ferrous reinforcement bar or anchorage, it is necessary to remove all cracked concrete adjacent to the spall; grind and brush the reinforcement to remove all rust and scale; and paint the metal with a rust-inhibiting primer prior to applying the cast stone composite. If the reinforcement bar is much too close to the surface of the stone, it may be advisable to cut out the deteriorating section of reinforcement after consultation with a structural engineer. If deteriorating cramps are removed, it may be necessary to install new stainless steel anchorage.

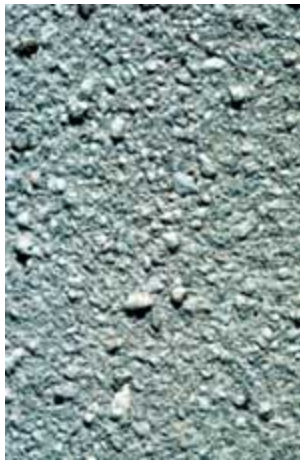
Sandblasting and wet grit blasting can seriously erode the surface and should not be used to clean cast stone surfaces. Photo: Richard Pieper.

In either case, dark particulate staining in protected areas may be persistent, however, and require experimentation with other cleaning methods. Some micro-abrasive cleaning techniques used under very controlled circumstances by skilled cleaning personnel can be appropriate for removing tenacious soiling. Ordinary sand blasting or wet grit blasting can seriously damage the surface of the cast stone and should not be used.

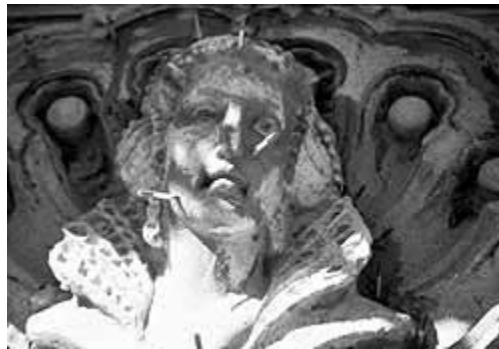
A delaminated layer of ornamental cast stone on the Orpheum Theater, San Francisco, California (1925), was successfully re-attached using epoxy. The multiple delivery ports for the epoxy are removed after treatment and the holes patched. Photo: David P. Wessell.

Where the decorative facing of dry tamped cast stone has separated from core layers, injected grouts may be used to re-secure the facing. Re-attachment of a separated facing layer may be time consuming, and should be undertaken by a conservator, rather than a mason. This technique may be the best, most economical, approach for repair of figurative sculpture or unique elements that are not repeated elsewhere on a building. Theoretically, cementitious grouts are most appropriate for re-attaching separated facings, but hairline fissures may require the use of resin adhesives. Low-viscosity epoxies have been used for this purpose, and may be applied through small injection ports. Cracks that would allow adhesive to leak must be repaired prior to injection, of course. Holes made for adhesive injection will require patching after re-attachment is complete.

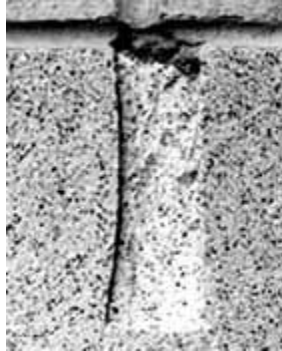
The damaged area is cut out to create a shallow void of even depth, half inch or more. Photo: Richard Pieper.

Where spalls have a feather edge, it will be necessary to cut back the repair area to a uniform depth (1/2" or more). As with natural stone composite repairs, a bonding agent may assist adhesion of the repair material to the original concrete. For unusually large or deep patches, mechanical anchoring of the repair with small nylon or stainless steel rods may be required. If the adjacent cast stone is tooled or weathered, it will be necessary to scribe or brush the repaired area to give it a matching surface texture. Adding enough coarse aggregate to match adjacent original material will sometimes interfere with adhesion of the composite, and it may be necessary to press additional aggregate into the applied patch prior to finishing. If this is not skillfully done, however, the surface of the patch may take on a mosaic appearance. For this reason, it is advisable to undertake test composite repairs in an unobtrusive location first.

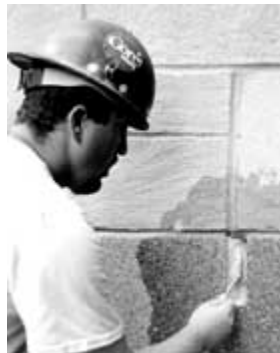
The composite mortar is applied to the void with a small spatula or trowel. Photo: Richard Pieper.

The methods of composite repair used for stone masonry are also generally applicable for the repair of historic cast stone. For repairs to damaged cast stone to be successful, however, both the cement matrix color and the aggregate size and coloration must match that of the historic unit. Crushed stone and slag (such as "Black Beauty" abrasive grit), which are similar to many common traditional aggregates, are widely available, although some additional crushing and/or sieving may be necessary to obtain aggregate of an appropriate size. Remember that half or more of a weathered surface is exposed aggregate, so careful aggregate selection and size grading is extremely important for patching. Even differences in aggregate angularity (rounded pebbles vs. crushed stone) will be noticeable in the final repair. If more than one aggregate was used in the cast stone, the ratio of the selected aggregates in the mix is, of course, equally important. Variation in coloring of the cement matrix may be achieved through the use of either white, "light, " or gray portland cement. If additional tinting is required, only inorganic alkali-resistant masonry pigments should be used. Because most historic cast stone was manufactured primarily from portland cement and aggregate (with a less than 15% lime/cement ratio), it is not necessary to add large amounts of hydrated lime to cast stone composite repair mixtures. Small amounts of lime may be added for plasticity of the working mix.

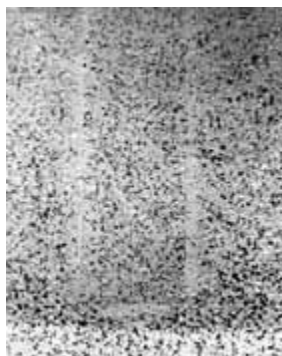
This completed composite repair could have been improved by brushing to remove the matrix residue at the edges of the repair before the surface cured. Photo: Richard Pieper.

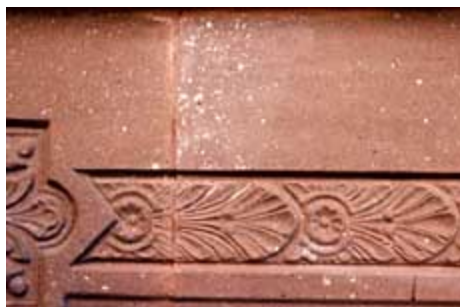
Unlike natural stone, cast stone generally may not be tooled in place to reduce lippage of uneven surfaces at joints. Tooling often exposes coarse aggregate from below the surface. Photo: Richard Pieper.

Tooling or grinding of the surface of the cast stone may expose coarse aggregate beneath the surface and will not, in any case, restore original patterned pigmentation that has weathered away. Silicate paints or masonry stains may be applied in patterns to replicate the original appearance, but may not be durable or completely successful aesthetically. Where matrix has eroded, it is advisable to accept the weathered appearance of the cast stone, unless extensive replacement is mandated by other factors.

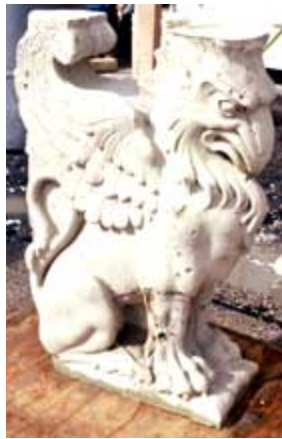
After removal from the mold, the new cast stone units are scrubbed to remove surface paste and expose underlying aggregate. End cast pieces, such as this sculpture, may have numerous air bubbles at the surface. Photo: Richard Pieper.

Air bubbles. Small pits on the surface of the stone may form if the unit is not given adequate vibration to release trapped air during pouring. Bubbles can also be a problem when end casting long items such as columns or railings, where it is difficult to vibrate bubbles away from the finish surface of the unit.

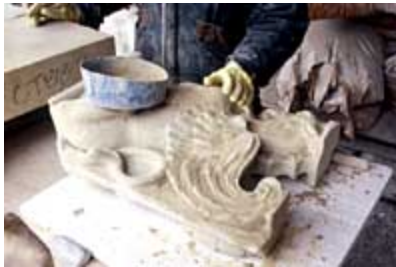
The holes on the surface of the casting (see above, left) are being filled with a mortar similar to the concrete mix used to cast the element. Photo: Richard Pieper.

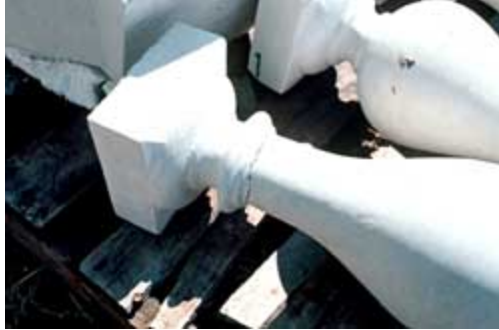
Surface cracking may reduce the durability of cast stone units. Cracking is often problematic on reinforced elements with thin "necks," such as balusters, unless curing is carefully controlled. Photo: Richard Pieper.

Surface cracking or checking. Overly wet mixes and insufficient moisture during curing can result in surface cracking of large castings, such as columns. Such cracking dramatically reduces the durability of new cast stone. Small reinforced elements, such as balusters, also frequently crack at thin "necks" in the castings.

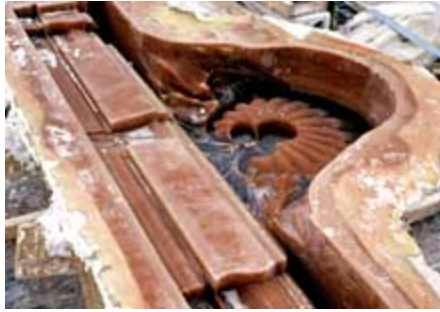
Production molds made of durable rubbers backed with wood and plaster supports are used to fabricate new cast stone. Photo: Richard Pieper.

Surface rippling or irregularity. Production molds for fabrication are often made of rubber mold facings encased in larger "mother molds" of plaster and wood. Vibration can loosen the rubber facing from the outer mold and result in rippling or irregularities on the surface of the finished casting. Even when rippling is not noticeable, irregularity caused by mold movement can make it difficult to line up surfaces of adjacent units when assembling cast stone installations.

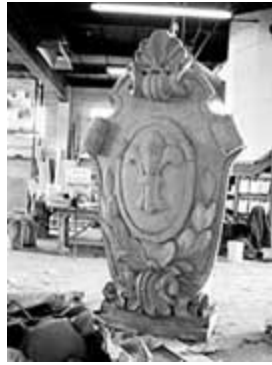
GFRC is sometimes used to replicate deteriorated elements of cast or fine grained natural stone. Because the GFRC element is a rigid, but relatively thin shell, it must be supported and attached with an interior framework of steel.

Glass fiber reinforced concrete (GFRC) is more and more frequently encountered in building restoration and is used to replicate deteriorated stone and cast stone, and even architectural terra cotta. This is a relatively new material that uses short chopped strands of glass fiber to reinforce a matrix of sand and cement. GFRC has become a popular low cost alternative to traditional precast concrete or stone masonry for some applications. Fabricators use a spray gun to spray the mortar-like mix into a mold of the shape desired. The resulting concrete unit, typically only 1/2" thick, is quite rigid, but requires a metal frame or armature to secure it to the building substrate. The metal frame is joined to the GFRC unit with small "bonding pads" of GFRC.

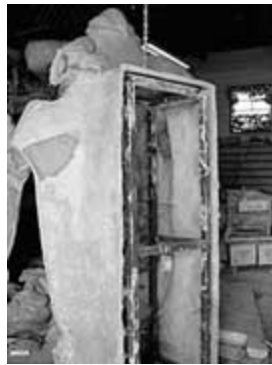
The attachment hardware inside this GFRC cartouche (left) will not be visible when the unit is installed (armature visible at right). Photos: Towne House Restorations, Inc
