*Pipelines 2012, pp. 288-297, 2012-08-22*

# Condition Evaluation of Asbestos Cement Water Mains

Rudaba Chowdhury\*, Yafei Hu, and Dunling Wang

National Research Council Centre for Sustainable Infrastructure Research

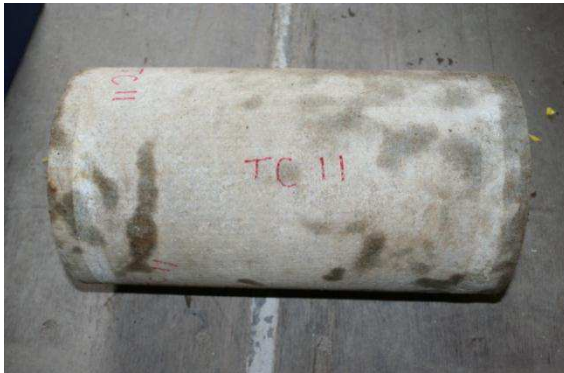
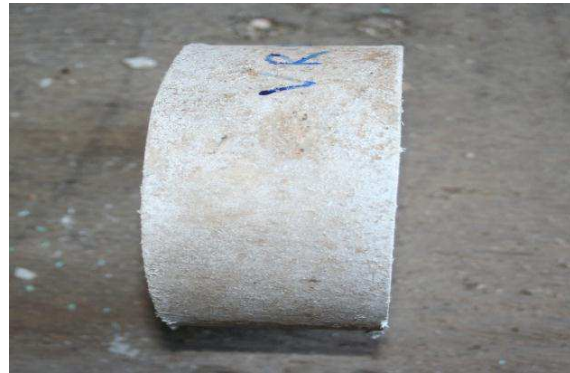
**Figure 1: Cut AC pipe samples**

Wherever possible, a 300 mm long sub-sample was first cut for crush testing (Figure 1a) and the remaining portion of the pipe (Figure 1b) was used for chemical tests and elemental analysis. The sub-samples for crush tests were removed from the barrel portion of the pipe, avoiding tapered joint ends and any obvious damage. The detailed test procedures are summarized by Hu et al. (2011).

(a) 300 mm sub-sample for crush test

(b) 100 mm long section for chemical analysis

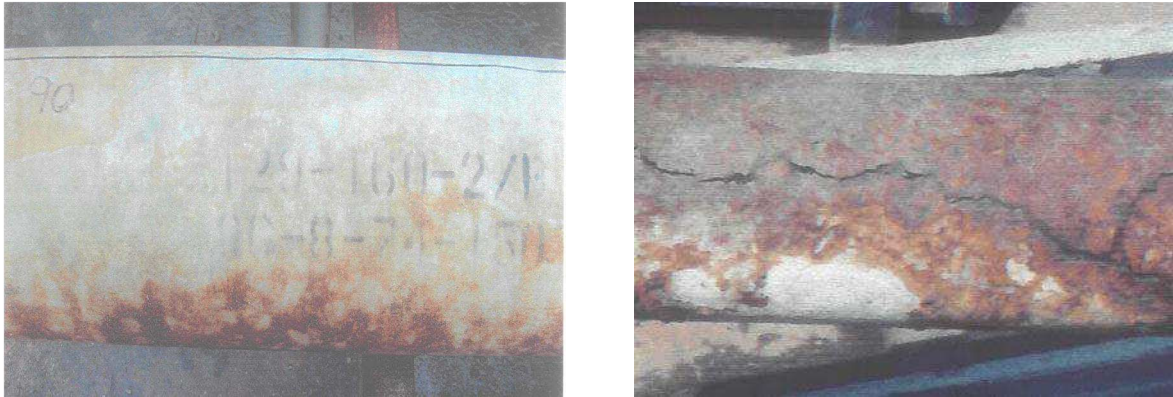
**Figure 2: Visual examination of degraded pipes**

The pipe samples from utilities A and B were relatively intact and did not show significant exterior deterioration except for some pipes that had rust and/or stain deposits (Figure 2a). Some of the samples from utility C showed severe distress, for instance, the removal of the smooth cementitious layer and cracks on the outside surfaces (Figure 2b).

(a) Slightly deteriorated pipe

(b) Severely deteriorated pipe

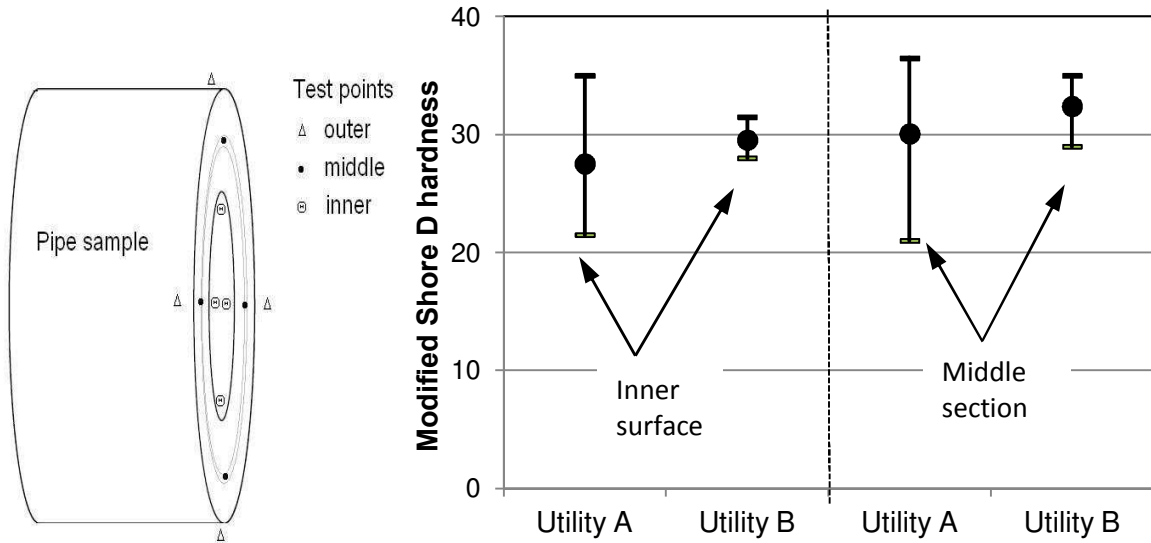
**Figure 3: Barcol hardness tests of AC pipe samples**

Figure 3b shows the hardness test results for inner and middle sections (as shown in Figure 3a) of AC pipe samples as measured using the modified Shore D durometer. The hardness in the middle section was higher than that on the inner surface. This was expected as almost all pipes had some essentially undegraded areas in the middle section.

The hardness values measured on the outer surface (not shown) were generally higher than those in the middle section. This may be related to the waffle pattern on the outside surface of AC pipes, which made it difficult for the durometer to be positioned in close contact with the outside surface.

(a) Test points

(b) Hardness test results

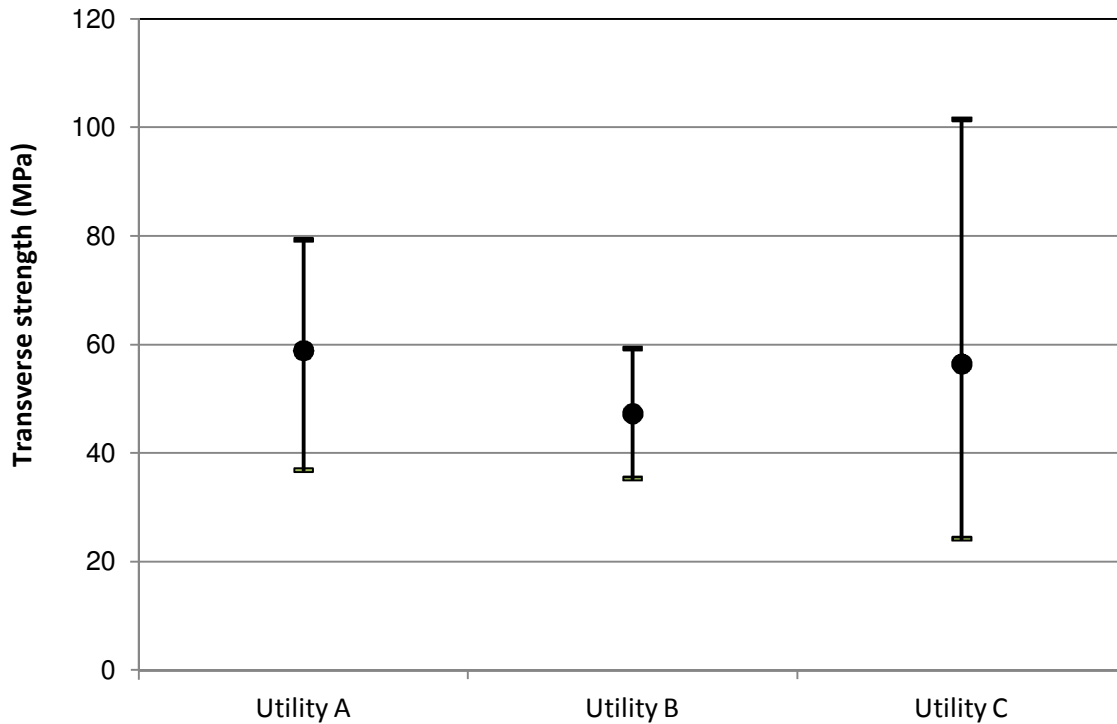
**Figure 4: Transverse crush strength of AC samples**

The load value at the point of failure was recorded for each crush test. The corresponding transverse failure strength was calculated based on the value of the failure load and the measured dimensions of the sample. Figure 4 plots the crush strength data for samples from the three utilities. In Figure 4 and following figures, a dot in a figure represents the average value, while two bars represent the maximum and minimum values measured.

Transverse strength is a material property and a change in transverse strength reflects the change in the structure of AC pipe material due to deterioration. Figure 4 shows that utility C had the most variation in pipe strength, while utility B had the least variation, with utility A in between. The transverse strength for new Class 150 AC pipes is about 45 MPa (AWWA, 2003). This figure indicates that the deterioration resulted in about 18% of pipes samples with transverse strength below specifications.

The effect of the different aggressiveness of the conveyed water on the transverse strength of AC pipes cannot be observed in Figure 4 because the pipe samples have different ages. Figure 6 re-plots the transverse strength with sample age included. Again, the utility with the most aggressive water (utility C) had the greatest decrease rate in transverse strength and the utility with the least aggressive water (utility B) had the smallest reduction in transverse strength (MPa/year).

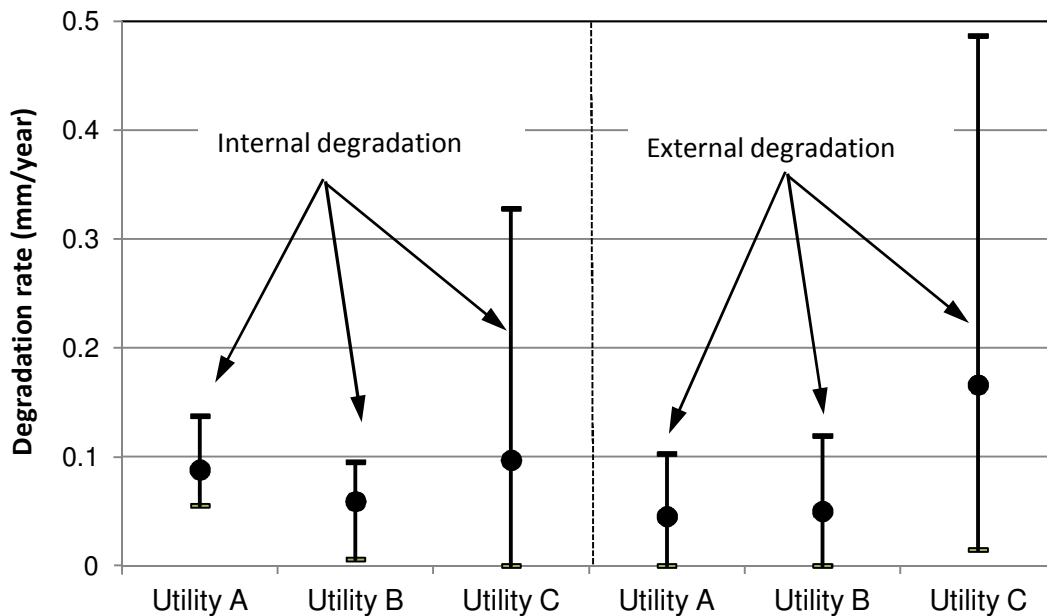
**Figure 5: Internal and external degradation rates of pipe samples**

Figure 5 shows the measured internal and external degradation rates from the phenolphthalein tests. Degradation rates were calculated by dividing the measured degradation depth of a pipe sample by the service years. Both the internal and external degradation rates varied significantly from sample to sample and from utility to utility. The samples from utility A degraded more rapidly on the inside than the outside, while the opposite occurred for utility C. Utility B had similar degradation rates on both internal and external surfaces. In general, variation in degradation rates was much greater on the outside than on the inside. This may be because the soils surrounding AC pipes may vary significantly for a given utility, but all AC pipes in a utility likely experience the same (possibly time varying) conveyed water quality.

The dry summer and low annual precipitation experienced by utilities A and B lead to arid soil conditions and low water tables. As lime leaching and sulphate attack all require an environment with soil pore water present for ions to move through the soil, an arid environment with low soil moisture content will minimize leaching and sulphate attack. When the leached products cannot be dispersed into the surrounding soils, they will become highly concentrated and slow down further leaching. That may explain the relatively low degradation rate of AC pipes for utilities A and B (Figure 5). On the contrary, utility C is located in a low-lying alluvial area near the coast and has a high water table, conditions that are conducive to the degradation of AC pipes buried in the soil. Also, the alluvial deposition can produce a soil environment with high sulphate content, which may contribute to the high degradation rate of the AC pipes operated by utility C (Figure 5).

The effect of the different aggressiveness of the conveyed water on the deterioration of AC pipes in the three utilities can be observed in Figure 5. Utility C, with very aggressive water, had the highest internal degradation rate and the highest average internal degradation rate. Utility B, which had the least aggressive water, had the lowest average internal degradation rate. Utility A experienced an average internal degradation rate in between, which corresponded to conveyed water with an aggressiveness index in between those of utilities B and C.
