# Understanding the Nature and Characteristics of Dark-Black Stains on Rooftops in Uyo Metropolis-Nigeria

**ABSTRACT.** Understanding the Nature and Characteristics of Dark-Black Stains on Roof-Tops in Uyo Metropolis-Nigeria; a study aimed at knowing the nature and characteristics of dark black stains on rooftops in Uyo metropolis has been undertaken. The study which covered key areas of the town, involved taking samples from rooftops, these samples were sent out for tests using Energy Dispersive X-Ray Fluorescence (ED-XRF), Optical Emission Spectrometer (OES), X-Ray Diffractometer (XRD) and Scanning Electron Microscope (SEM). The tests were carried out on the dark black stains which were scrapped from the rooftops. Tests were also carried out on the sheets, which were directly cut from the roofs. The work was able to establish that the dark black stains on the roofs can be cleaned using soft brush and water. The results of the work equally provided the nature and characteristics of the dark black stains on the surface of roofs in Uyo metropolis. The major components of the dark black stains are alumina (16%), silica (43.80%), carbonaceous and volatile organic matter (16.59%), iro

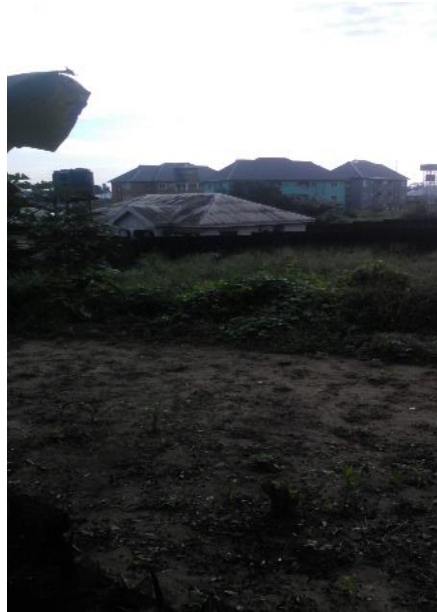
*Fig. 4. The Roof Top of the Building in the Front is covered with Dark-Black Deposit, the Storey Buildings Behind are Roofed with Dark-colour Roofing Sheets to Conceal the Effect of the Dark-Black Deposit.*
