# The Repair, Replacement and Maintenance of Historic Slate Roofs

## Preservation Briefs

### 29

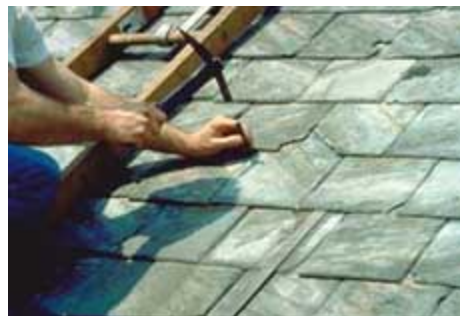
Slate roof repair. Photo: Jeffrey S. Levine.

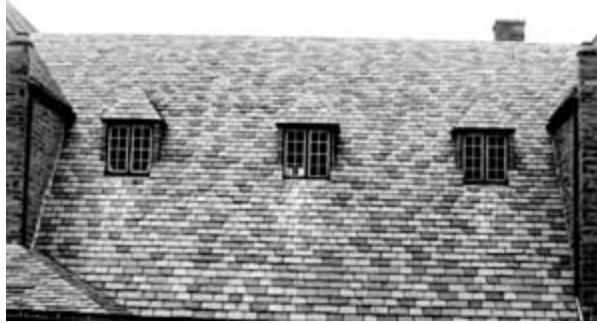
This graduated slate roof is composed of large, thick slates at the eave which are reduced in size and thickness as the slating progresses to the ridge. Photo: Jeffrey S. Levine.

Graduated slate roofs were frequently installed on large institutional and ecclesiastical structures. The slates were graduated according to thickness, size, and exposure, the thickest and largest slates being laid at the eaves and the thinnest and smallest at the ridge. Pleasing architectural effects were achieved by blending sizes and colors.

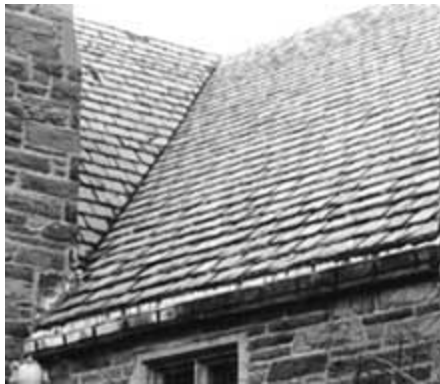
Valleys are formed at the internal angle of two roofing slopes. Flashing is often placed under the slate to increase moisture protection at this vulnerable joint. Photo: Jeffrey S. Levine.

Two types of valleys were traditionally employed, the **open valley** and the **closed valley**. The open valley is lined with metal over which slates lap only at the sides. Closed valleys are covered with slate and have either a continuous metal lining or metal flashing built in with each course. Open valleys are easier to install and maintain, and are generally more watertight than closed valleys. Round valleys are a type of closed valley with a concave rather than Vshaped section. Given the broader sweep of the round valley, it was not uncommon for roofers to interweave asphalt saturated felts rather than copper sheet in the coursing in order to cut costs.

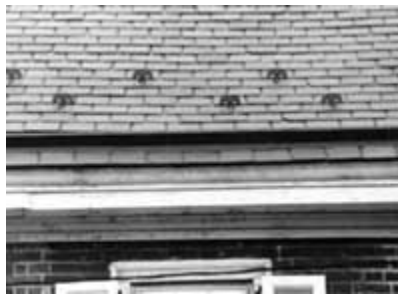
Eave details include snow guards, snow boards, and gutter treatments. Snow guards are generally used in areas where the ice and snow accumulate to avoid dangerous slides from the roof. Photo: Jeffrey S. Levine.

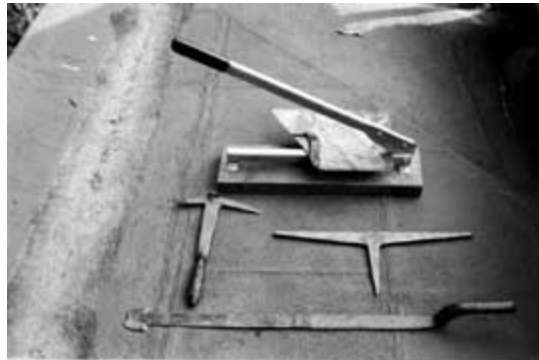
These traditional slater's tools are used to cut and trim, hammer, measure, and rip out nails. Photo: Jeffrey S. Levine.

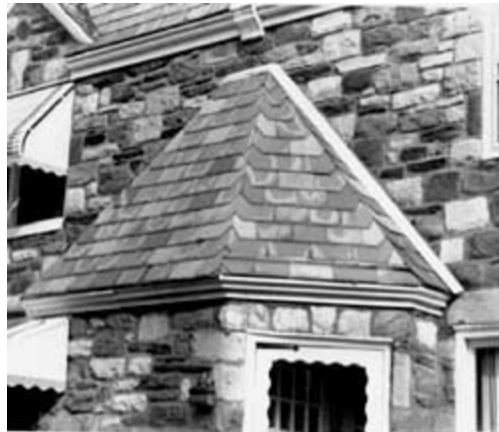
The white blotches on these Pennsylvania Soft-Vein slates indicate areas where gypsum is leaching out onto the surfaces of the slates. Photo: Jeffrey S. Levine.

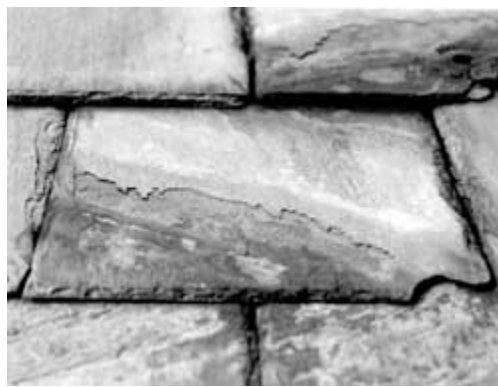
Paper thin lamination can be seen flaking off this weathered, 120 year piece of Pennsylvania Hard-Vein slate. Photo: Jeffrey S. Levine.

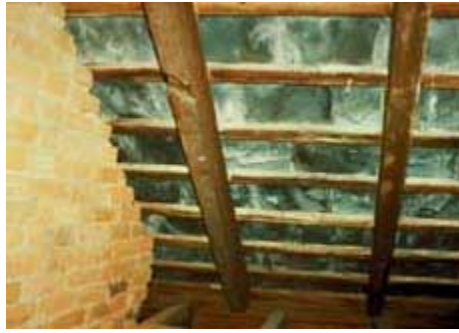
View of these slates laid on open sheathing shows that delamination and flaking are just as bad or worse on the underside of slates as on the exposed surface. This is why most slates cannot be flipped over for reuse. Photo: Jeffrey S. Levine.

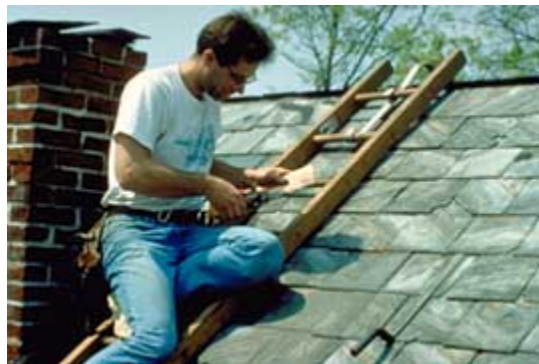
After removing the deteriorated slate and sliding the new slate into place, it is secured with a copper nail. A copper bib (shown here) is formed to protect the newly created nail hole. Finally, a slate hammer is used to push the bib in place over the nail head. Photo: Jeffrey S. Levine.

To prevent water penetration through the newly created nail hole, a piece of copper with a friction fit, measuring roughly 3" (7.5 cm) in width and 8" (20 cm) in length, is slid lengthwise under the joint between the two slates located directly above the new slate and over the nail. Alternate methods for securing the replacement slate include the use of metal hooks, clips, and straps that are bent over the tail end of the slate. The application of roofing

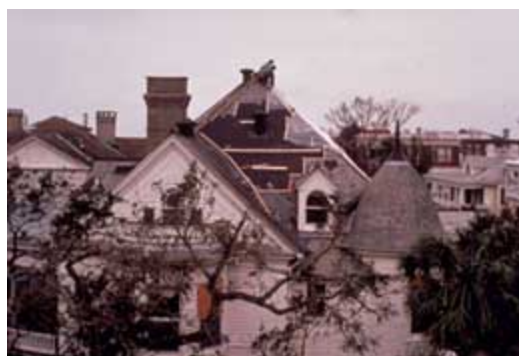
After a hurricane or other natural disaster, it may be necessary to stabilize a roof temporarily until materials can be obtained and a qualified roofing contractor hired. Significant slate roofs should not be stripped off and replaced with asphalt shingles. Photo: NPS files.

In emergency situations, such as when severe hurricanes or tornadoes blow numerous slates off the roof, a temporary roof covering should be installed immediately after the storm to prevent further water damage to the interior of the building and to permit the drying out process to begin. Heavy gauge plastic and vinyl tarpaulins are often used for this purpose, though they are difficult to secure in place and can be blown off in high winds. Roll roofing, carefully stitched in to areas of the remaining roof, is a somewhat more functional solution that will allow sufficient time to document the existing roof conditions, plan repairs, and order materials.

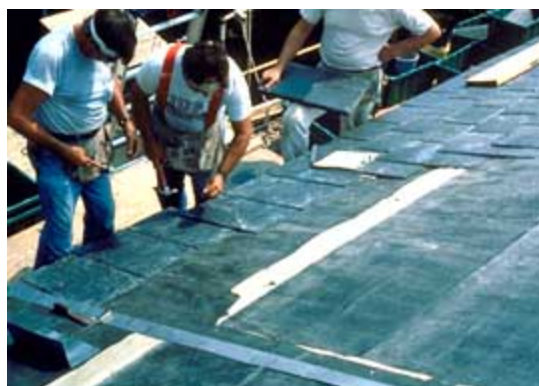
Roofing felt is being installed over the decking; a rubberized membrane is used selectively at the eaves and under some flashing. Photo: NPS files.
