The Repair and Replacement of Historic Wooden Shingle Roofs

Preservation Briefs

19

Sharon C. Park, AIA

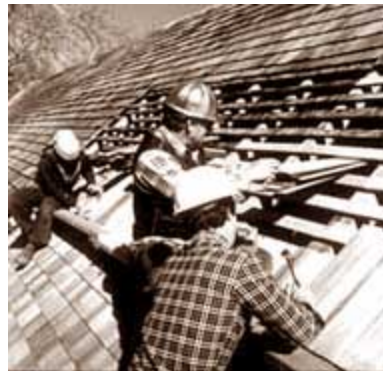
Appropriate re-roofing work in progress. Photo: NPS files.

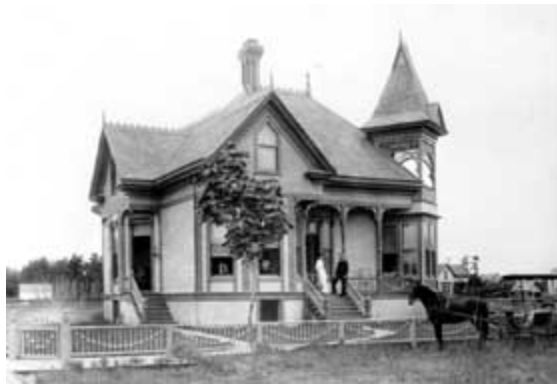
Readily available and inexpensive sawn shingles were used not only for roofs, but for gables and wall surfaces. Photo: Lane County Historical Society.

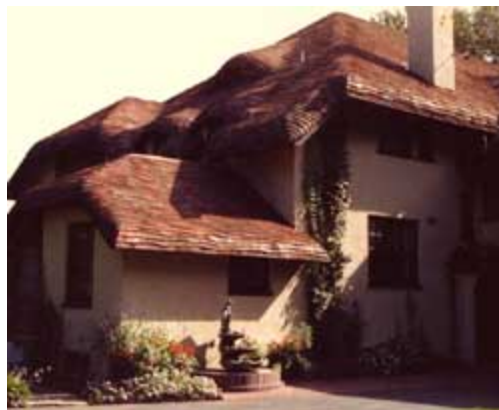
With the popularity of the revival of historic styles in the late 19th and early 20th centuries, a new technique was developed to imitate English thatch roofs. Photo: C.H. Roofing.

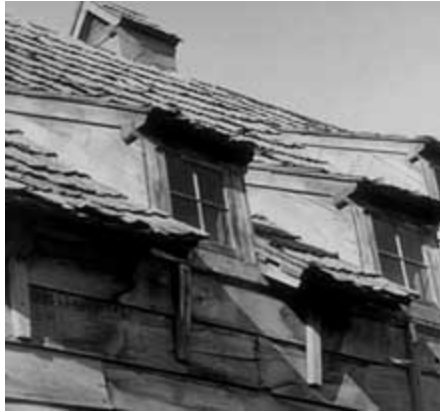
The long, biaxially tapered handsplit shingles are overlapped both vertically and horizontally. Photo: NPS files.

Not all shingles were laid in evenly spaced, overlapping, horizontal rows. In various regions of the country, there were distinct installation patterns; for example, the biaxially-tapered long shingles occasionally found in areas settled by the Germans. These long shingles were overlapped on the side as well as on top. This formed a ventilation channel under the shingles that aided drying. Because ventilation of the shingles can prolong their life, roofers paid attention to these details.

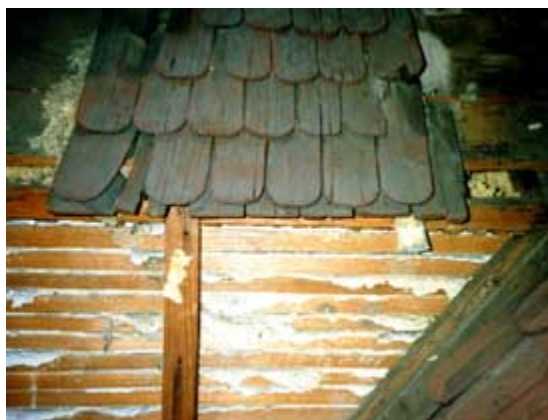
These weathered historic 19th-century handsplit and dressed shingles were found in place under a later altered roof. See also, below. Photo: John Ingle.

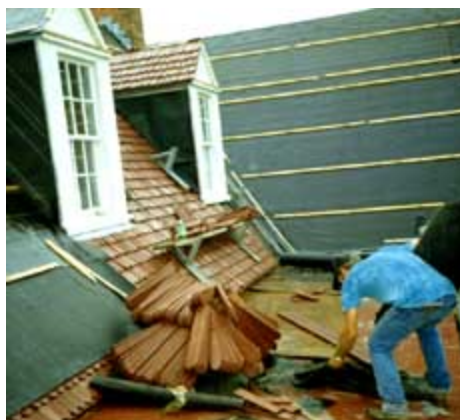
The replacement shingles matched the historic shingles and were of such high quality that little hand dressing was needed at the site. Photo: John Ingle.

When damage is extensive, replacement of the shingles will be necessary, but the historic sheathing or shingle lath under the shingles may be in satisfactory condition. Often, the historic sheathing or shingle laths, by their size, placement, location of early nail holes, and water stain marks, can give important information regarding the early shingles used. Before specifying a replacement roof, it is important to establish the original shingle material, configuration, detailing and installation. If the historic shingles are still in place, it is best to remove several to determine the size, shape, exposure length, and special features from the unweathered portions. If there are already replacement shingles on the roof, it may be necessary to verify through photographic or other research whether the shingles currently on the roof were an accurate replacement of the historic shingles.

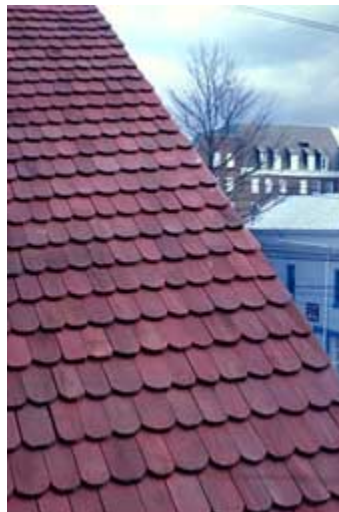
New rounded butt sawn shingles, with a smooth finish and red oxide stain, were used to replace the deteriorated shingles. The varying widths, between 4" and 7" will keep them from curling and cupping. Exposure length was determined from historic nail patterns on the historic spaced sheathing below.

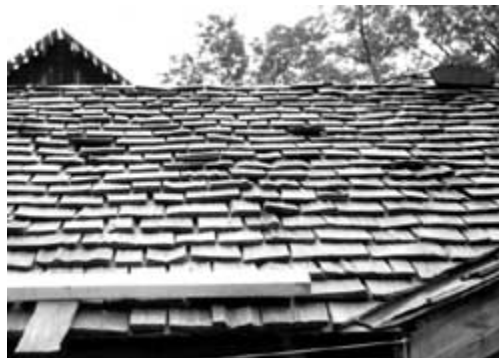
These commercially available roofing products with rustic split faces are not appropriate for historic preservation projects. Photo: NPS files.
