THE SECRETARY
OF THE INTERIOR'S
STANDARDS FOR
REHABILITATION &

ILLUSTRATED
GUIDELINES ON
SUSTAINABILITY
FOR
REHABILITATING
HISTORIC
BUILDINGS

U.S. Department of the Interior
National Park Service
Technical Preservation Services

2011

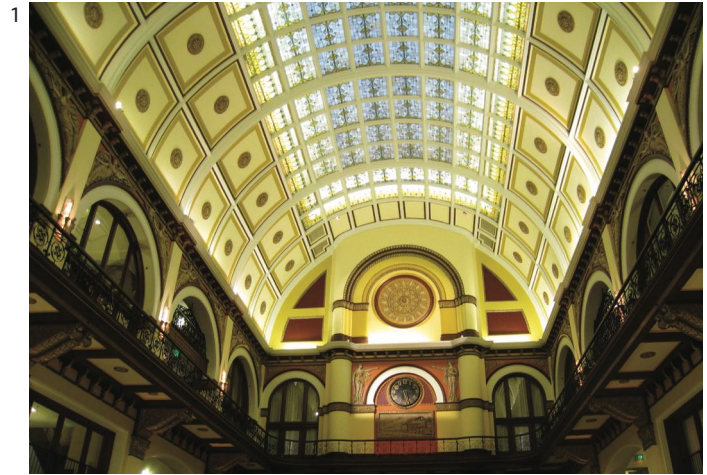
[1] Stained glass skylight provides natural light in a historic train station.

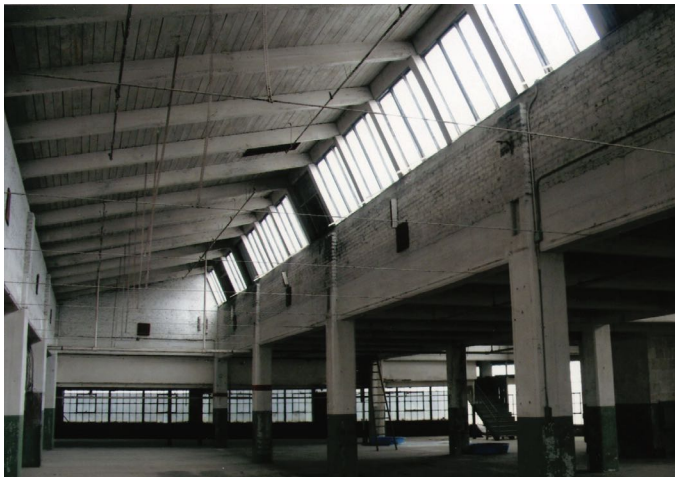
3

[2-3] Clerestory windows provide natural light in a historic industrial building: Before and after rehabilitation.

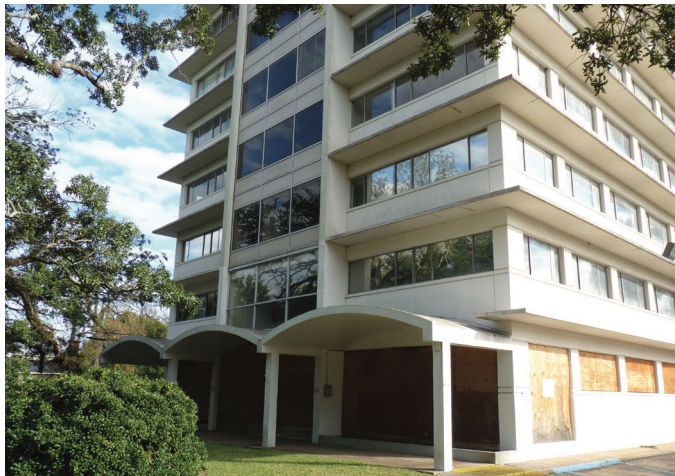
4

[4] Covered walkways and horizontal sun screens are distinctive and sustainable features in some mid-century modern office buildings.

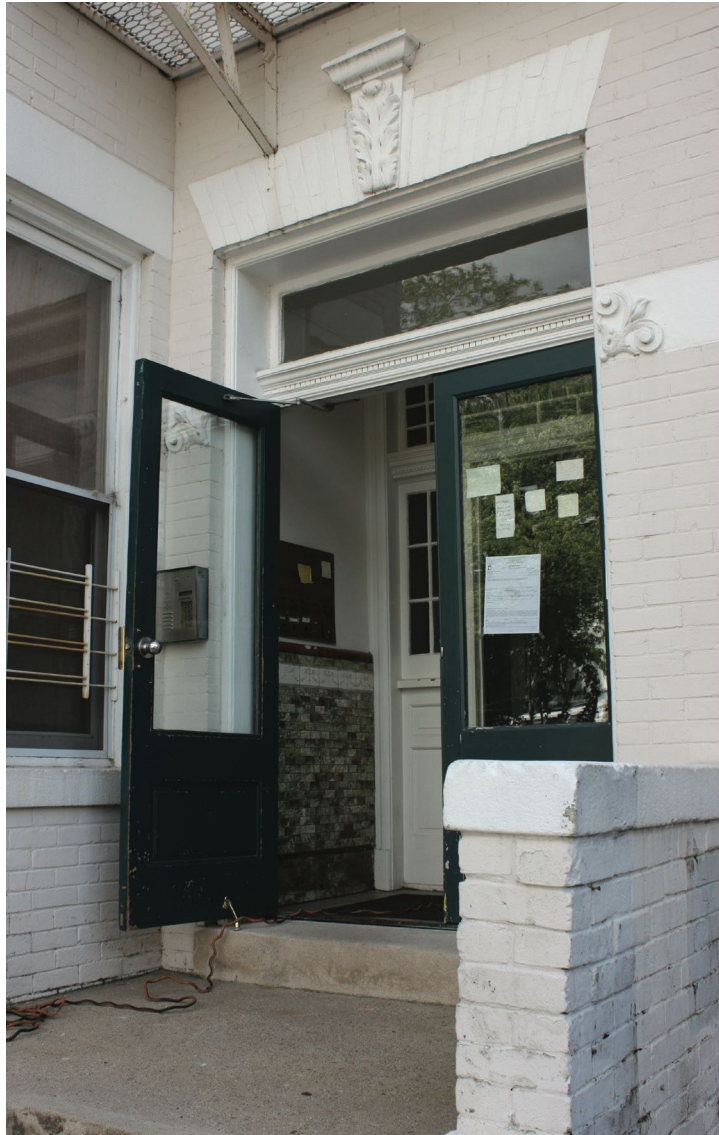
11

[11] A vestibule helps retain interior conditioned air in the living space in this historic row house.

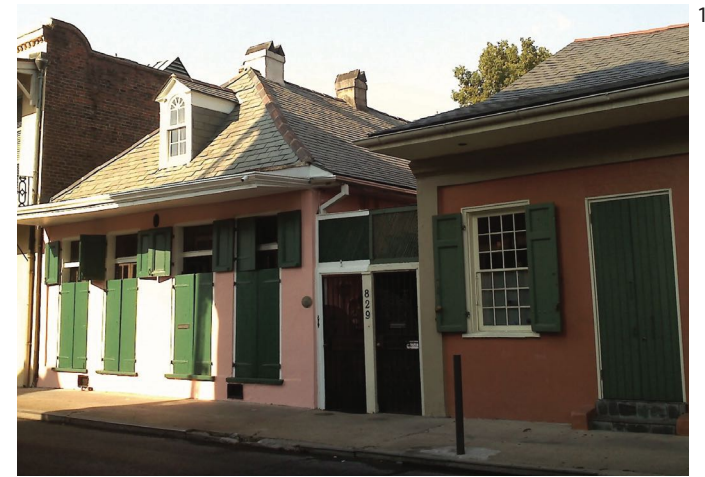
10

[10] Wood shutters provide natural light when open and keep interiors cool when closed in historic residential buildings.

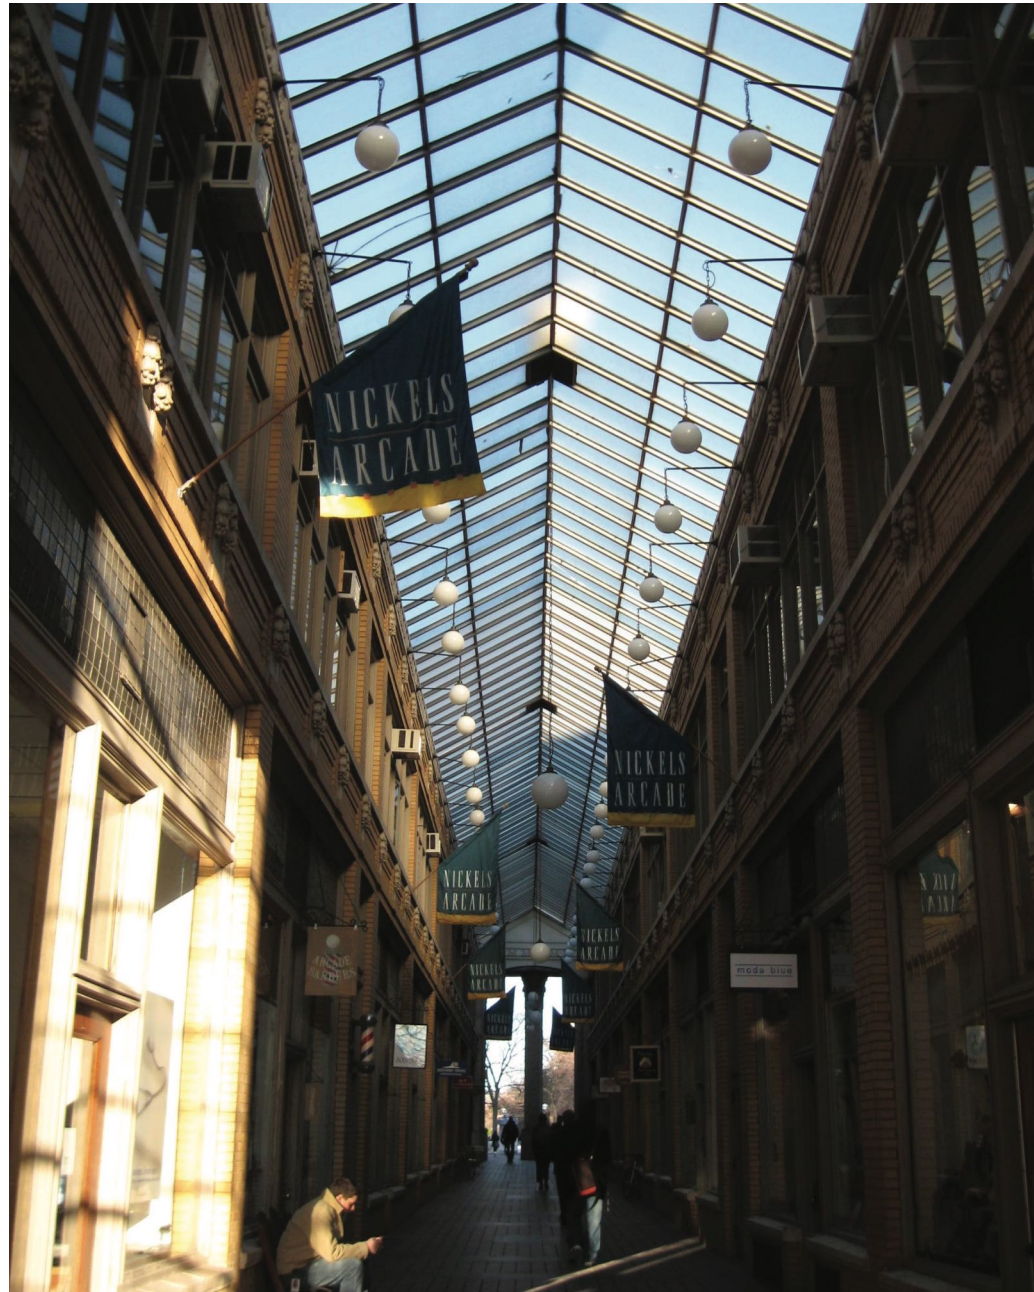
[15] Glass skylight illuminates historic shopping arcade.

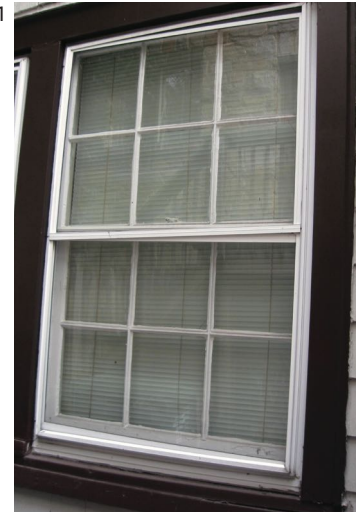
32

Not Recommended: [31-32] Ill-fitting exterior aluminum storm windows viewed from both inside and outside are clearly not energy efficient.

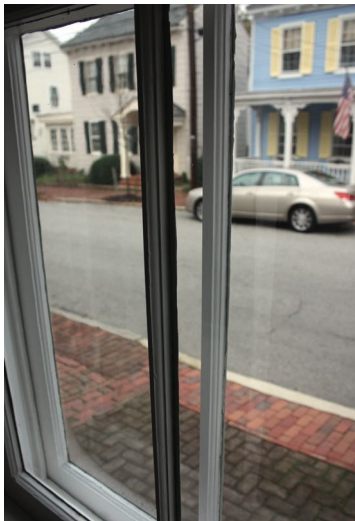
29

Recommended: [28-29] These exterior storm windows match the pane configuration of the historic interior windows in a residence and in a multi-story hotel building.

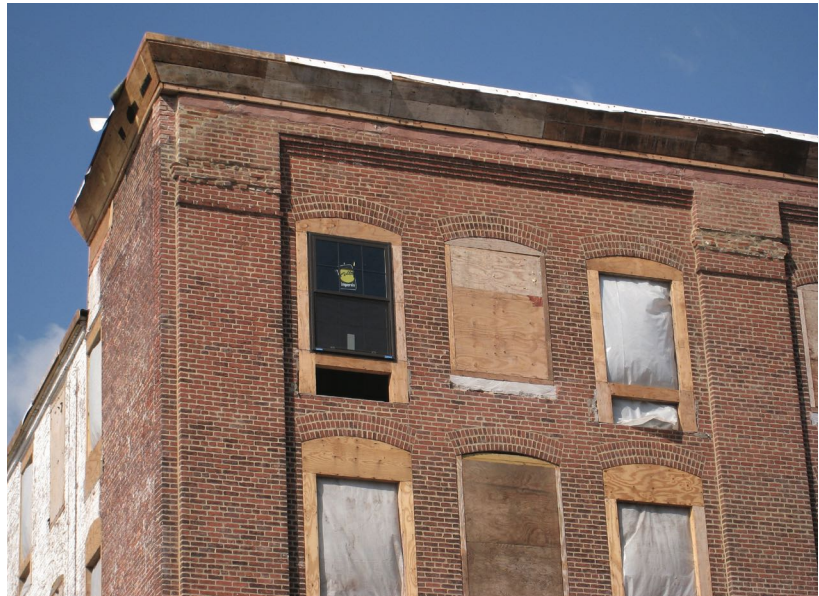
33

Recommended: [33-35] Original metal windows were appropriately repaired as part of the rehabilitation of this historic industrial building.

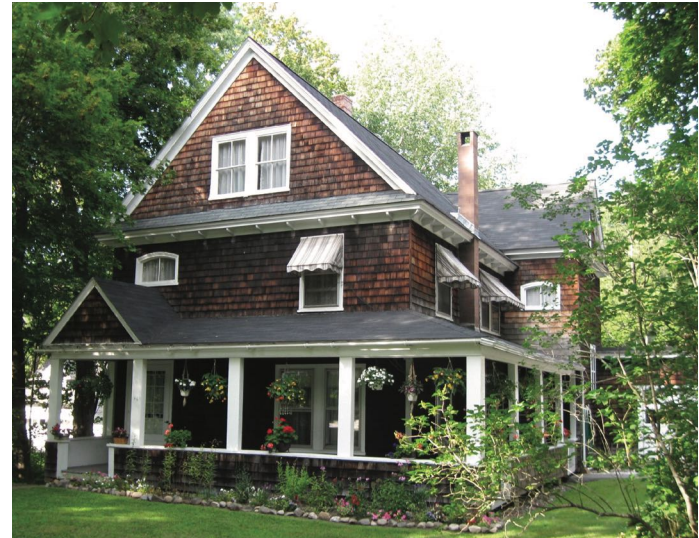
41

Recommended: [41] Traditional canvas awnings should be retained when they exist on historic buildings.

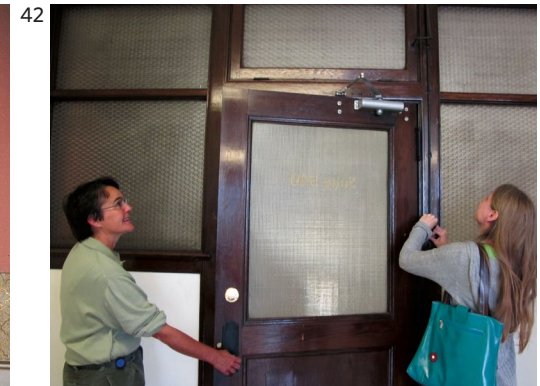
43

Recommended: [43] The wall and door glazing ensures that the corridor receives natural daylight and the operable transom helps air to circulate in this historic office building.

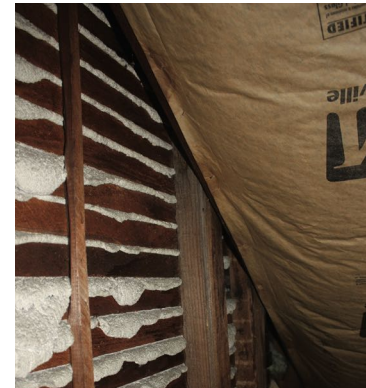
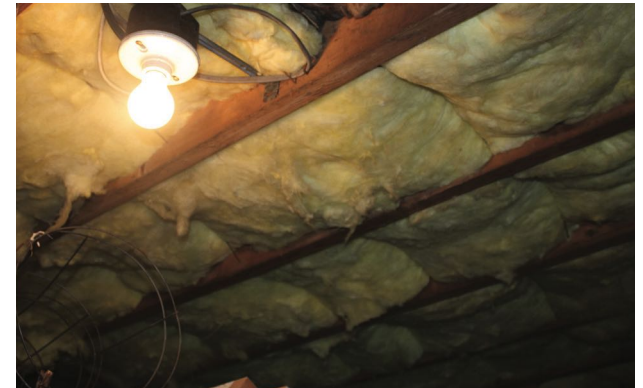
Recommended: [47-48] Insulation should be installed first in unfinished areas such as attics, crawl spaces and basements of residential buildings.

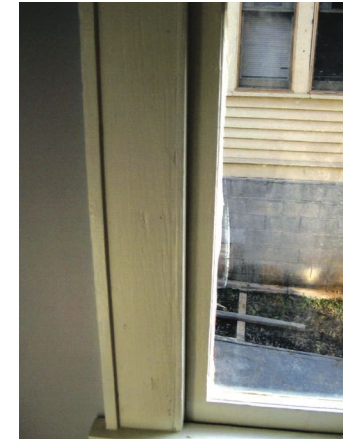
53

Recommended: [52-53] The original proportion and relationship of the wall to the windows and trim, which is important in defining the character of these historic interior spaces, has been retained here.

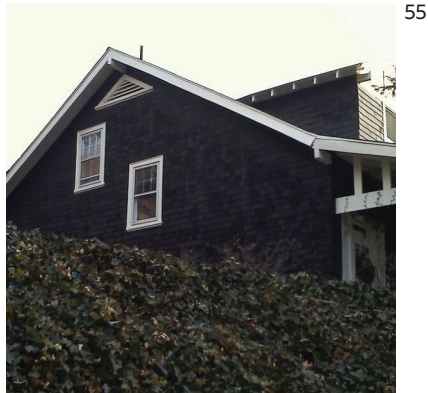
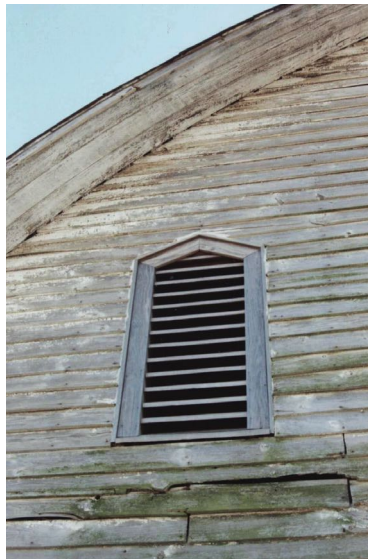
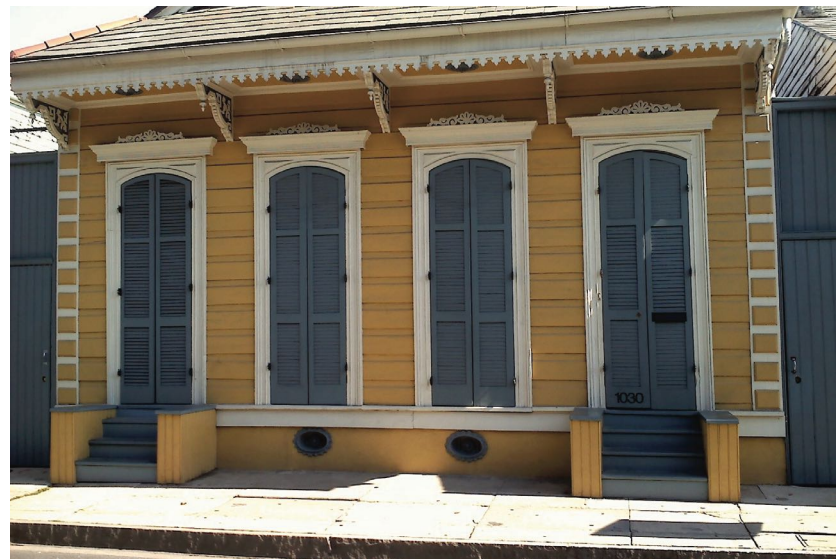
Recommended: [55-57]
Wood vents in the gable ends of a historic house and a barn and cast-iron oval vents in a masonry foundation traditionally helped air circulate.

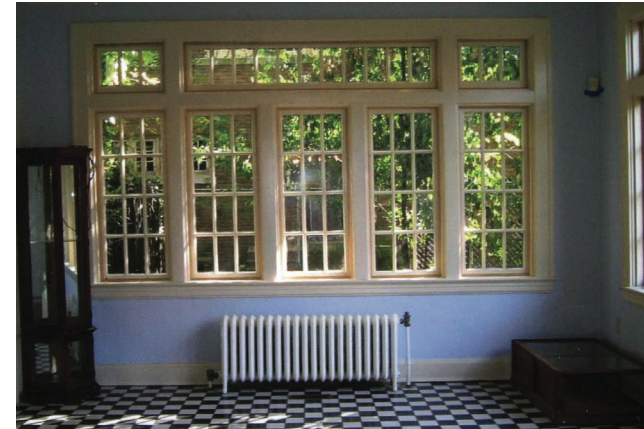
60

Recommended: [60] Original radiators that are still functional and efficient were retained in the rehabilitation of this historic house.

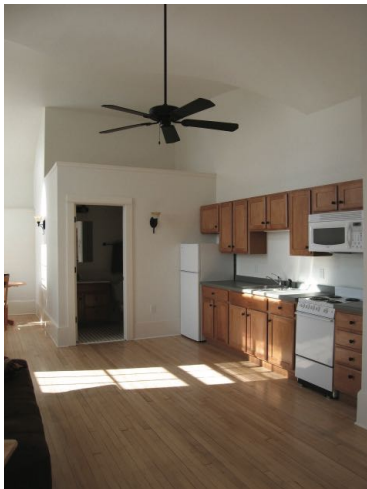
58

Recommended: [58] Ceiling fans enhance the efficiency of HVAC systems in historic buildings.

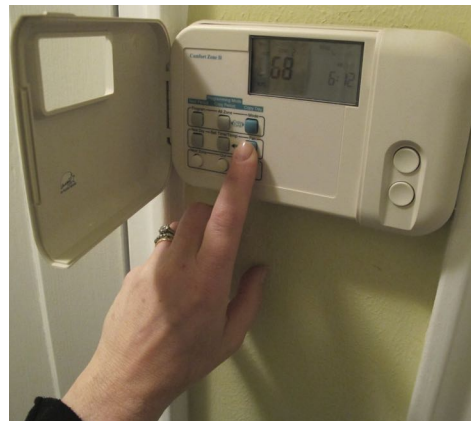
59

Recommended: [59] Installing a programmable thermostat can help existing systems to operate more efficiently.

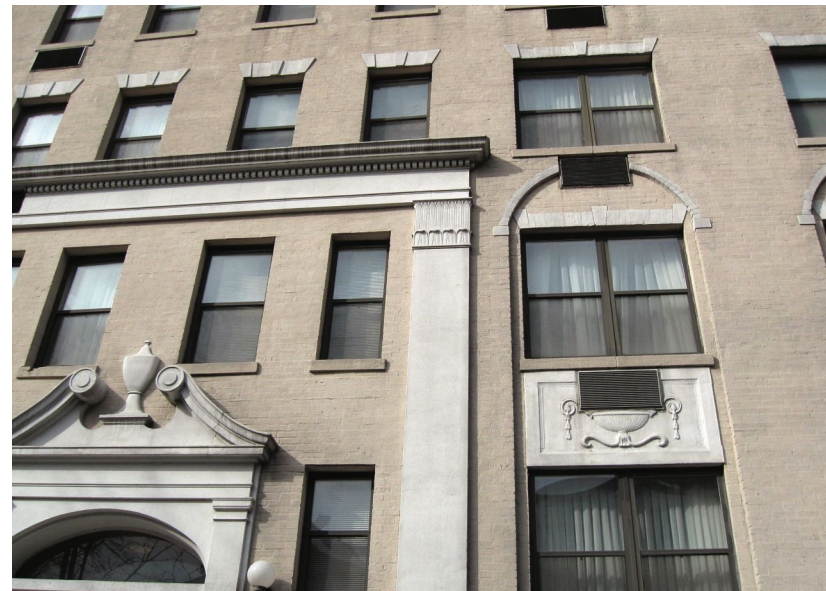
61

Not Recommended: [61] The cuts made in the brick and the decorative stone trim to install through-the-wall air conditioners have not only destroyed building material, but have also negatively impacted the character of this historic apartment building.

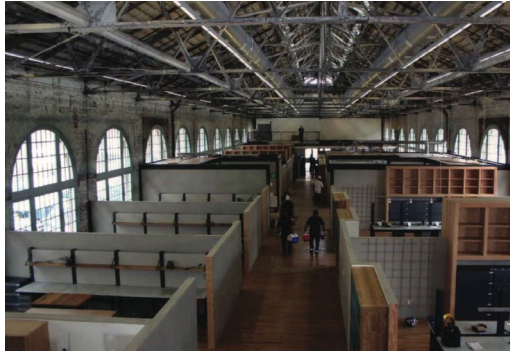
64

[64] The ductwork has been left unpainted which is compatible with this historic industrial interior.

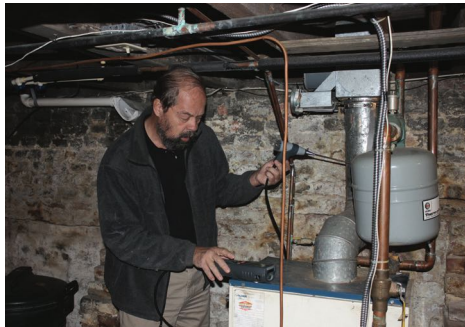
67

Recommended:[67] A professional energy auditor analyzes the performance of an existing furnace to ensure it is operating efficiently.

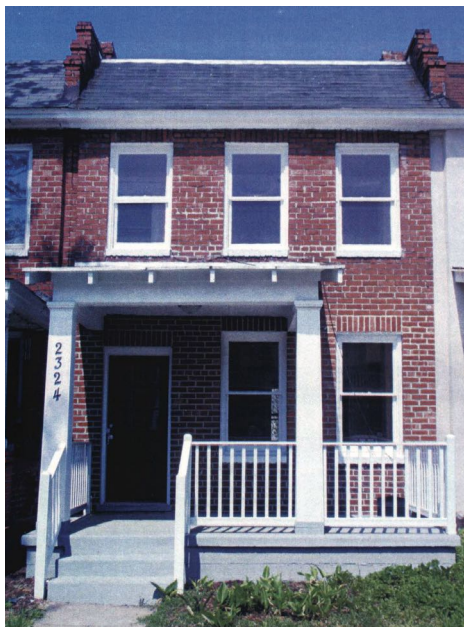
73

Recommended: [72-73] Solar panels were installed appropriately on the rear portion of the roof on this historic row house that are not visible from the primary elevation.

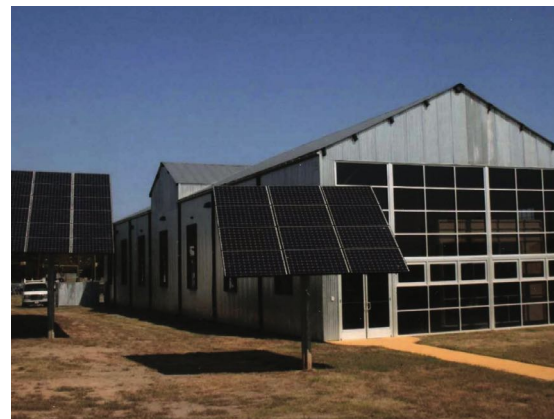
74

Recommended: [74] Free-standing solar panels have been installed here that are visible but appropriately located at the rear of the property and compatible with the character of this industrial site.

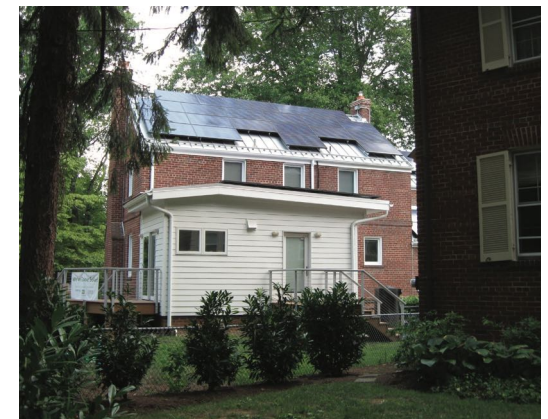
75

Not Recommended: [75] Solar roof panels have been installed at the rear, but because the house is situated on a corner, they are highly visible and negatively impact the character of the historic property.

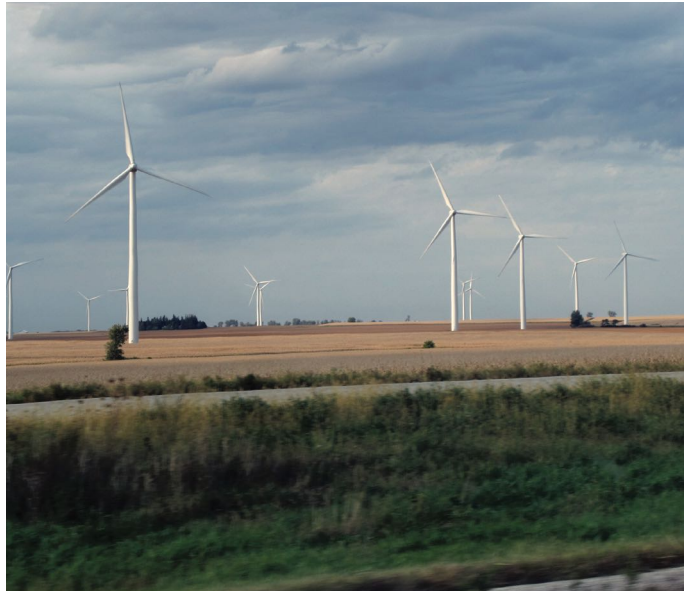
80

Recommended: [80] It is often best to install wind-powered equipment in off-site, rural locations to avoid negatively impacting a historic building and its site.

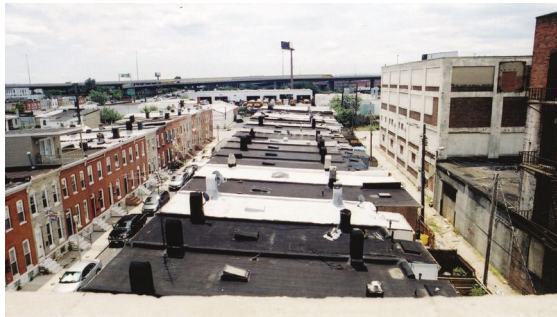
86

Recommended: [85-86] A cool or green roof is best installed on a flat roof where it cannot be seen from the public right of way and will not negatively impact the character of the historic building.

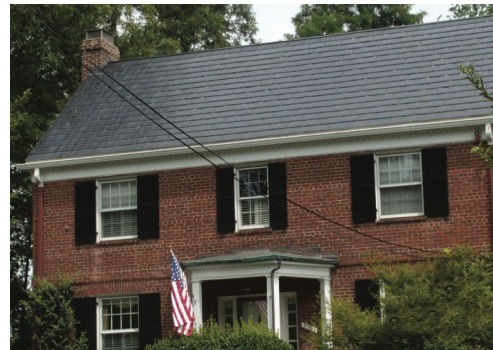
87

Not Recommended: [87] Historic roofing materials in good condition should be retained rather than replaced with another material perceived as more sustainable, such as, in this case, solar roofing shingles.

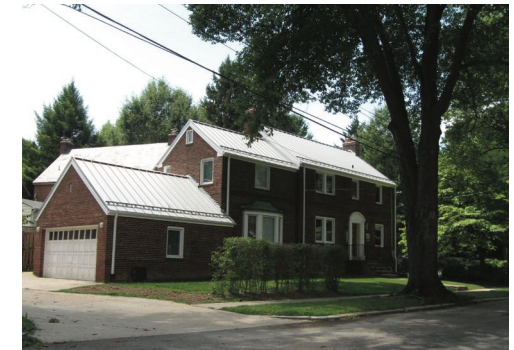
88

Not Recommended: [88] This new, cool white metal roof is not an appropriate material or color for this historic mid-20th century house.

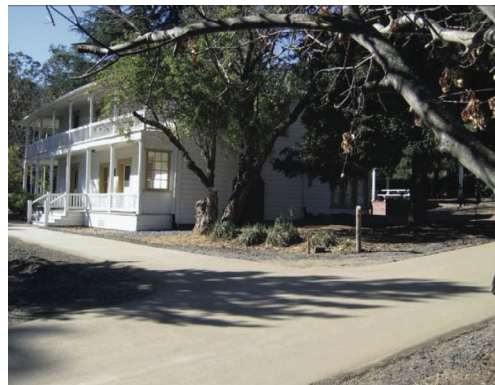
95

Recommended: [94-95] Permeable pavers were used at this historic residential property for a driveway and parking (above) and a hard-packed, construction aggregate provides environmentally-friendly paths for visitors at this historic site (below).

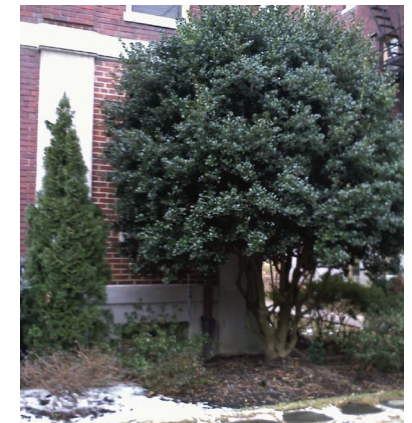
97

Not Recommended: [97] This tree, which was planted too close to the building, has caused the masonry wall to retain moisture that damaged the mortar and required that the brick be repointed in this area.

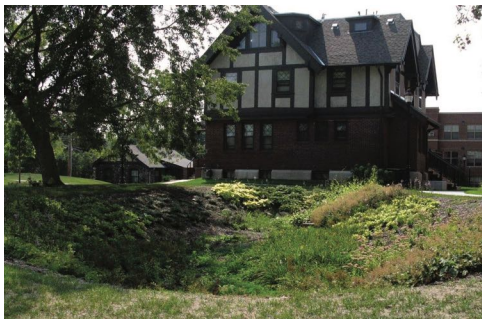
98

Recommended: [98-100] Rain gardens and rain-water collection tanks are features that may be added to a historic property to improve storm-water management and increase on-site water use.

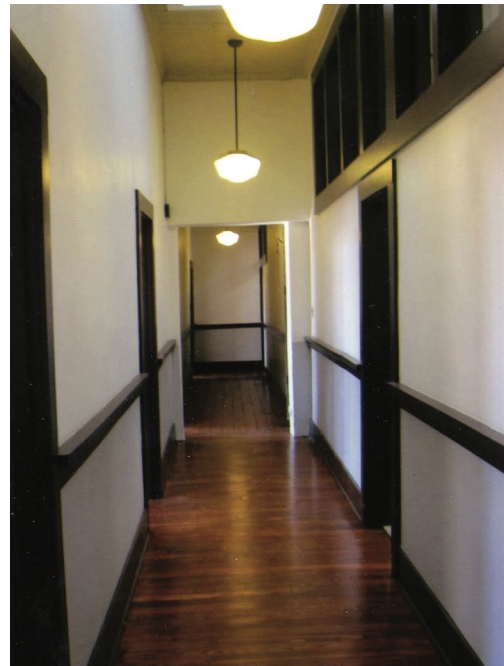
108

[108-109] The original, partially-glazed doors and office partitions, as well as skylights, that let natural light into the corridors were retained as part of the rehabilitation of this early-20th century building.
