26 PRESERVATION BRIEFS

The Preservation and Repair of Historic Log Buildings

Bruce D. Bomberger

U.S. Department of the Interior
National Park Service
Cultural Resources
Preservation Assistance

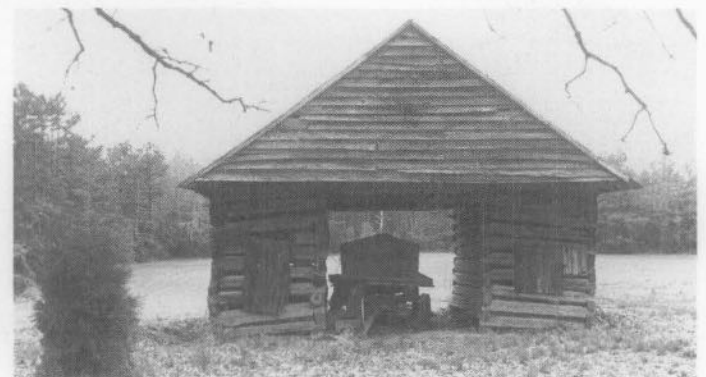
Fig. 3. This mid-19th century double-pen corncrib on the Jamison Farm in Rowan County, North Carolina, is an example of a type of log building that did not require chinking. Photo: Denise Whitley.

structed as temporary shelters by soldiers during the Revolutionary War, and across the country, Americans used logs not only to build houses, but also commercial structures, schools, churches, gristmills, barns, corncribs and a variety of outbuildings (Fig. 3).

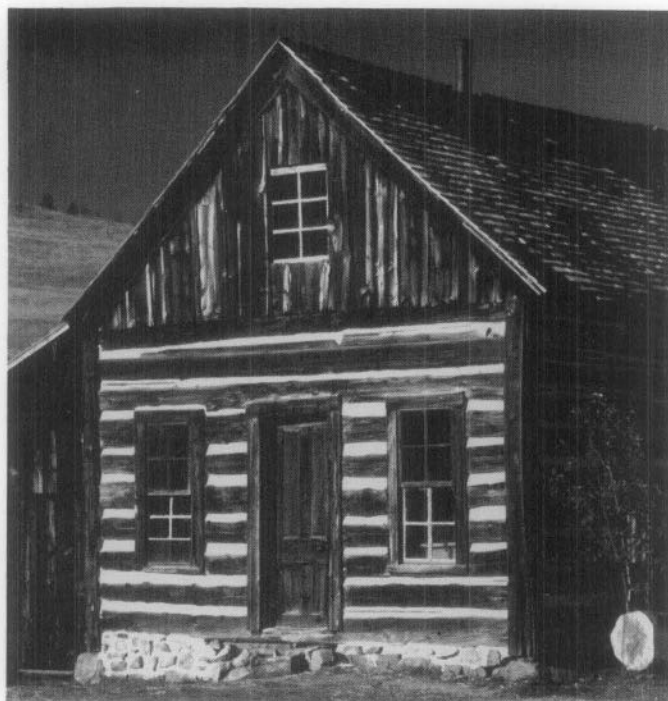
Fig. 9. This historic log building on the Walker Ranch in Boulder, Colorado is an example of the Rocky Mountain cabin form which is typified by the entrance door being located in the gable end. Photo: Bernard Weisgerber.

A somewhat different form evolved in the West around the middle of the 19th century which became especially distinctive of the Rocky Mountain cabin. While the entrance doorway to most earlier log houses was generally placed beneath the eaves, as a means of adapting to the greater snowfall in the Rockies, here the entrance was placed in the gable end, and sometimes protected from roof slides by a porch supported by two corner posts created by an extension of the roof beyond the gable wall (Fig. 9).

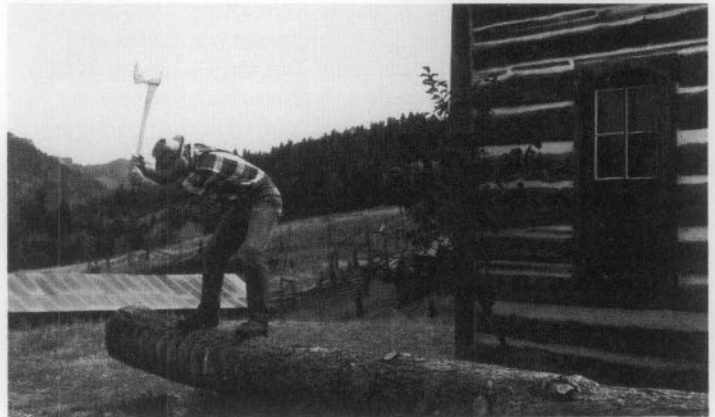
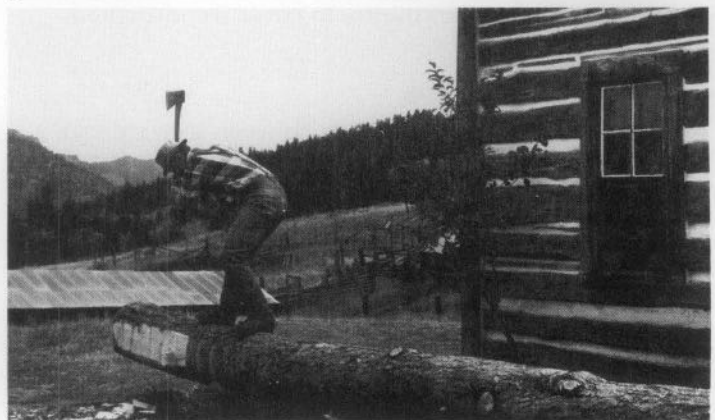
Fig. 11. Log-hewing tools and techniques: (a) scoring the log with a single-bladed felling axe, or "pole axe" in preparation for removing a uniform thickness of wood; (b) removal to depth of scoring; (c) finish hewing with a broad axe. Photos: Courtesy Bernard Weisgerber.

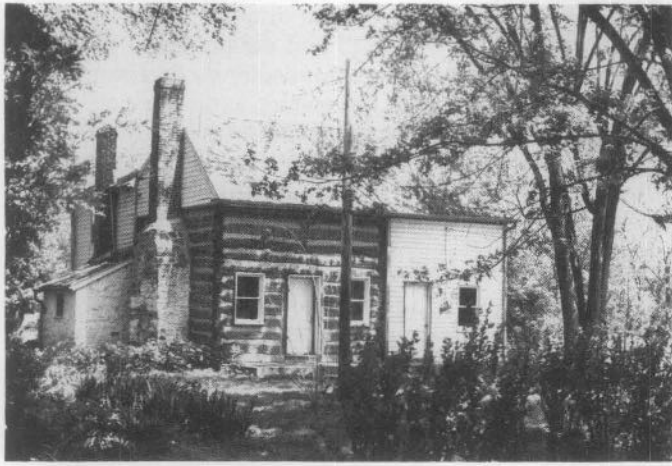
Fig. 13. Historic wood clapboard siding originally applied to conceal the fact that this house was built in two sections of different materials has been inappropriately removed from the 1793 log portion. Photo: National Park Service Files.

Sometimes log houses were sided or stuccoed later in an attempt to express a newly-achieved financial or social status. Many log houses were immediately sided and trimmed upon completion to disguise their simple construction beneath Georgian, Federal and later architectural styles. Frequently a log house was covered, or recovered, when a new addition was erected in order to harmonize the whole, especially if the original core and its addition were constructed of different materials such as log and wood frame (Fig. 13).

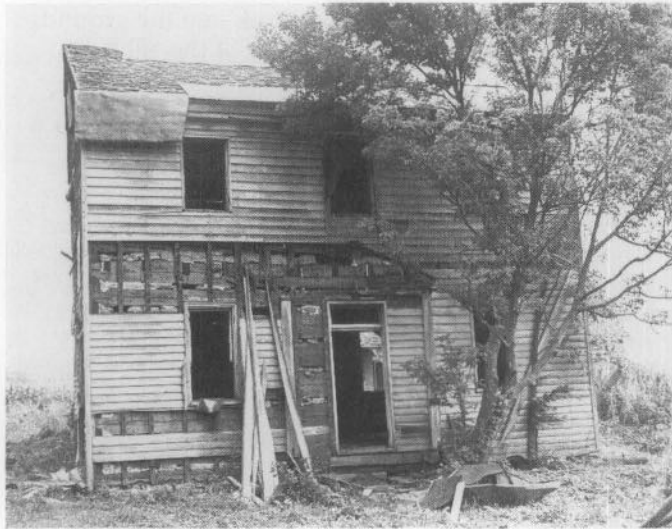
Fig. 14. Removal of the historic wood siding from the 1804 Zachariah Price DeWitt House in Butler County, Ohio, reveals that the clapboards were attached to vertical wood furring strips nailed to the logs. Photo: National Park Service Files.

Vertical wood furring strips were generally nailed to the logs prior to applying weatherboarding or stucco (Fig. 14). This ensured that the walls would be plumb, and provided a base on which to attach the clapboards, or on which to nail the wood lath for stucco.

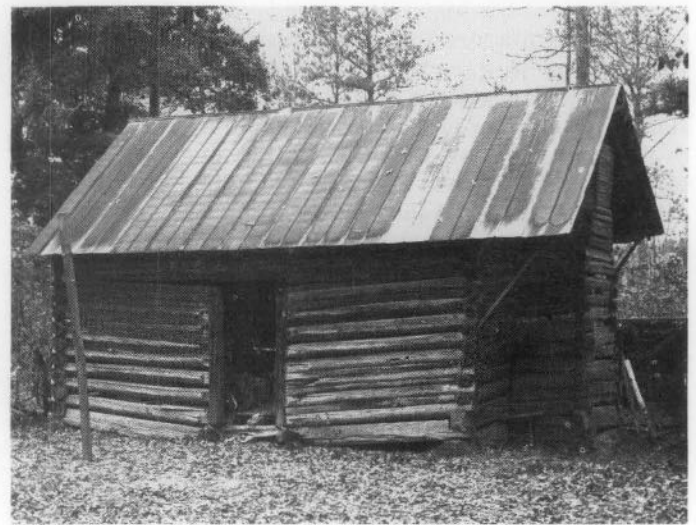
Fig. 15. The mid-19th century O'Quinn House, Moore County, North Carolina, provides a rare surviving example of a clay-lined log chimney. Although the logs of the house are saddle-notched, the chimney logs are "V" notched. The roof was extended out over the chimney to protect the daubing from the weather, and the chimney stack would have originally projected through a hole in the roof. Photo: Michael Southern.

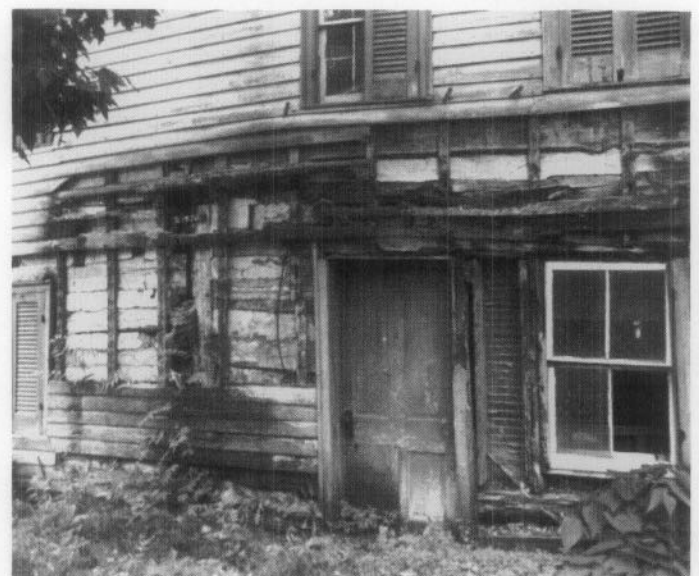
Fig. 17. Contact of this building's sill log with the ground has led to its decay, infestation by wood-destroying insects, and resulting building settlement. Photo: Anne Grimmer.

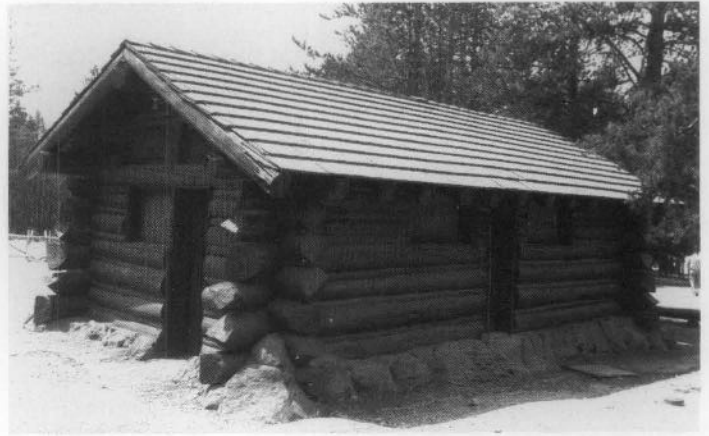
Fig. 18. Exposed roofing members of Rustic style buildings such as this structure at Yellowstone National Park are highly susceptible to deterioration. Photo: Laura Soulliere Harrison.

story was added, or repaired as the result of storm or fire damage. Often, roof framing may be composed of reused material recycled from earlier buildings. Inspection of the roof framing should note its configuration and condition. Typical problems to look for are framing members that have been dislodged from their sockets in the roof plate, or that are cracked, ridge damage, sagging rafters, broken ties and braces, and decay of exterior exposed rafter or purlin ends, especially common on Rustic style buildings (Fig. 18).

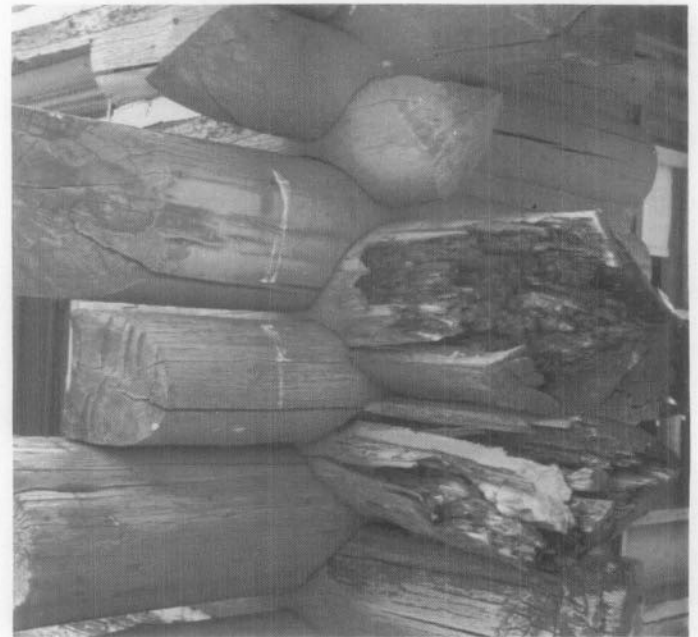
Fig. 20. (a) These deteriorated log crowns were (b) repaired with new crowns which were attached to the historic logs with reinforcing bars and epoxy. Epoxy repair of log crowns is most successful when the repaired crowns are protected from excess moisture by a roof overhang. Photos: Harrison Goodall.

The technique of treating, for an example, a decayed log crown with epoxies is begun by removing loose decayed wood, and drying the area if necessary (Fig. 20). The rot-affected cavity and surface of the log end is then saturated with liquid epoxy by repeated brushing, or by soaking it in a plastic bag filled with epoxy that is attached to the log. The porous condition of the rot-damaged wood will draw up the epoxy like a lamp wick. Once the liquid epoxy has saturated the log end and cured, the log end has been consolidated, and is ready for the application of an epoxy putty filler. The filler resin and hardener must also be mixed; pigments must be mixed with the filler epoxy to color the patch, and more importantly to protect it from ultraviolet sunlight. The filler can be applied with a putty knife, pressing it into the irregularities of the cavity. The cured patch can be worked like wood and painted with an opaque stain or a dull finish paint to help it blend with surrounding wood, although epoxy repairs can be difficult to disguise on natural, unpainted wood.

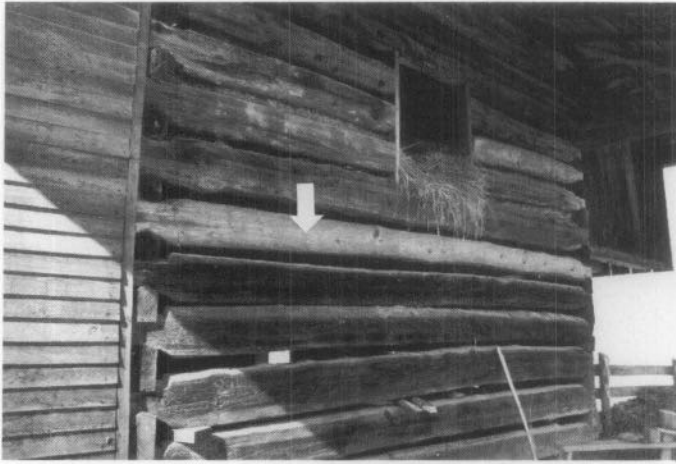
Fig. 22. The lighter-colored replacement log in this barn matches the dimensions and hewing marks of the original logs, and will darken in time to blend visually with the other logs. Photo: Bernard Weisgerber.

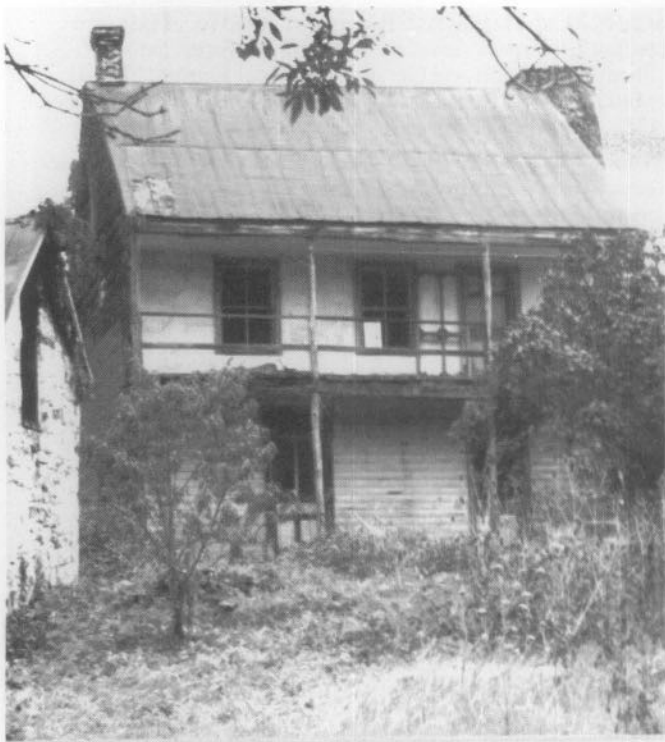
Fig. 25. (a) Prior to rehabilitation, the exterior of this late 18th century log house was sided with wood clapboard, which had been covered over by a later artificial siding, while the upper gallery of the second floor porch was stuccoed. (b) During the rehabilitation both the historic wood siding and stucco were removed to expose the logs, the gables were sided with wood shingles, and what would have originally been milled wood columns supporting the porch were replaced with rough, unmilled log posts. Collectively, these treatments diminished the building's architectural integrity, and gave it an appearance it never had. (c) The depth that the window frames extend out beyond the log surface allowing space for siding is an indication that cladding was part of the building's original construction. Photos: National Park Service Files.
