## Monitored Thermal Performance of ICF Walls in MURBs

## Research Highlight

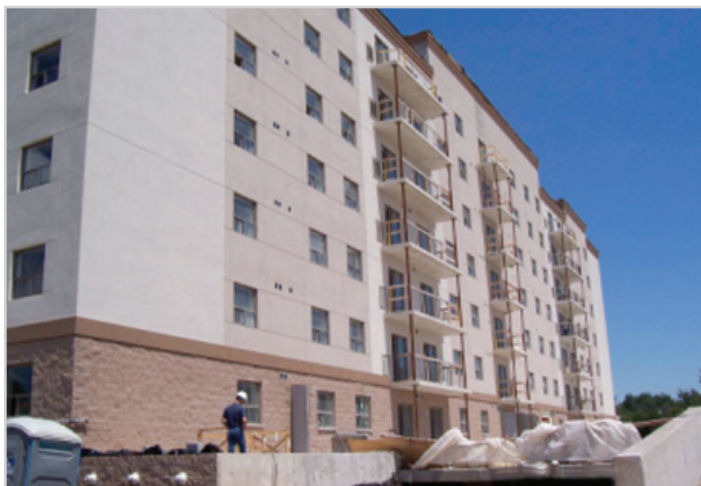
Figure 1 The building studied for the research project

Jamesway Construction built the study building, shown in figure 1, in 2005 in Waterloo, Ont. The seven-storey building has 100 apartments and a floor area of 8,140 m<sup>2</sup> (87,620 sq. ft.).

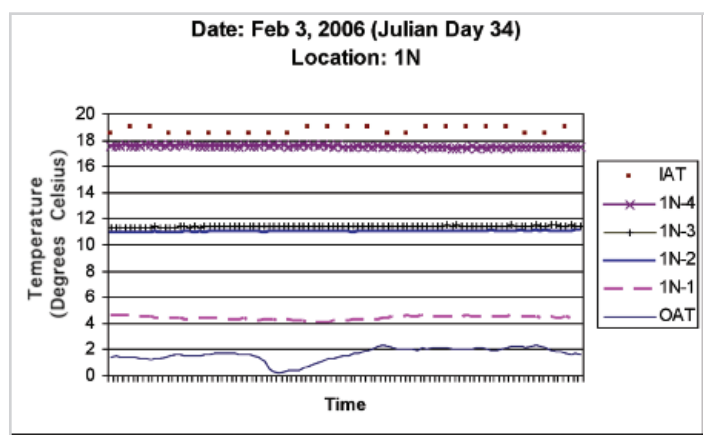
Figure 3 shows the through-wall temperature conditions at the first storey location on the north wall (1N) on February 3, 2006, when the wall was observed to be at a quasi-steady-state condition. The temperature difference across the inner (1N-4 to 1N-3) and outer (1N-2 to 1N-1) layers of insulation was approximately 6.3°C. By comparison, there was only a difference of 0.4°C across the concrete (1N-3 to 1N-2). This indicates that the concrete does not contribute significantly to the overall thermal resistance of the wall under steady-state conditions.

**Figure 3** Quasi-steady-state wall performance

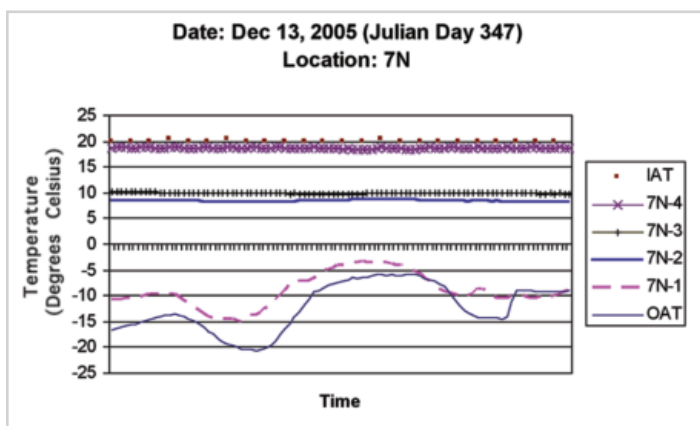
Figure 4 shows the wall conditions on the 7th floor, north wall location (7N) for a day with significant fluctuations in the outdoor air temperature (OAT). Not surprisingly, the temperature at 7N-1 (the exterior wall surface) closely follows the OAT; however, the temperature at the inner locations held constant throughout the day.

This indicates that the inner surface of the concrete (7N-3) is well isolated from outdoors temperature changes by both the insulation levels on the exterior of the wall and the capacitance of the concrete. The level of isolation is so large that what happens outdoors has almost no impact on the interior concrete temperature and therefore no significant impact on the heat flow through the wall from the interior in the short term (that is, daily or even weekly).

Figure 4 ICF wall isolating IAT from OAT
