**ABANDONED MOBILE HOMES TOOLKIT
BEST MANAGEMENT PRACTICES RESOURCE GUIDE**

**U.S. Environmental Protection Agency, Region 2
290 Broadway, 22nd floor
New York, NY 10007-1866**

**TechLaw, Inc.
205 West Wacker Drive, Suite 1622
Chicago, IL 60606**

April 13, 2011

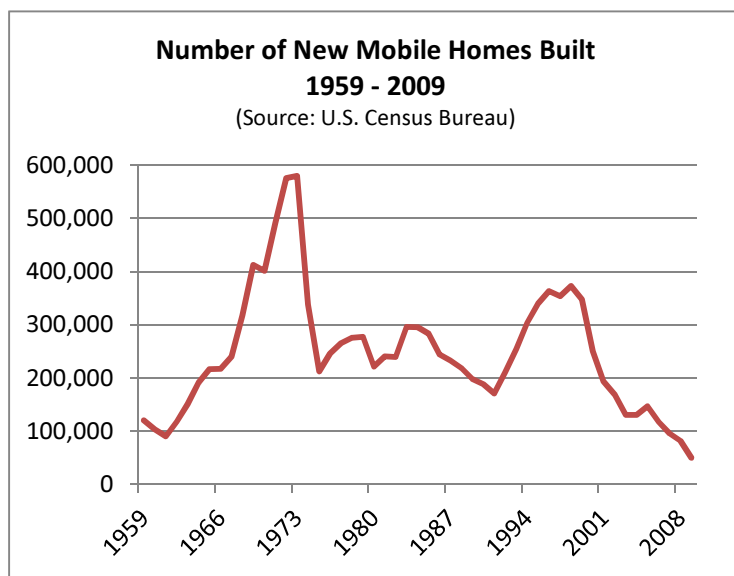
Figure 1 - Number of New Mobile Homes Built 1959 - 2009

Of these 8.7 million mobile homes, 332,000 were classified as vacant in 2007.⁵ U.S. Census data shows that mobile home construction peaked in the early 1970s (just prior to enactment of nationwide regulations designed to combat past manufacturing quality concerns). As a result, many of these 332,000 vacant mobile homes were likely built before enactment of the nationwide construction standards. They are reaching the end of their useful lifespans. Figure 1 graphically depicts the number of new mobile homes built between 1959 and 2009.⁶

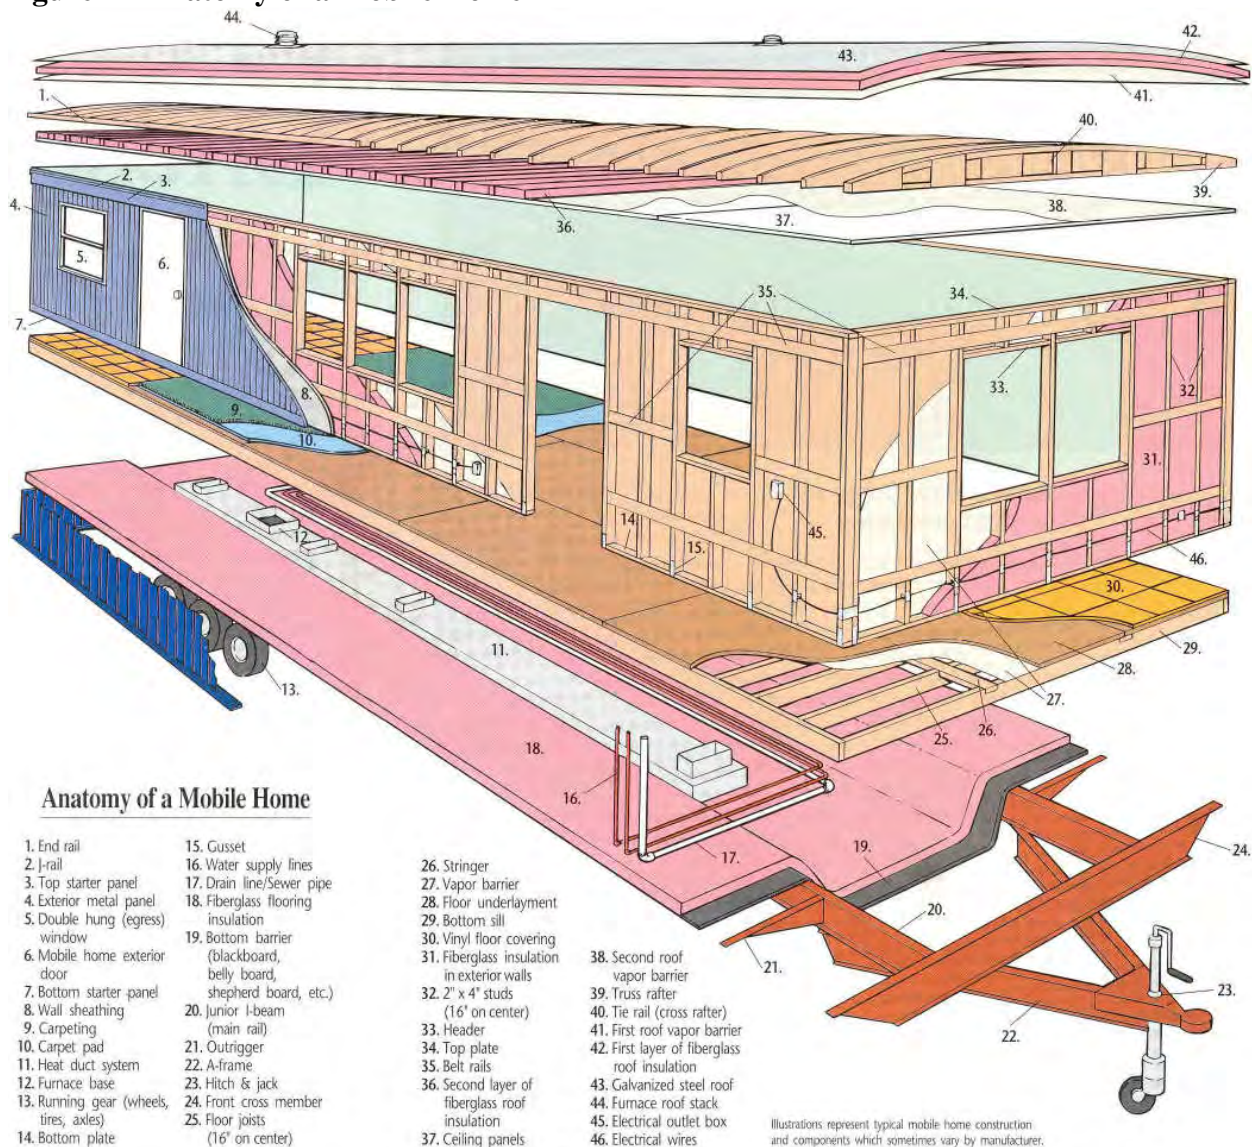
Figure 2 - Anatomy of a Mobile Home¹⁷

The anatomy of a typical mobile home is depicted in Figure 2.

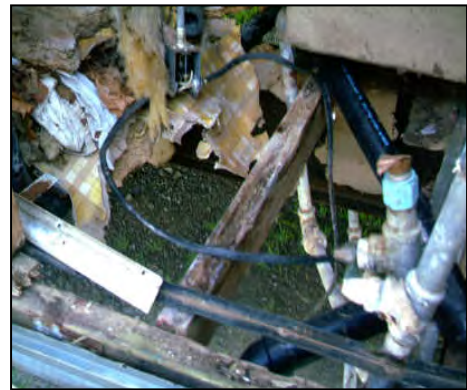
Photograph depicting the rotted floors of MHU2. The floor cavities were exposed raising a safety concern

During the inventory phase, the interior of MHU2 was determined to be unstable. The lower portions of the walls were rotted out and posed a significant safety hazard to the deconstruction team. The deconstruction experts determined that it would be safest to conduct this deconstruction by first removing the roof of the structure; next, deconstruction of the bottom portions of the exterior walls (including removal of the aluminum siding) would take place; finally, deconstruction of the interior would commence. The following observations were made during the inventory phase for this unit:

- The structure's roof appeared to be stable;
- The most salvageable portion of the structure was determined to be the roof and ceiling materials (i.e. trusses and roof paneling).
- Lower portions of the walls and some of the floor were rotted;
- Mold was discovered in the exposed insulation; and
- Rodent feces were found in the insulation and in the wall and floor cavities.

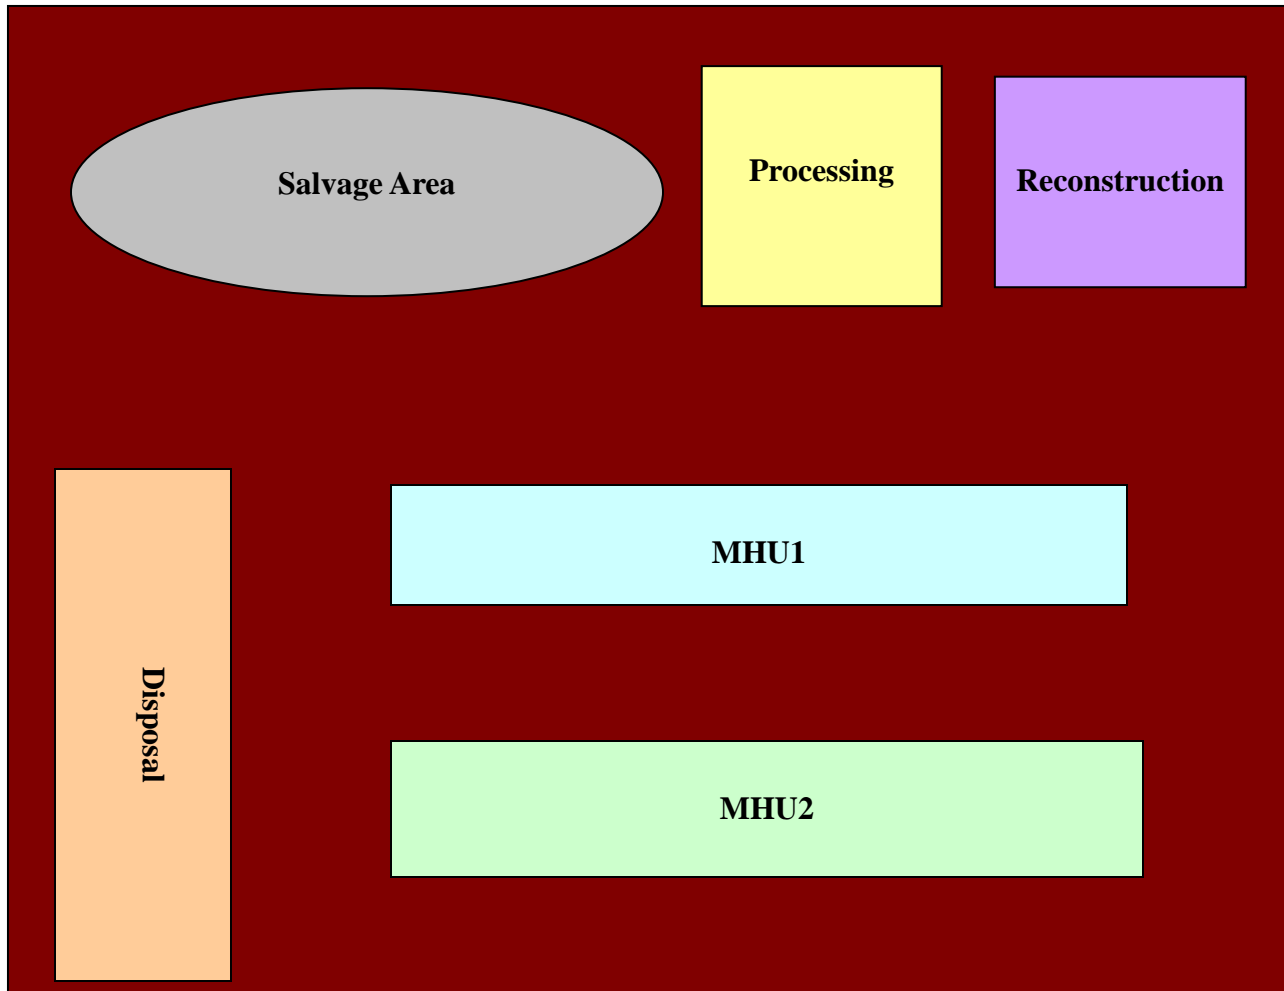
Figure 3 - Deconstruction Site Layout

This path made disposal more efficient, provided more ventilation, and encouraged a clean work site.

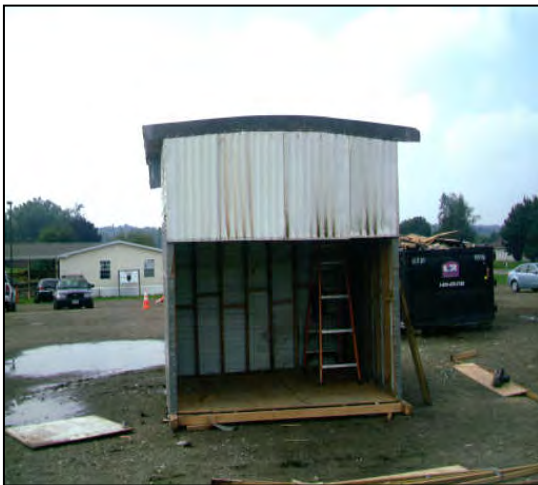
The main reconstruction project, the tool shed; 12 feet high by 6 feet wide.

Reconstruction activities consisted of building four saw horses and a tool shed. The reconstruction project was completed in approximately 18 hours. This included approximately eight hours using manual tools and labor and ten hours using power tools. The reconstruction project used approximately 26 percent of the materials salvaged from MHU1 and MHU2. Five volunteers supported the construction of four saw horses as well as a tool storage shed. The tool shed was constructed using lumber from the floor and wall frames from MHU1, some salvaged roof trusses, and the aluminum siding salvaged from both structures.

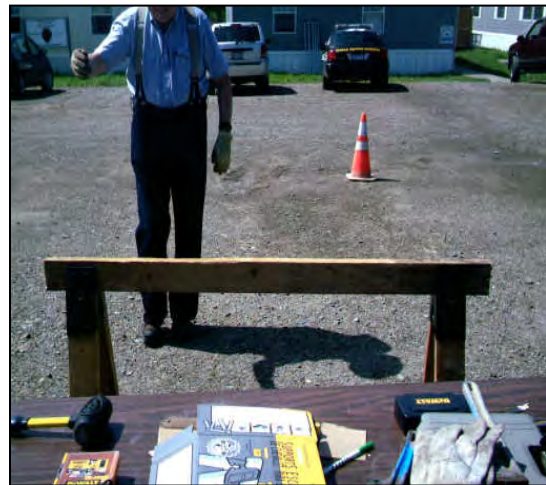
The first reconstruction project; saw horses.

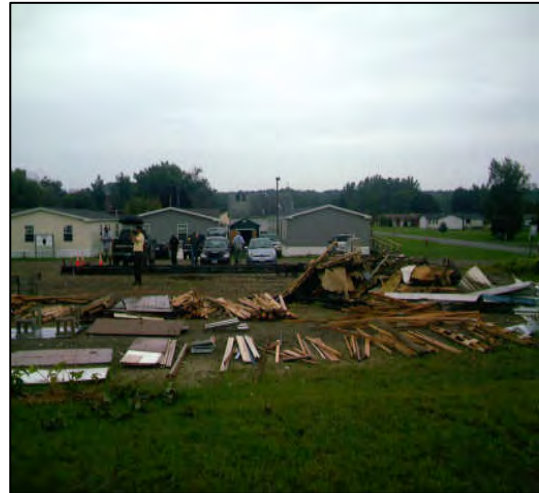
Salvaged material from the deconstruction of the two abandoned manufactured homes.

Approximately 1.75 tons of salvaged material was gathered from MHU1. Of the 1.75 tons, 0.53 tons of salvaged materials were immediately reused on construction of the four saw horses and the tool shed. The majority of this material was comprised of the 2 x 4 lumber that was salvaged and used in constructing the floor and walls of the tool shed.

In comparison, approximately 1.01 tons of materials were salvaged from the deconstruction of MHU2; 0.63 tons of this material was reused as ceiling trusses for constructing the tool shed's roof.

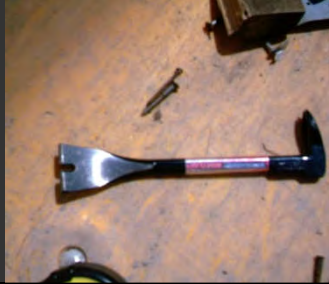
Item and Description		Item and Description	
<p>Bear Claw (Manual) Used during processing for prying nails from salvaged material.</p>

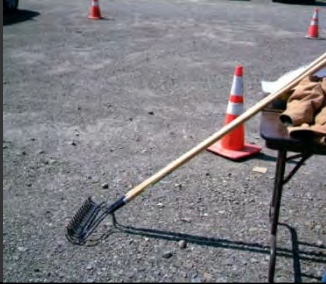
<p>Push Broom (Manual) Used to clean the work station which permitted hazardous materials to be removed as they posed potential safety issues.</p>

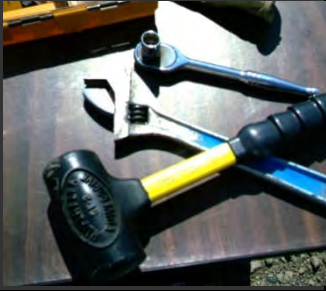
<p>Rubber Mallet, Adjustable Wrench, and Socket Wrench (Manual) Used during the reconstruction phase. The hammer was used to beat the salvaged aluminum siding around the corners of the storage shed.</p>

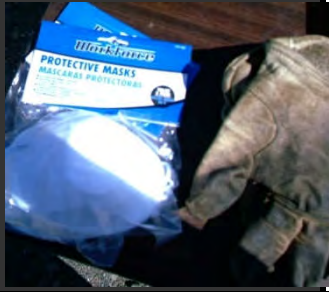
<p>Dust Masks and Work Gloves (Personal Protective Equipment) These items are essential to the health and safety of the deconstruction team as dust and mold infested items will be encountered during the majority of deconstruction projects.</p>

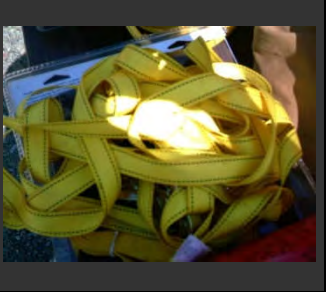
<p>Tension Straps (Manual) Used to stabilize exterior walls whose support has been removed. The strap prevented the wall from collapsing on workers.</p>

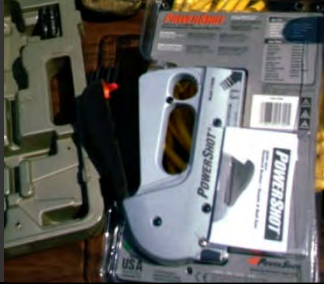
Item and Description		Item and Description	
<p>Heavy Duty Stapler (Manual) Used during the processing and reconstruction phases. Used to reinforce salvaged trusses prior to reuse.</p>
