TRUMAN HOME HARRY S TRUMAN NATIONAL HISTORIC SITE Independence, Missouri

EXTERIOR WOODWORK

NUMBER 2

Paint Removal from Wood Siding

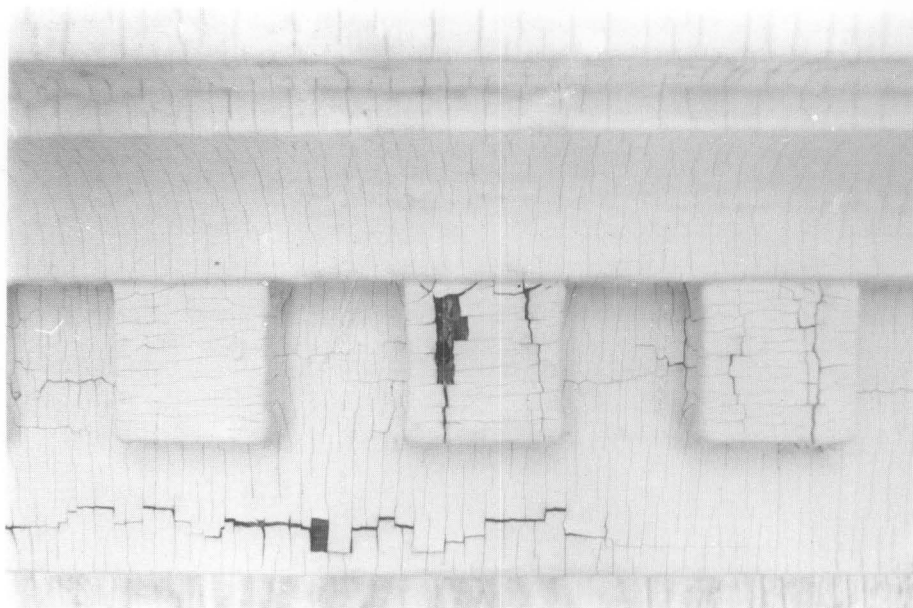
Examination of the exterior paint finishes in areas directly exposed to the elements revealed severe paint film failure, including cross-grain cracking, alligatoring, and peeling (see figure 1). Even in places shielded by porches and cornices, moderate paint film failure had occurred. A number of exposed areas, including soffits, fasciae, and siding, experienced near total paint failure due to recurrent moisture penetration from deteriorated roofs and built-in gutters. Windows were also in very poor condition; many exhibited loose glazing, broken glass and rotted sash. More than 20 coats of paint concealed deteriorated woodwork and cladding from direct examination. On much of the projecting mill work, the final layers of paint had been applied so heavily that stalactites in excess of one-quarter inch were apparent due to paint dripping.

Figure 1. Detail of a cornice dentil shows the severe cracking and failure of paint finish. Photo: Alan O'Bright

bathroom causing the paint to peel off in hand-size sheets. It was clear the exterior finishes had lost most, if not all, of their elastic integrity. In order to achieve a sound surface for painting, the decision was made to remove a majority of the exterior paint finishes to bare wood in preparation for a three-coat paint application.

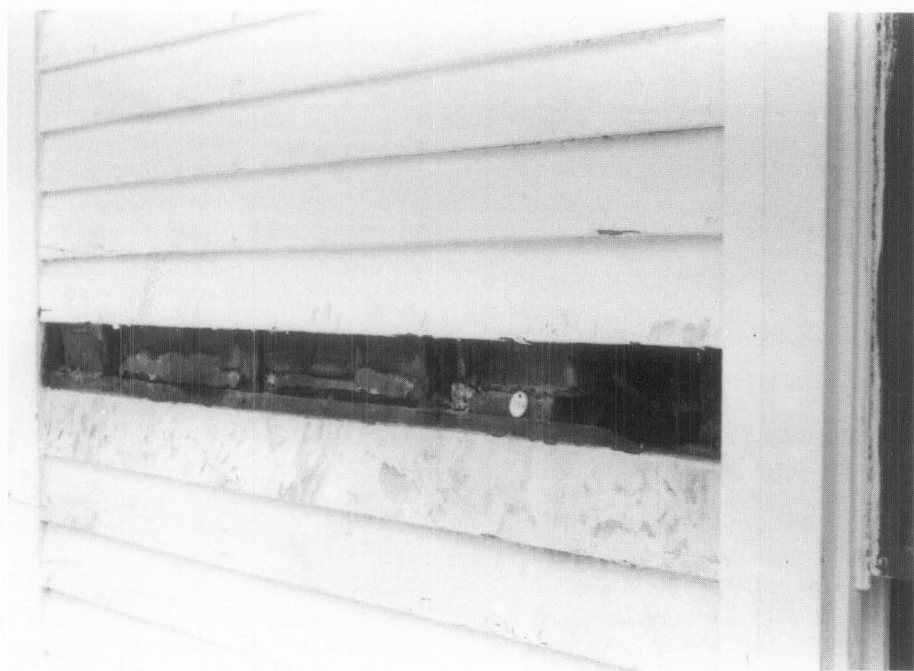
As part of the planning required before the selection of the paint removal method, a physical investigation was conducted of the exterior structure to determine the method of construction and condition (see figure 2). This is particularly critical whenever paint removal is planned. Decisions as to which paint removal methods will be used—especially methods involving heat—are in part guided by the potential flammability of the wall material and debris in the wall cavity and cornices. Sections of lapped siding were carefully removed and the underlying board sheathing cut with a hole saw to reveal the wall cavities. Fortunately, the bulk of the balloon-framed structure was found to be in good condition and the project team believed that potential fire risks could be minimized. With the exception of the 1884 addition, all wall cavities had been filled from foundation sill to soffit with soft brick and mortar.

Figure 2. In assessing the safety of using thermal heat to remove paint from the siding, an investigation was performed to determine wall construction and condition. In this portion of the structure, there was no sheathing backing the siding but brick nogging extended from the foundation to the soffit. Photo: Alan O'Bright

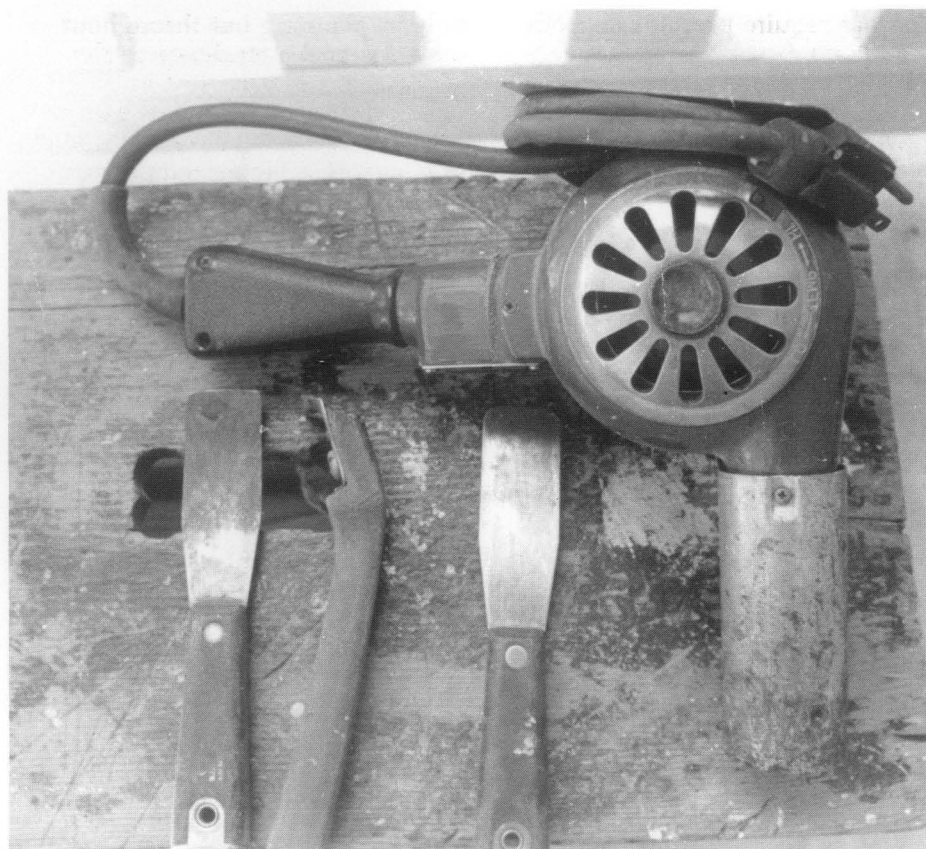
A heavy-duty heat gun was approved for the contractor's use (see figure 3). The metal encased unit featured variable heat control (500-750° F) through adjustable side vents, and a cool down switch, which extends the life of the replaceable heating elements. Since these elements can have a working life as short as 60 to 80 hours, extra elements were purchased and were available at the site for immediate replacement of those in the five heat guns used in the project.

Figure 3. Heat guns, putty knives with corners rounded, and paint scrapers were used in paint removal. Photo: Michael Lee

During paint removal the scraped paint tended to adhere to the putty knife, slowing the paint removal process. The workers tried several putty knives and scrapers, but none was successful in shedding the paint residue from the blade. Therefore, the knives had to be periodically cleaned of gummed paint with another putty knife. For siding, a 2 to 2½ inch-wide rigid putty knife worked best. Narrower blades were used for millwork and tight spots. To reduce chances of the workers gouging the wood with the putty knives, the edges of the blades were rounded using a grinder.

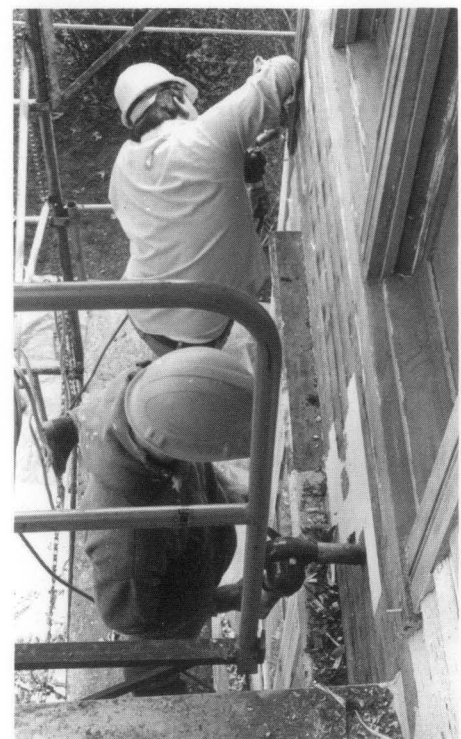
worker alternately heated and scraped the surface. Time was lost in this method because the heat gun had to be set down periodically in order for the worker to clean his putty knife. The second technique, developed by the contractor's site supervisor, was to fasten two heat guns together side by side using metal bars bolted to each gun base (see figure 4). In this way one worker heated the surface while another scraped in a continuous process. This method worked very well for expansive areas of siding and attained an average rate of 8 to 10 square feet per crew hour. On siding in tight areas where one worker operated a single heat gun, paint was removed at a rate of approximately 4 square feet per crew hour (see figure 5).

Figure 5. Using scaffolding, workers remove the paint with heat guns. Cracked or deteriorated siding was repaired or replaced. Photo: Alan O'Bright

The siding was inspected for rot and cracks, and suspect sections were marked for repair or replacement. The marked sections were passed over in the paint removal process.

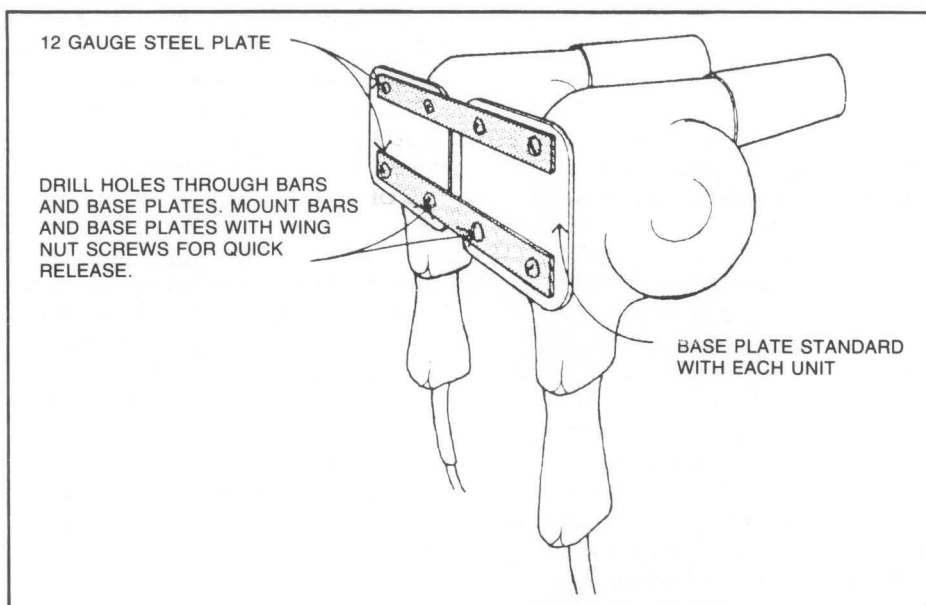
Figure 4. Method used to join two heat guns for simultaneous use. Drawing: Alan O'Bright

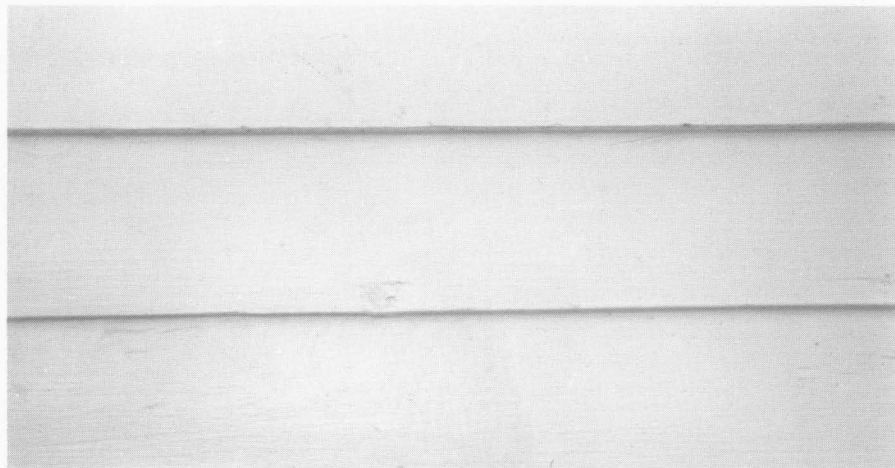
Areas on the Truman home where paint was removed with the heat guns and then lightly sanded provided an excellent painting surface (see figure 6). By using workers experienced with thermal removal of paint, very few scraper tool marks were left that were noticeable. The new paint bonded well to the wood

Figure 6. A typical section of the finish painted siding shows that little damage was done in removing the paint. Photo: Michael Lee
