FIRE ESCAPES IN URBAN AMERICA: HISTORY AND
PRESERVATION

A Thesis Presented

The University of Vermont

In Partial Fulfillment of the Requirements
for the Degree of Master of Science
Specializing in Historic Preservation

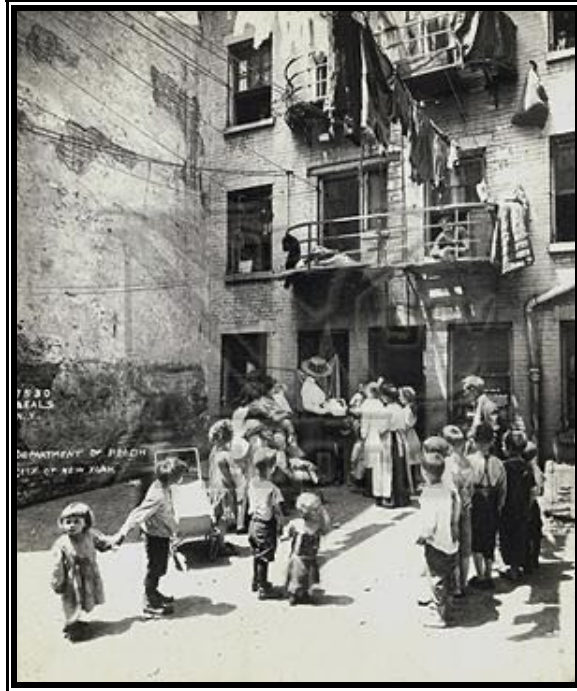
Figure 5: Landlords often provided the most rudimentary fire escapes for tenement houses. (*Visiting Nurse*, 1915, New York City Department of Records Municipal Archives Photo Gallery, Photo ID: DOH 2556, <http://www.nyc.gov/html/records/>)

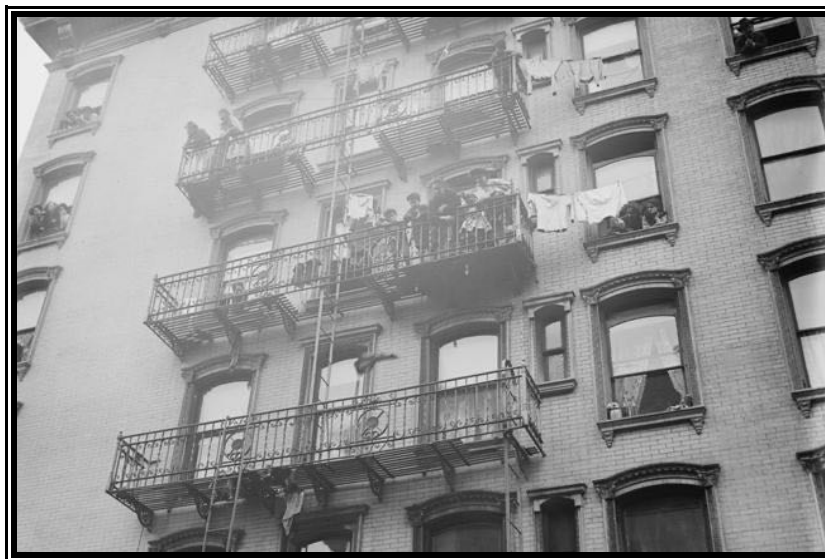
Figure 12: Fire escapes on the main facades of tenements occasionally were more decorative. (*Tenement Dwellers Dropping Clothes from Fire Escapes for Italians of the Lower East Side, 1909*; George Grantham Bain Collection at the Library of Congress, Library of Congress Prints and Photographs Online Catalogue, <http://hdl.loc.gov/loc.pnp/ggbain.03081>)

Inspectors used the detailed guidelines and filled out an “F” card describing the conditions of fire escapes for efficient inspection. For the first time, regulations were strictly enforced and tenement house conditions significantly improved and regulations were strictly enforced; and as iron balconies and stairs began lining exterior walls, the physical and cultural character of tenement house neighborhoods underwent a major transformation (Figure 11). As well, the rigid enforcement of suitable exterior egress prompted landlords to seek out designs that would not seriously tarnish their real-estate investments and purchase more decorative contraptions for primary, street-front façades (Figure 12).

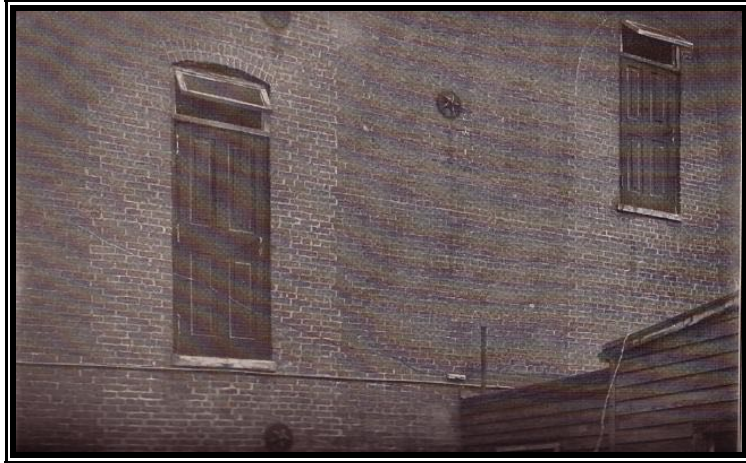
Figure 18: False exits on a Pennsylvania theatre. (“False Emergency Exits,” Quarterly of the National Fire Protection Association 9 (1916), 386.)

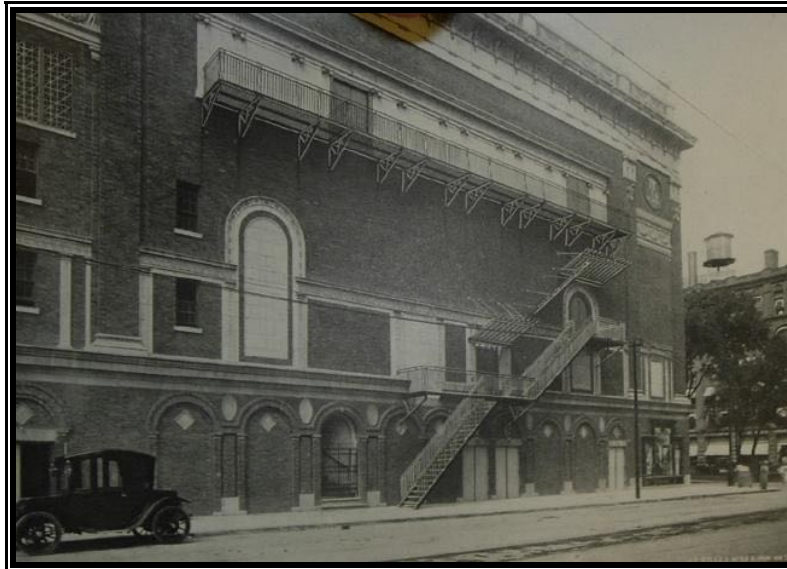
Figure 19: Demonstration of sufficient fire escapes on a Detroit, Michigan, theatre. (J.E. Bolles Wire and Iron Work. *Sectional Catalogue*. Detroit: The Firm, 1913: 89)

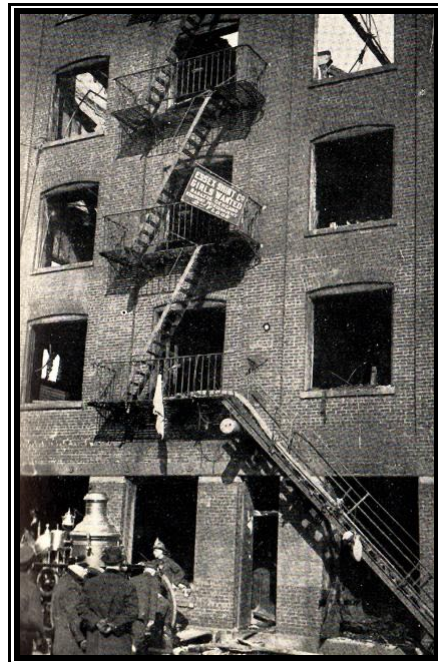
Figure 22: Flames shot out the window at this deadly factory fire, rendering the fire escape impassible. (“Two Factory Fire Holocausts,” Quarterly of the National Fire Protection Association 9 (1916), 273.)

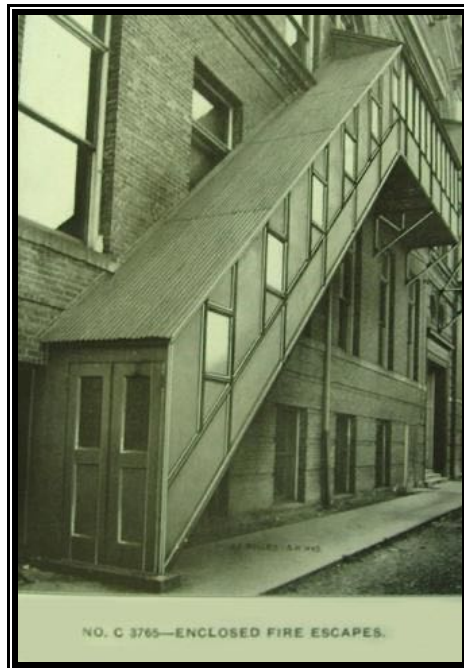
Figure 98: J.E. Bolles, No. C 3765 Enclosed Fire Escape (J.E. Bolles Iron and Wire Works. *Sectional Catalogue*. Detroit: The Firm, 1913: 6)

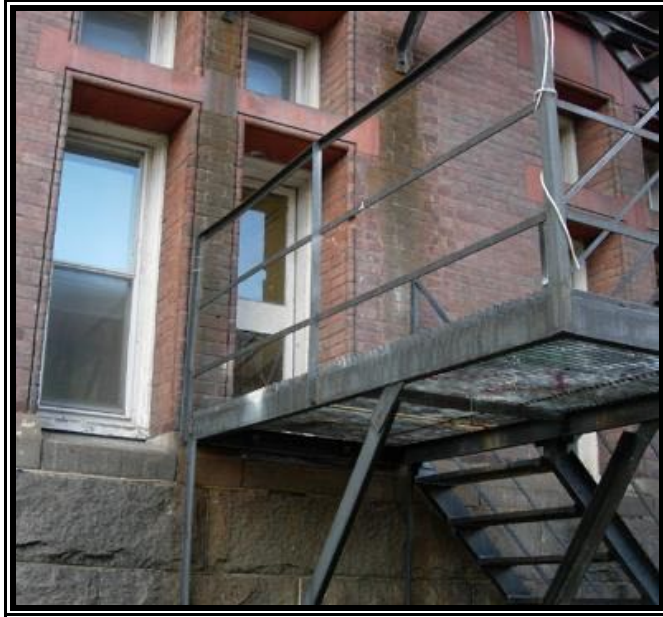
Figure 105: Rust runs down the masonry facade; anchorage many have weakened (author, 2005)

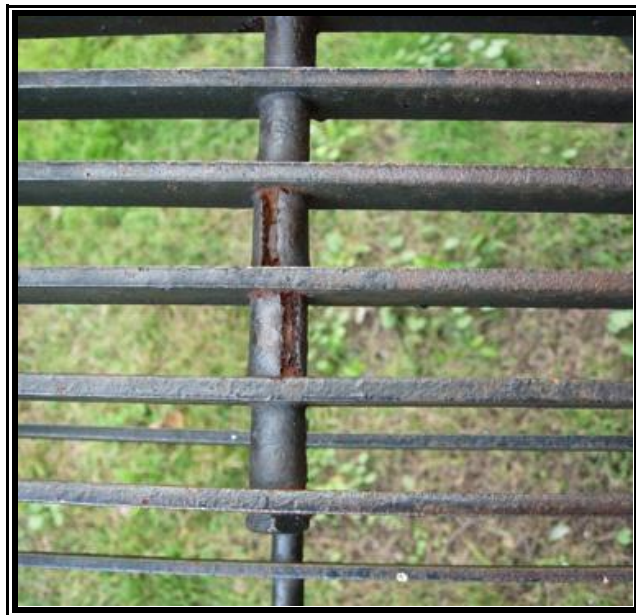
Figure 106: Voids in stair tread need to be filled (author, 2005)

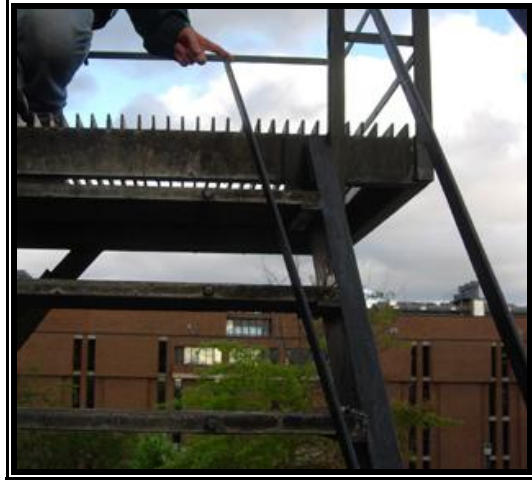
Figure 107: Railing has become detached due to severe oxidation (author, 2005)

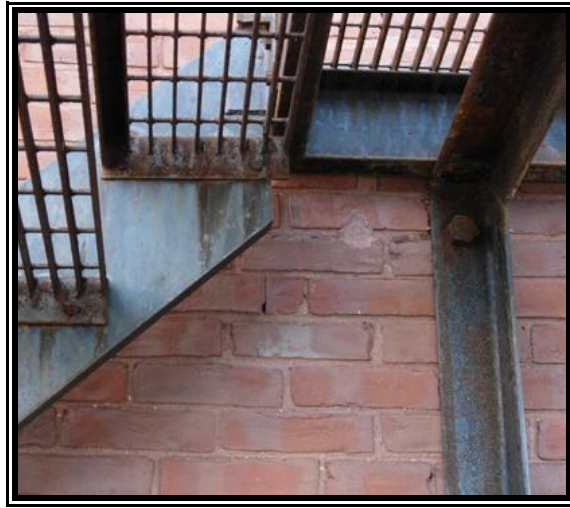
Figure 108: Deteriorating stair treads and bracket (author, 2005)

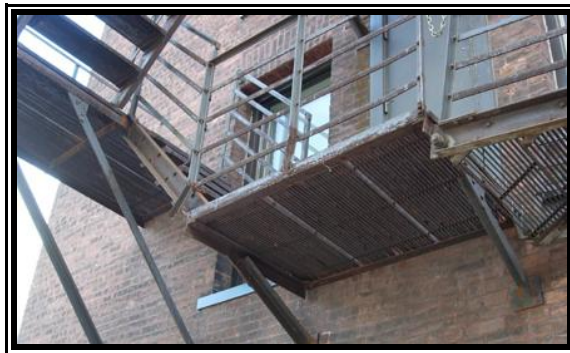
Figure 109: Broken balcony railings (author, 2005)

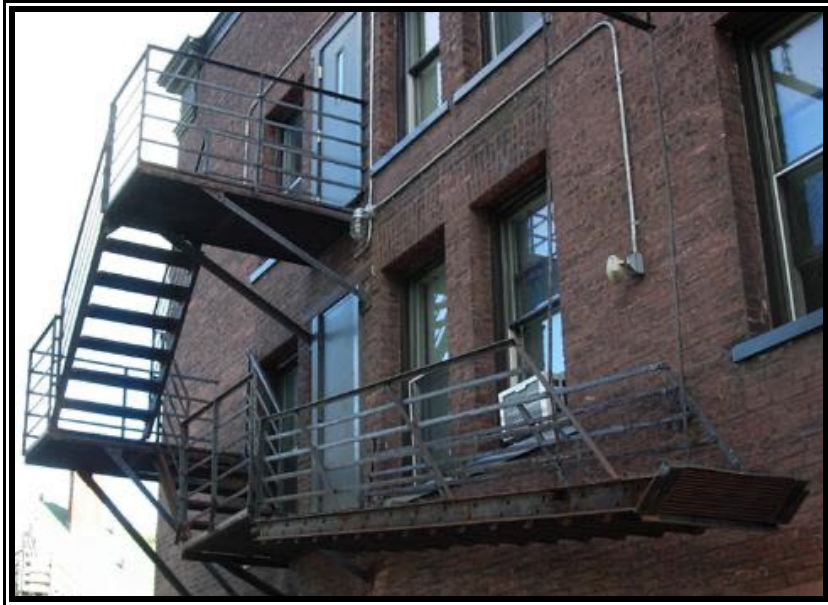
Figure 110: Severely rusted drop ladder; hinge probably stiff (author, 2005)

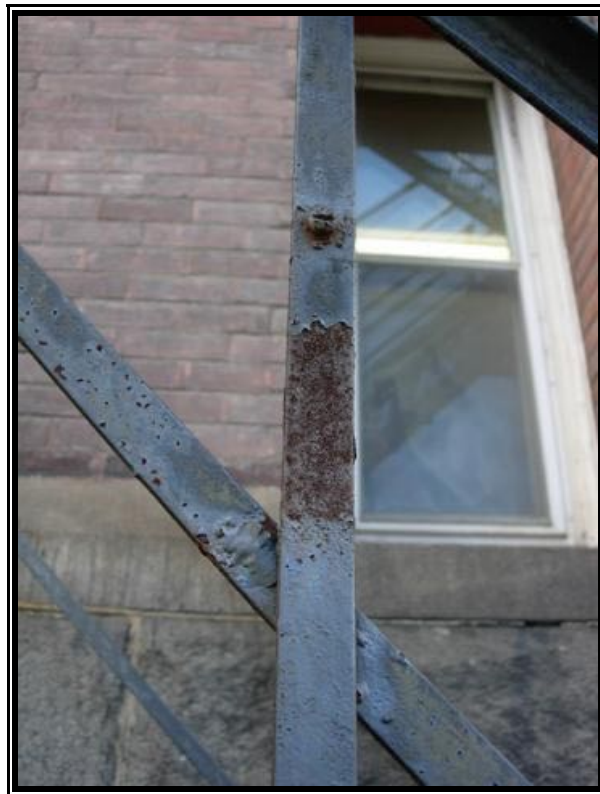
Figure 111: Rust that can be scraped and primed and painted (author, 2005)

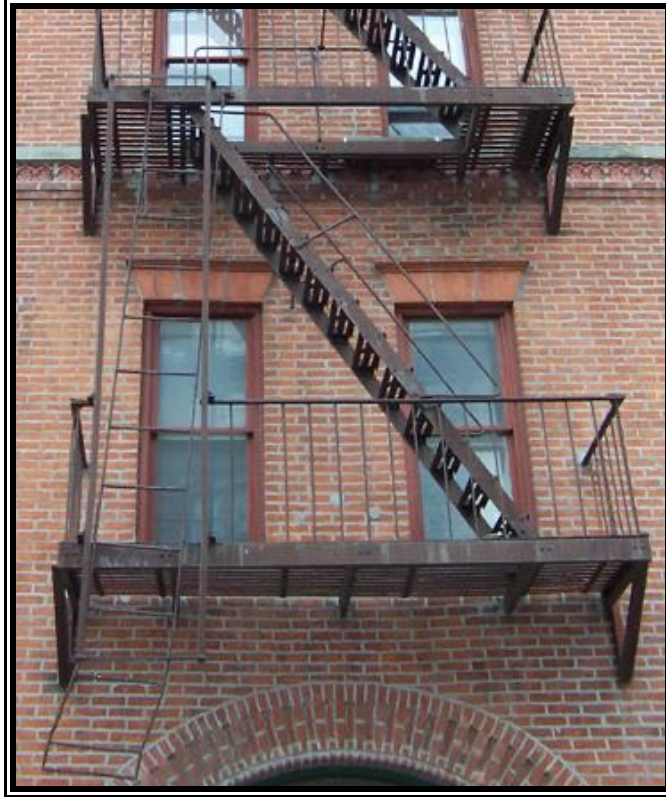
Figure 112: Drop ladder is bent out of shape and unusable (author, 2004)

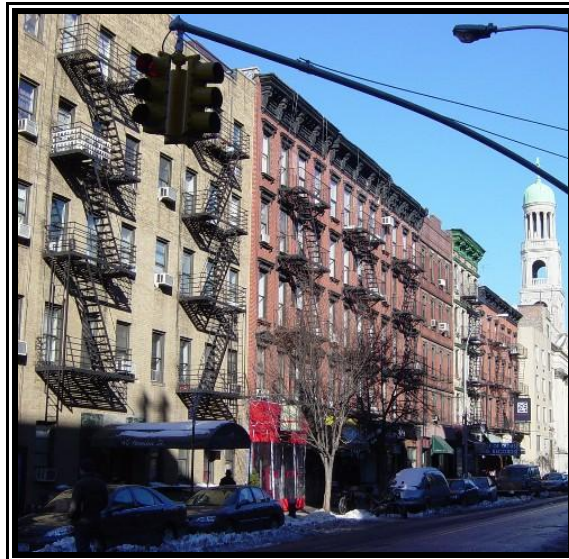
Figure 118: Ornamental fire escape at 169 Sullivan Street, South Village, New York City (Greenwich Village Society for Historic Preservation, “South Village - A Distinguished History Largely Unrecognized,” New York City, http://www.gvshp.org/south_village948.htm)
