ELECTRO-KINDLING

Easily-Ignited Free-Burning Plastic Materials in Electrical Applications

Jesse Aronstein, Ph.D., P.E.

Original: May 14, 1993. This Revision: July 19, 1996

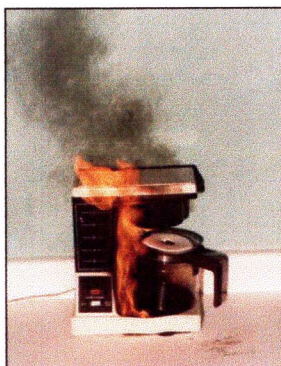
Figure 1A - Ignition Occurs Under continuously energized hot plate.

A TV program about coffee maker fires included a demonstration that showed the danger vividly. [Prime Time Live, October 17, 1991 (ABC).] The coffee maker's plastic housing burned vigorously for about 1/4 hour after igniting from its own heating element. (The heating element was continuously energized, simulating a component malfunction.) Flaming plastic flowed on the test bench surface. "It's like pouring diesel fuel on your counter top and letting it burn," said the engineer conducting the demonstration. This effect is shown in Figures 1A and 1B.

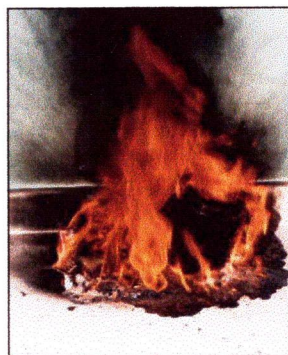
Figure 1B - Burning Plastic Flows on Countertop.

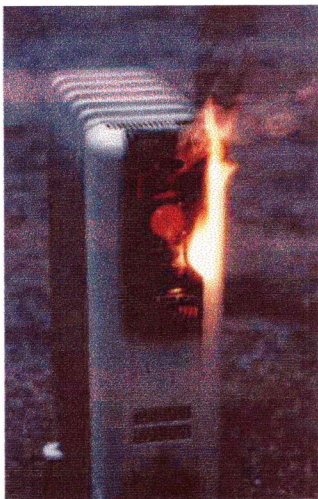
Figure 2A - Fire Spreads from Inside Front Panel.

A small amount of free-burning plastic "electro-kindling" fuels a substantial fire. The old saying "a little goes a long way" has never been more appropriate. As an example, the portable electric heater shown in Figure 2 (following page) is mostly metal. Plastic trim pieces on the front panel are held in place by integral mounting fingers inserted into holes in the metal front panel. The mounting fingers are inside the electrical enclosure. For the fire spread test shown in Figure 2, one of the plastic fingers next to the thermostat was ignited inside the panel enclosure, as happens from certain electrical component failures. [Recall announcement: Oil-Filled Portable Heaters, as reported in the New York Times, National Edition, August 15, 1991, p.A18] After about two minutes, the plastic finger burned through its opening in the front panel, spreading the fire to the outside of the metal enclosure (Figure 2A). More plastic became involved, and the fire grew (Figure 2B). Burning plastic fell to the floor, igniting another plastic trim piece near the bottom of the front panel (Figures 2C and 2D). This fire burned for more than 1/4 hour. In an actual household setting, a fire of this magnitude is likely to spread further.

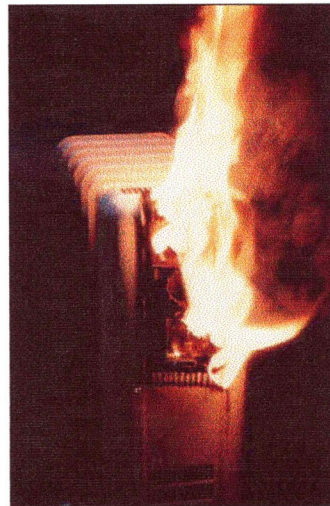
Figure 2B - Fire Grows as Plastic Panel Burns Vigorously.

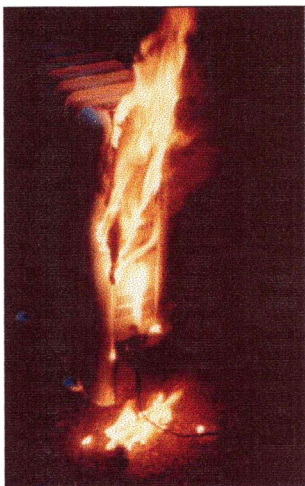
Figure 2C - Fire Spread, Flaming Plastic Drops to Floor.

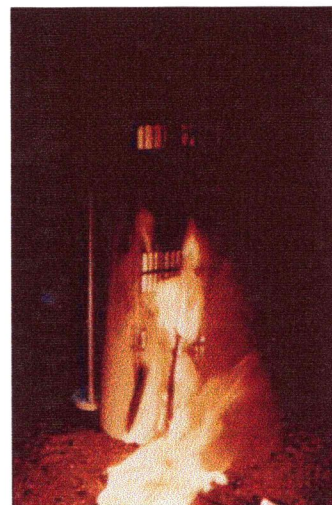
Figure 2D - Plastic Power Cord Cage on Bottom of Panel Burns.

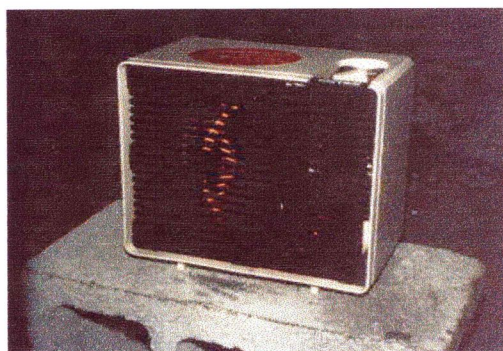
FIGURE 3A - Core Displaced Against Housing, Heater Wires Red Hot.

In the past, portable heaters were made mainly of metal. Today, many have housings and grills made entirely of free-burning plastics. Now the heater itself can ignite, where previously only nearby furnishings and fabrics were the major concern. An example is shown in Figure 3. The heater's fan and resistance wire assembly, its central core, is supported by the plastic rear grill. Loosening of the mounting screws or breakage of the rear grill can cause the core to drop.

The fan blade then rests against the housing and cannot rotate. Without airflow, the heater wires become red hot. Heater wires resting against the housing melt and penetrate the plastic. An overtemperature (safety) thermostat cuts power, but resets itself automatically upon cooling. The cycle then repeats. Each time, the heater wires become red hot before the safety thermostat cuts the power. This continues until the unit is turned off or, in the worst case, until the housing ignites. Figure 3 shows a test of this type of failure. The plastic shroud and housing ignited after several on-off cycles, and then burned vigorously, emitting thick noxious smoke.

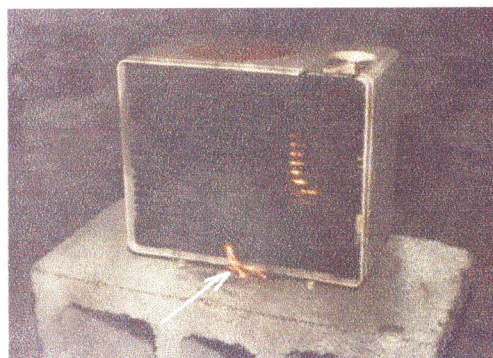
FIGURE 3B - Plastic housing Ignited, Hole Burned/Melted Through Bottom, and Flame (at arrow) Comes From Beneath Housing.

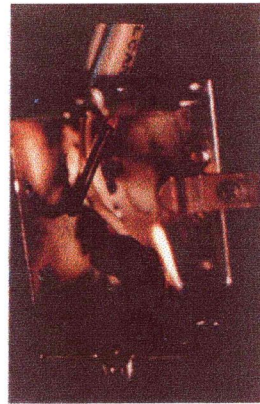
Figure 4B - Connector Shell Ignited

Even in small amounts, electro-kindling materials can be hazardous. The insulating shell of the splicing connector in Figure 4A is made of a type of thermoplastic sometimes called "drip self-extinguishing." When the insulator is ignited in a laboratory test, a flaming drop of melted plastic falls off, extinguishing itself as it drops or after it hits the floor. The rest of the connector insulator remains intact. The fire scenario may be quite different when the connector is used in a typical wiring system. Ignition can occur from failure of the splice connection itself or from failure of an adjacent component. There may be no safe place for a burning drop of plastic to fall. The sequence in Figure 4 is a test of this situation. Shortly after the shell is ignited in this test, a flaming drop forms and falls to the junction box floor just below the connector (Figure 4B). The flaming drop then re-ignites the connector shell. This cycle repeats several times. More flaming plastic falls to the floor of the box. The continuing fire heats and ignites the wire insulation. Although nominally self-extinguishing, the wire insulation combustion is supported by heat from the flaming plastic shell. At the stage shown in Figure 4D, the wire insulation and the cable jacket and filler materials are involved. A small amount of electro-kindling has served to develop and spread the fire.

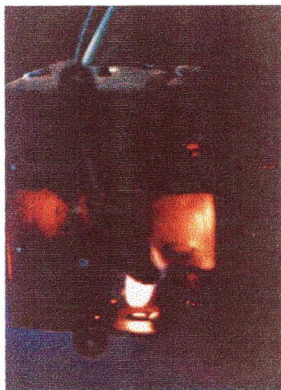
Figure 4C - Flaming Drop of Plastic
on Floor of Junction Box

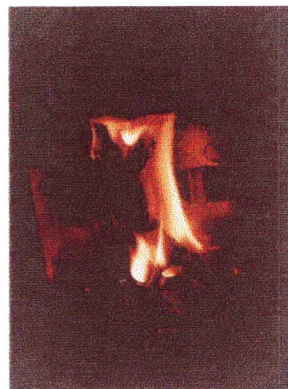
Figure 4D - Fire Grows and Spreads
to Wire Insulation and Cable Jacket

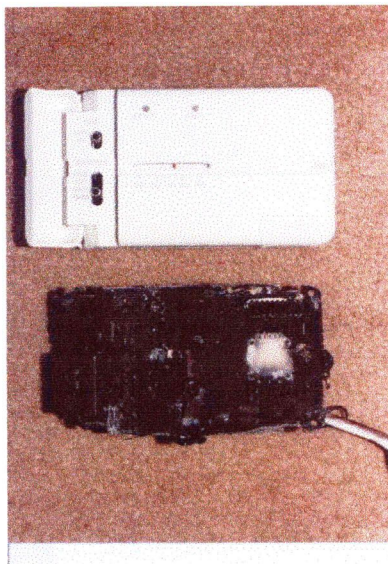
FIGURE 5 - THERMOSTAT WITH "ELECTRO-KINDLING" HOUSING
(Bottom unit ignited and burned due to downstream short circuit in heat pump wiring.)

The wall thermostats shown below in Figure 5 are used to control heat pumps. The top (unburned) unit shows what the bottom one originally looked like before it ignited. According to eyewitnesses, there was a short circuit in the wiring of the heat pump. Soon afterward, the occupant came into the living room to find the thermostat on fire and flaming globs of plastic dripping onto the couch. Whatever internal component in the thermostat failed due to the downstream short circuit is not known. What is known, however is that the thermostat housing did not safely contain the event. The housing ignited and served to spread the fire to the couch below. The bill for fire and smoke damage was in excess of \$20,000. (Sample and incident report courtesy of M. Lane, Corporate Investigative Services.)

It could have been worse. Early detection and fast response limited the damage, and nobody was injured. Change the circumstances slightly, however, and it could have been a tragedy. The savings to the manufacturer of a few pennies on each case, by using of a free-burning (instead of self-extinguishing) plastic, turns out to be a poor buy when the reduction in fire safety factor is considered. Failure of this type of equipment is not so rare that the fire ignition potential can be ignored. In the same large housing community as the above fire incident, there had been several other hazardous failures of the same type of thermostat.

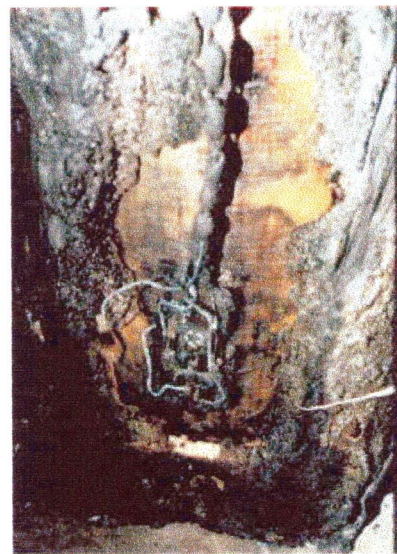
FIGURE 6 - WATER HEATER FIRE.
(Lower thermostat area shown in photo.
Unit constructed with plastic electrical enclosure,
foam thermal insulation, and plastic outer shell.)

Some large appliances are constructed mainly of combustible plastic. The water heater shown in Figure 6 (above right) ignited and burned in a home. An electrical failure occurred at the lower thermostat assembly. The plastic electrical enclosure, the foam thermal insulation, and plastic outer shell of the water heater all burned. This failure could have been reasonably contained, and fire avoided, if the materials in the immediate vicinity of the thermostat had been non-combustible. Instead, the thermostat in this design is surrounded with electro-kindling, and the result was fire ignition and spread. (Samples and incident reports of Figures 5 & 6 courtesy of M. Lane, Corporate Investigative Services.)

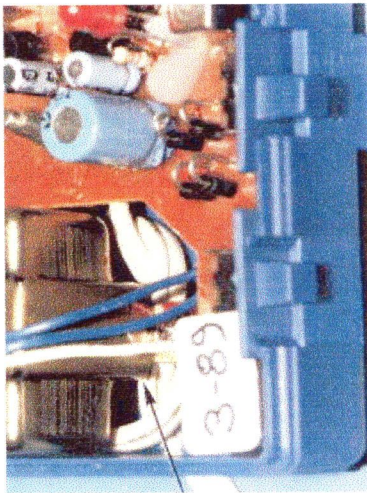
FIGURE 7A - Baby Monitor, Power Cord Touching Transformer (arrow).

Potential ignition sources for electro-kindling also exist in low-power electrical apparatus. The "baby monitor" (wireless intercom) transmitter shown in Figure 7 (below) is an example. There are several possible internal failures that can result in ignition of the housing if it is made of an easily-ignited material. One possible failure sequence can cause shorting of the power cord that enters the case under the transformer. The cord is knotted to prevent it from being pulled out. At the knot, the power cord is in contact with the transformer (Figure 7A). A simple component failure - for instance the shorting of a power supply diode on the circuit board - can cause the transformer to run hot. Insulation on the power cord can then soften and flow where it is pressed against the overheated transformer, allowing the wires to short together. The resulting momentary arc can cause a brief internal flame which can ignite the housing. A test of the plastic housing on this sample demonstrates (Figure 7B) that it ignites easily and burns vigorously -- it is made of electro-kindling. Flaming drops of molten plastic fall from the burning housing and continue to burn on the floor below.

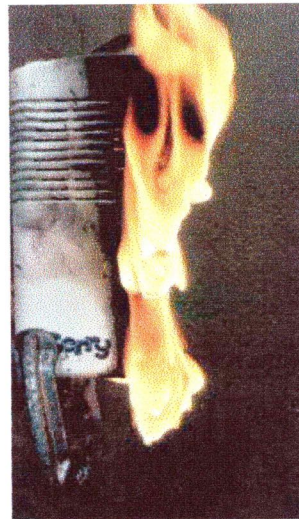
FIGURE 7B - Baby Monitor, Burn Test of Plastic Housing.

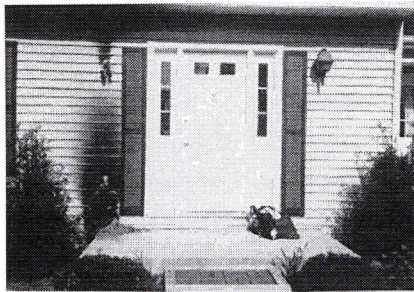
Figure 8A - Plastic Light
Fixture Fire, Overall View

Figure 8 (below) shows how a light fixture made of electro-kindling can bring the house down. The undamaged fixture to the right of the door is one of two identical units on either side of the door. Its companion on the left side ignited. Flaming plastic dropped to the ground, spreading the fire to the siding. A passer-by saw the fire and smothered it with dirt from the flower bed. A lucky break. Luck, though, is an unreliable substitute for an adequate built-in safety factor. Fixtures like this used to be constructed of metal and glass, providing a substantial fire safety factor relative to this modern version made almost entirely of free-burning plastic. An identical unit could be constructed of self-extinguishing (rather than free-burning) plastic.

Overlamping may have caused this fire. Or, perhaps a bird got in through a broken lens and built a nest inside. If the fixture is non-combustible, we need only be concerned with possible ignition of nearby material. Here, however, the fixture itself ignites. Worse, once ignited, the plastic behaves as a sort of "consumer napalm," spreading the flame and greatly increasing the possibility of a penalty of death by fire for overlamping (or for failing to replace a damaged lens).

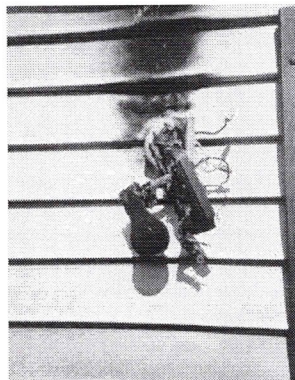
Figure 8B - Remains of
Light Fixture

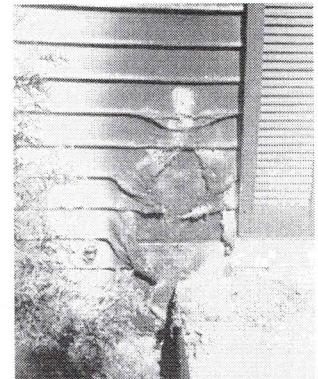
Figure 8C - Fire Spread
to Siding
