# Aluminum and Vinyl Siding on Historic Buildings

### ***The Appropriateness of Substitute Materials for Resurfacing Historic Wood Frame Buildings***

John H. Myers, revised by Gary L. Hume

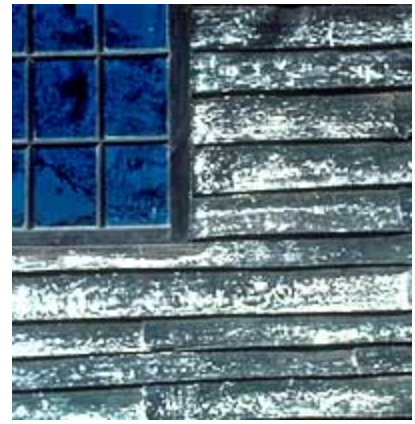
Historic wood siding exhibits rich and varied surface textures. They range from hand-split clapboards of short lengths with feather-edged ends (shown here), to pit or mill sawn boards which can be beveled, rabbeted, or beaded. Photo: NPS files.

The variety of tools used, coupled with regional differences in design and craftsmanship, has resulted in a richness and diversity of wood sidings in America. For example, narrow boards with beveled, lapped joints called "clapboards" were used on New England frame dwellings. The size and shape of the "clapboards" were determined by the process of hand splitting or

"riving" bolts of wood. The width, the short lengths, the beveled lapping, the "feathered" horizontal joints, and the surface nailing of the clapboards created a distinctive surface pattern that is recognizable as an important part of the historic character of these structures.

The sawn and hand-planed clapboards used throughout the Mid-Atlantic and Southern states in the eighteenth and early nineteenth centuries, by contrast, have a wide exposure—generally between six and eight inches. The exposure of the siding, frequently coupled with a beaded edge, created a very different play of light and shadow on the wall surface, thus resulting in a different character. The "German" or "Novelty siding"—a milled siding that is thin above and thicker below with a concave bevel—was used throughout many parts of the United States in the late nineteenth and early twentieth century but with regional variations in material, profile, and dimensions. One variation of this type of milled siding was called "California siding" and was milled with a rabbetted or shiplap edge to insure a tight installation of the weather boards. Shingles were also commonly used as an exterior cladding material, and in buildings such as the Bungalow style houses, were often an important character-defining feature of the exterior. Shingles were often applied in decorative patterns by varying the lap, thus creating alternating rows of narrow exposures and wide exposures. Shingles were also cut in geometric patterns such as diamond shapes and applied in patterns. This treatment was commonly used in the gable end of shingled houses. Siding and wood shingles were often used in combination with materials such as cobblestone and brick in Bungalow style buildings to create a distinctive interplay of surfaces and materials.

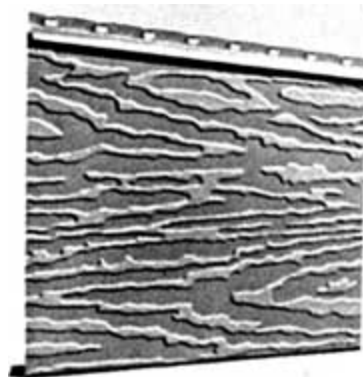
Aluminum and vinyl siding are available in a variety of widths and colors, but the optional wood graining is not characteristic of real wood siding. Photo: NPS files.

top of existing siding, details around windows and doors may appear set back from the siding rather than slightly projecting; and if the relationship of molding or trim to the wall is changed, it can result in the covering or removal of these historic features. New substitute siding with embossed wood graining—intended to simulate the texture of wood—is also visually inappropriate. Exaggerated graining would have been undesirable on real wood siding and is generally found only after sandblasting, a destructive and totally unacceptable treatment for wood.

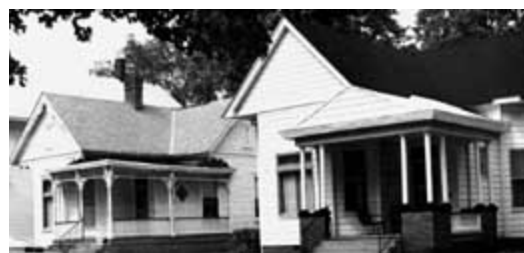
When aluminum was installed on the house on the right, the barge boards, scrollwork, columns, and railings were removed. The distinctive shingled gable and attic vent were covered, further compromising the building's architectural integrity. Photo: NPS files.

Although it is sometimes argued that an artificial siding application is reversible since it can be removed, there is frequently irreversible damage to historic building materials if decorative features or trim are permitted to be cut down or destroyed, or removed by applicators and discarded. The installation process requires that the existing surface be flat and free of "obstructions" so that the new siding will be smooth and even in appearance. To achieve the requisite flat surface, furring strips are usually placed over the wall surface (vertical furring strips for horizontal aluminum or vinyl siding and vice-versa for vertical siding). The potential danger in this type of surface preparation is that the furring strips may change the relationship between the plane of the wall and the projecting elements such as windows, door trim, the cornice, or any other projecting trim or molding. Projecting details may also cause a problem. To retain them, additional cutting and fitting will usually be required. Further, additional or special molding pieces, or "accessories" as they are called by the industry, such as channels, inserts and drip caps, will be needed to fit the siding around the architectural features. This custom fitting of the siding will be more labor-intensive, adding to the cost of the siding installation.

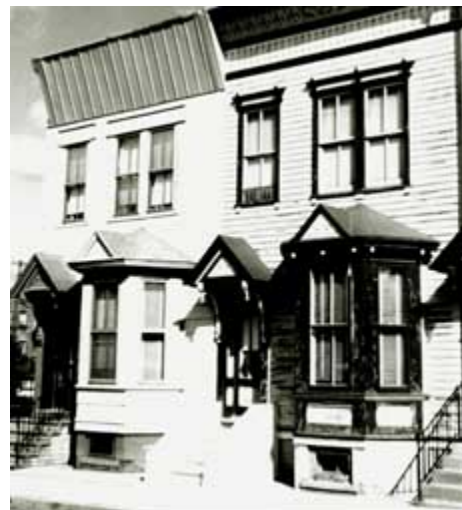
When a building is in need of maintenance, such as the house on the right which needs painting, some owners consider installing aluminum or vinyl siding. The result (see left) can be a complete loss of architectural character due to the covering of details and change of scale due to inappropriate siding dimensions. Photo: NPS files.

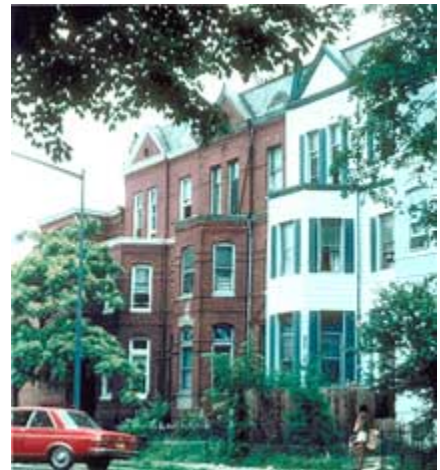
The inappropriate siding applied to the house on the right has altered the character of the urban setting. Photo: NPS files.

While this discussion focuses primarily on the historic character of individual wood frame buildings, of equal importance is the context of buildings that comprise a historic district or neighborhood. Changes to the character-defining features of a building, such as distinctive clapboarding and other wall surfaces and decorative trim, always have an impact on more than just that building; they also alter the historic visual relationship between the buildings in the district. If character-defining weatherboards, clapboards or shingles are replaced on a number of buildings in a historic district, the historic character of the entire district may be seriously damaged. Because of the potential impact some substitute materials have on the character of a neighborhood or district, many communities regulate their use through zoning ordinances and design review boards. These ordinances and review boards usually require review and approval of proposed alterations to a historic building that could potentially impact the historic character of the building or the district, including the application of substitute materials, such as aluminum or vinyl siding.
