Aluminum and Vinyl Siding on Historic Buildings

Preservation Briefs

8

The Appropriateness of Substitute Materials for Resurfacing Historic Wood Frame Buildings

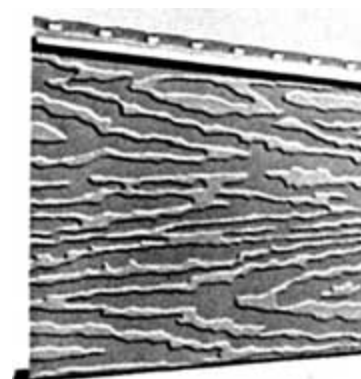
Aluminum and vinyl siding are available in a variety of widths and colors, but the optional wood graining is not characteristic of real wood siding. Photo: NPS files.

top of existing siding, details around windows and doors may appear set back from the siding rather than slightly projecting; and if the relationship of molding or trim to the wall is changed, it can result in the covering or removal of these historic features. New substitute siding with embossed wood graining—intended to simulate the texture of wood—is also visually inappropriate. Exaggerated graining would have been undesirable on real wood siding and is generally found only after sandblasting, a destructive and totally unacceptable treatment for wood.

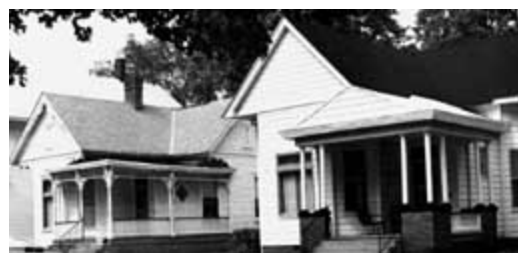
When aluminum was installed on the house on the right, the barge boards, scrollwork, columns, and railings were removed. The distinctive shingled gable and attic vent were covered, further compromising the building's architectural integrity. Photo: NPS files.

Although it is sometimes argued that an artificial siding application is reversible since it can be removed, there is frequently irreversible damage to historic building materials if decorative features or trim are permitted to be cut down or destroyed, or removed by applicators and discarded. The installation process requires that the existing surface be flat and free of "obstructions" so that the new siding will be smooth and even in appearance. To achieve the requisite flat surface, furring strips are usually placed over the wall surface (vertical furring strips for horizontal aluminum or vinyl siding and vice-versa for vertical siding). The potential danger in this type of surface preparation is that the furring strips may change the relationship between the plane of the wall and the projecting elements such as windows, door trim, the cornice, or any other projecting trim or molding. Projecting details may also cause a problem. To retain them, additional cutting and fitting will usually be required. Further, additional or special molding pieces, or "accessories" as they are called by the industry, such as channels, inserts and drip caps, will be needed to fit the siding around the architectural features. This custom fitting of the siding will be more labor-intensive, adding to the cost of the siding installation.
