Technical Preservation Services

Keeping a Lid on It: Asbestos-Cement Building Materials

Amy Lamb Woods
August 2000

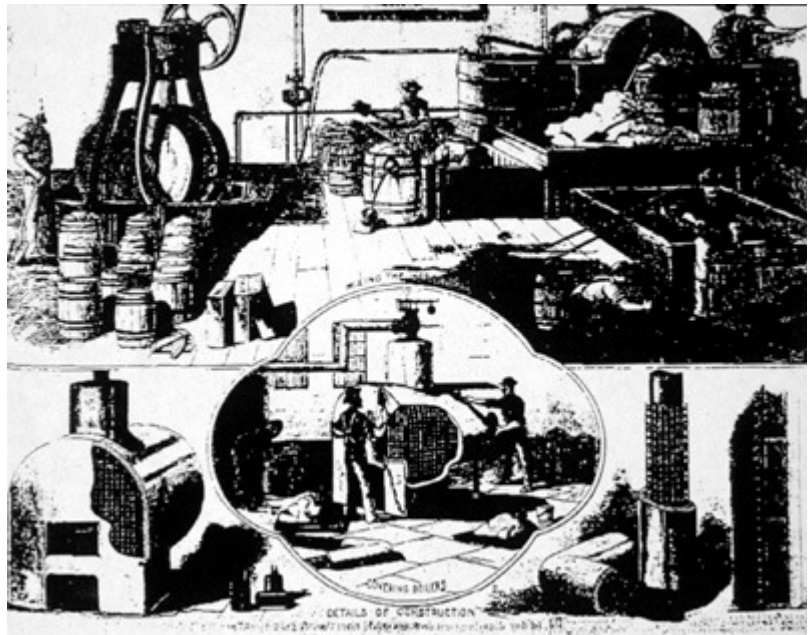
Figure 1. Manufacture of non-conducting asbestos-cement coverings for steam-pipes and boilers (*Scientific America*, 1876).²⁶

Asbestos-cement was first manufactured in the United States in 1905,⁶ introduced first in the form of a coating. It was easily installed and assumed to be indestructible when applied as a covering to boilers, steam pipes, hot blast furnaces, and stills. H. W. Johns Manufacturing Company (later Johns-Manville) became one of the leaders in the development of cement products containing asbestos. The company initially marketed asbestos-cement coating as an agent for repairing roofs, and guaranteed it to stop all leaks when properly applied, making seemingly worthless roofs serviceable for many years. This product was used in joints around chimneys, dormer windows, skylights, scuppers, shingles, and nail holes on roofs (Figure 1). Asbestos-cement was also invaluable for protecting beams, posts, walls, and ceilings, especially in hotel and restaurant kitchens, or places where it was desired to prevent the transmission of heat to adjoining rooms.⁷ H. W. Johns along with other early manufacturers, such as Keasbey & Mattison Company, Baltimore Roofing & Asbestos Manufacturing Company, Inc., Philip Carey Manufacturing Company, and Flintkote Company, engaged in producing a wide range of asbestos-cement products throughout much of the first half of the century.

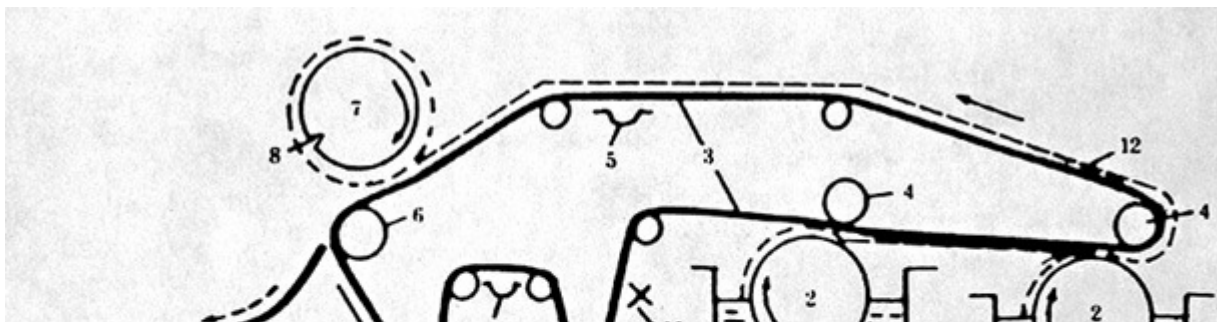
Figure 2. Simplified representation of a Hatschek machine for asbestos-cement production (Wilden, 1986).²⁷

It was not until 1907 that the invention by an Austrian engineer, Ludwid Hatschek, made possible the manufacture of pre-formed asbestos-cement products.⁸ The Hatschek machine, a wet transfer roller, was used to produce the initial asbestos-cement sheets (Figure 2), while two other manufacturing processes included the Mazza process for pipes, and the Magnani semi-dry process for corrugated sheets.⁹ After being formed, most products were steam cured to achieve the optimum microstructure for strength and durability. It is these asbestos-cement building products that have many desirable material characteristics, such as being lightweight, impermeable to water, durable, tough, resistant to rot, termites, soiling, corrosion, warping, and fire, and easy to clean and maintain. Asbestos-cement also possesses low thermal conductivity and is therefore a good electrical insulator. These highly desirable material characteristics, apparent in the new found material, sparked growth in manufacture of a plethora of forms and styles to suit different needs.

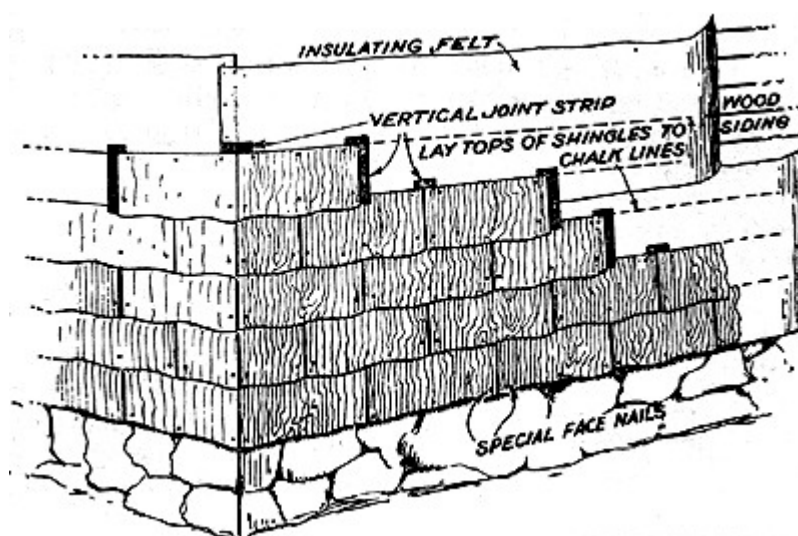
Figure 4. Asbestos-Cement siding installation specifications (McCawley, 1940).

Asbestos-cement siding shingles imitated wood siding shingles in shape and appearance, typically available in sizes of twelve by twenty-four inches. These shingles originally came in nondescript tones like gray-green, gray-pink, and Dover white. Textures such as grooved, wood-grained, or smooth were pressed into the large asbestos-cement sheets, then cut to the profile of the design, such as Tapertex (flat horizontal lines), Thatched, or Waveline. They were usually predrilled for ease of installation with two to three nails on the bottom of each shingle to secure the panels to the sheathing. Installation was executed from the bottom up. As one row of shingles was nailed, the bottom lip would secure the top of the shingle from the row below (Figure 4).¹⁴ This construction

technique allowed ease in replacing shingles, unlike wood or slate shingles that were secured at the top of each shingle.

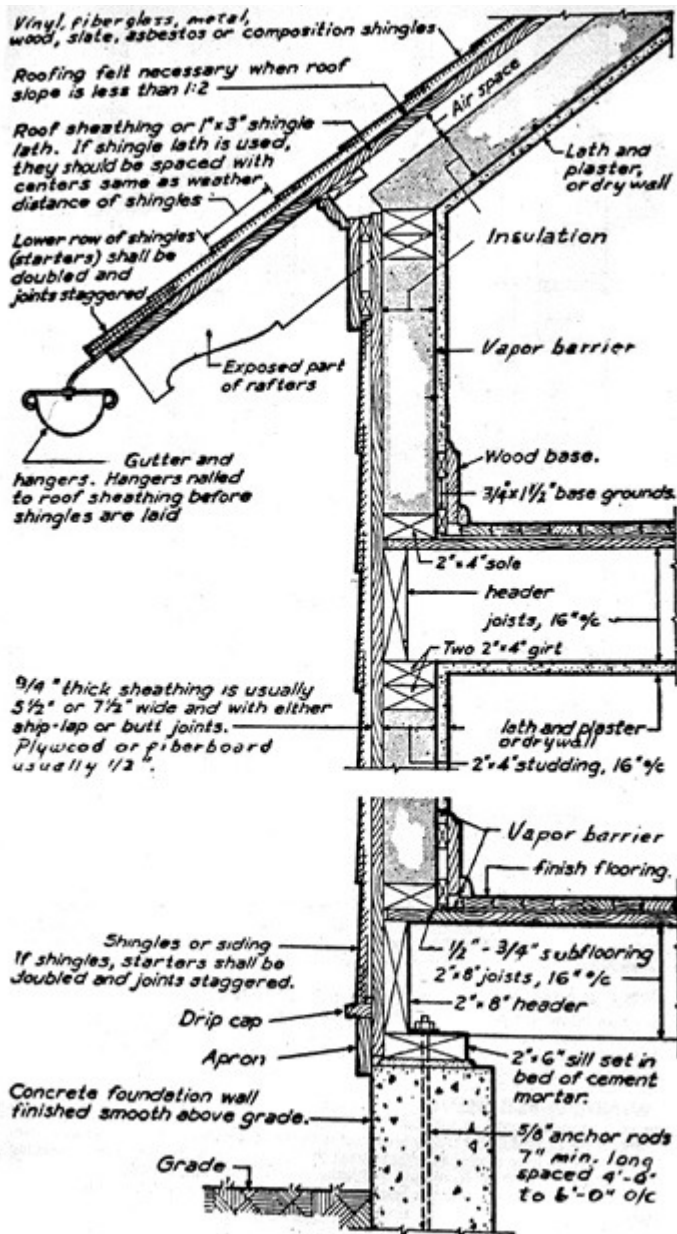
Figure 5. Partial wall section for shingle siding construction; shows a drip cap and apron in place to protect the bottom edge of siding shingles (Graf, 1985).

lawnmower damage, adding a bumper material to the bottom row of siding to reduce vulnerability to cracking and chipping (Figure 5), and keeping branches and debris away from the roof and out of gutters.

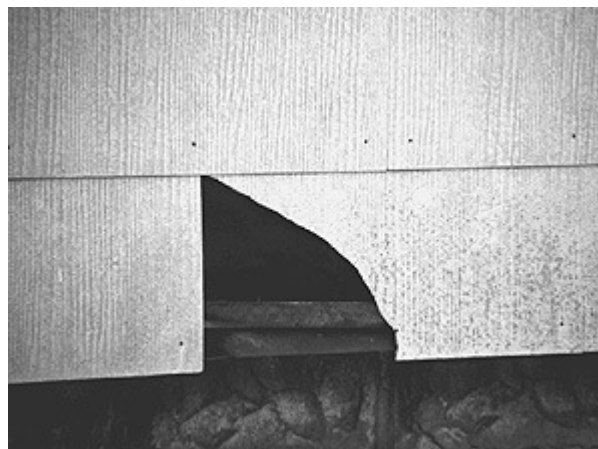
Figure 6. Asbestos-cement products most commonly deteriorate by cracking and chipping. These kinds of deterioration are not typically feasible to repair, and therefore it is recommended that a non-asbestos fiber cement piece be used as a replacement (photo by author).

Since asbestos-cement products were manufactured in standard sizes, shapes, colors, and textures, partial replacement is well suited for implementation. This process is acceptable when part of, or pieces of, the existing asbestos-cement building material have deteriorated to such a degree that it is much more feasible to replace than repair (Figure 6). Since the United States no longer produces asbestos-cement products, an alternative material should be selected to match the original. Some materials that have been manufactured to replicate asbestos-cement building components are non-asbestos reinforced cement, fiberboard with asphalt, fiberglass, metal, and vinyl. For the purposes of preservation, one of the non-asbestos reinforced cement products is most appropriate.

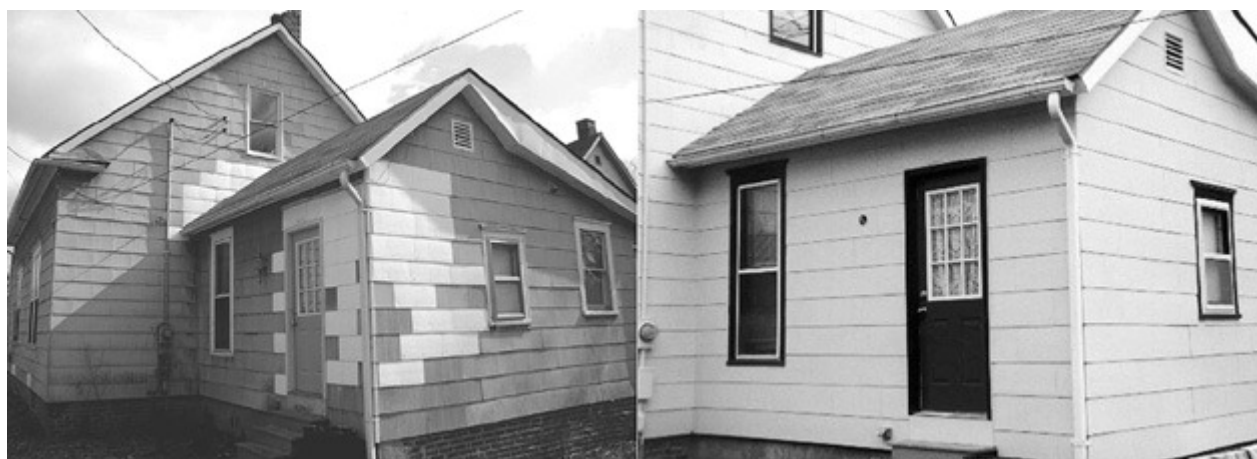
Figure 7. Replacement non-asbestos fiber-cement shingles in place, before being painted and after (photo by author).

Many varieties of non-asbestos reinforced cement or fiber-cement are currently available. Fibers that have been introduced with cement include: steel, glass, polypropylene, wood (these four being the most common), acrylic, akwara, alumina, carbon, cellulose, coconut, kevlar, nylon, perlon,

polyethylene, rock wool, and sisal.²⁵ Combinations of fibers are currently undergoing research in order to get properties closely matching those of asbestos. Several companies manufacture products that replicate asbestos-cement roofing and siding shingles, flat sheets, and corrugated sheets. Some of these manufacturers include: Supradur Manufacturing Company, Cement Board Fabricators, U.S. Architectural Products, Inc., Re-Con Building Products, and GAF Materials Corp. The fiber-cement products replicate the size, shape, thickness, and structure, along with texture and color of many of the asbestos-cement products previously available. Where color matching is not found, an alternative is to replace in size and shape then paint over the entire structure for a uniform appearance (Figure 7). In addition, the hardware and the installation procedures for these products are similar to those for asbestos-cement products due to their similar characteristics and proportions.
